**NESHAP COMPLIANCE (PRE-DEMOLITION) LIMITED (SOME AREAS
WERE NOT ACCESSIBLE) ASBESTOS INSPECTION**

526 S. Main
New Lexington, Ohio 43756

Lepi Enterprises, Inc.
640 G.W. Morse Street
Zanesville, Ohio 43701
(740) 453-2980

September 21, 2023 - September 22, 2023

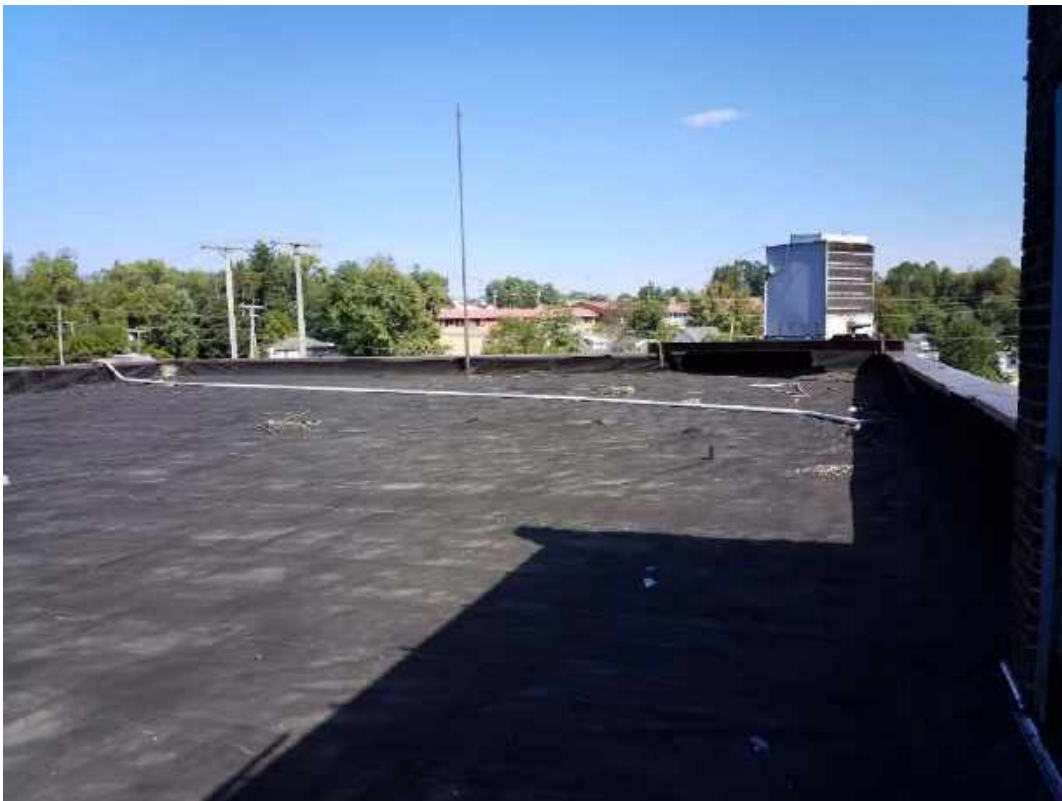
Roof, Street View

| Material Category | Material | Floor | Location | Friability | Regulatory Result | Estimated Quantity | Current Condition |
|---|---|---|---|---|--|---|---|
| Miscellaneous | 030 - Roofing Material | Street View | Roof | Category I Nonfriable | Assumed Positive (Not Tested by Lab) | 79189 sq. ft. | Damaged |

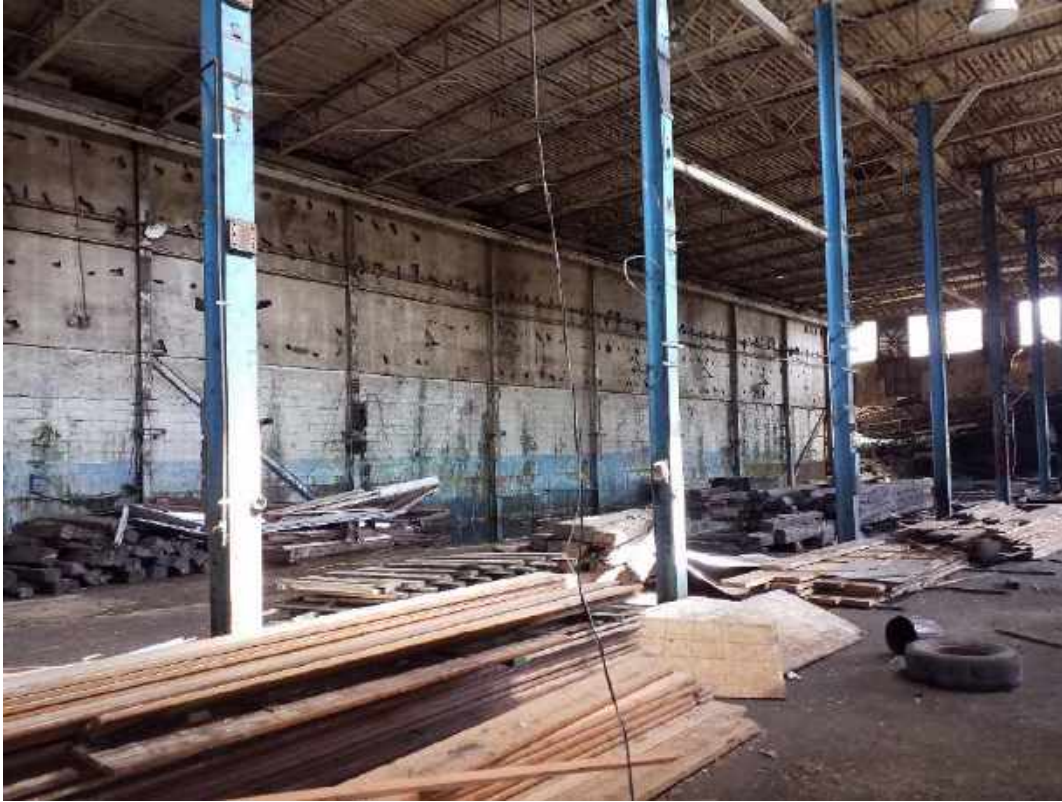
025 - corrugated transite, Room 44, Large L shaped warehouse

| Material Category | Material | Floor | Location | Friability | Regulatory Result | Estimated Quantity | Current Condition |
|---|--|---|---|---|--|---|---|
| Miscellaneous | 025 - corrugated transite | Large L shaped warehouse | Room 44 | Category II Nonfriable | Greater Than 1% Asbestos by Lab (ACM) | 10400 sq. ft. | Damaged |
