**NESHAP COMPLIANCE (PRE-DEMOLITION) LIMITED (SOME AREAS
WERE NOT ACCESSIBLE) ASBESTOS INSPECTION**

526 S. Main
New Lexington, Ohio 43756

Lepi Enterprises, Inc.
640 G.W. Morse Street
Zanesville, Ohio 43701
(740) 453-2980

September 21, 2023 - September 22, 2023

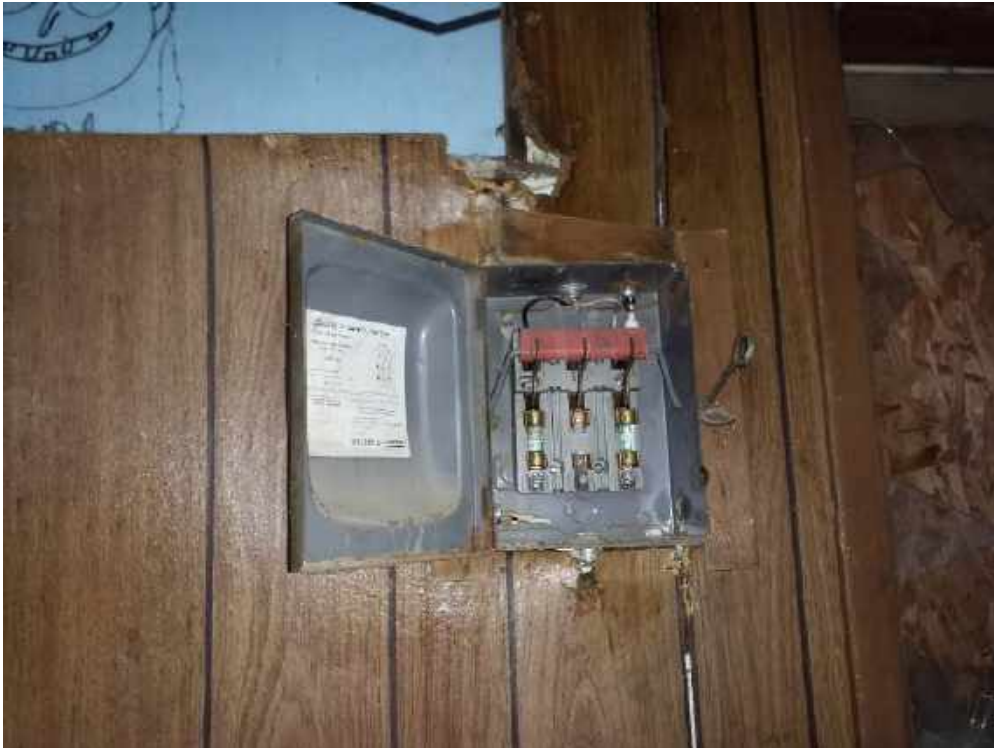
002 - Electrical transite in boxes, Room 3, 3rd Floor
