**NESHAP COMPLIANCE (PRE-DEMOLITION) LIMITED (SOME AREAS
WERE NOT ACCESSIBLE) ASBESTOS INSPECTION**

526 S. Main
New Lexington, Ohio 43756

Lepi Enterprises, Inc.
640 G.W. Morse Street
Zanesville, Ohio 43701
(740) 453-2980

September 21, 2023 - September 22, 2023

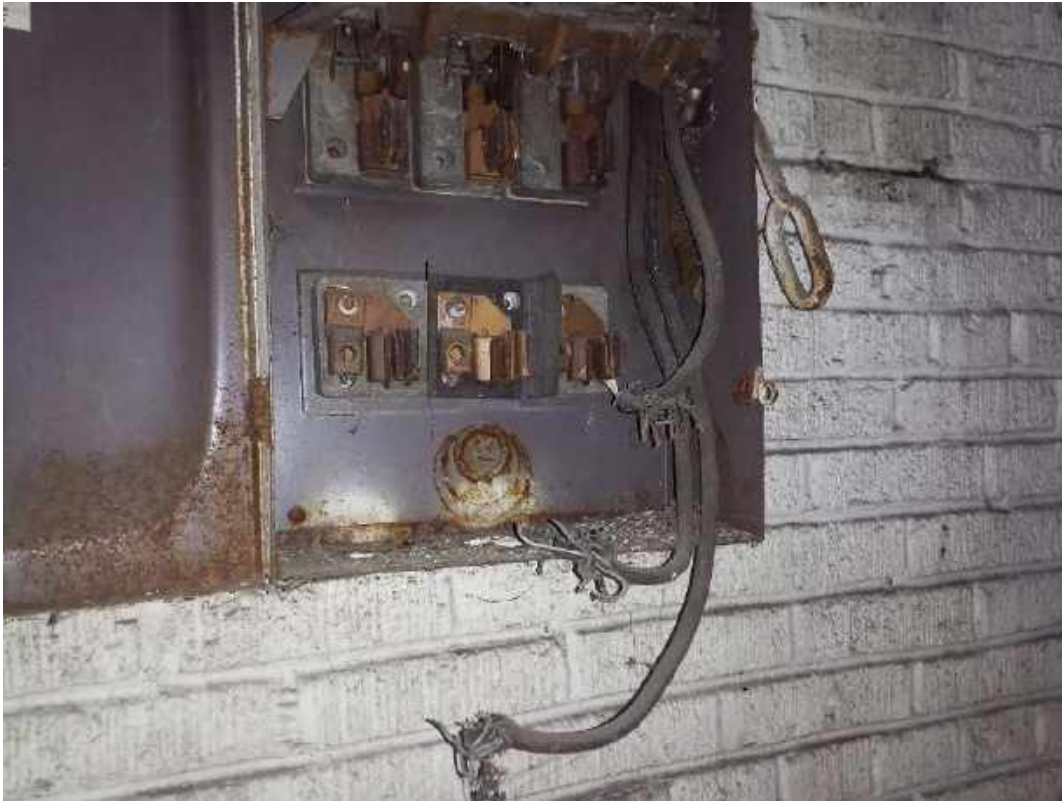
001 - Electrical wire, Garage next to Room 24 by mens restroom, 1st floor under offices

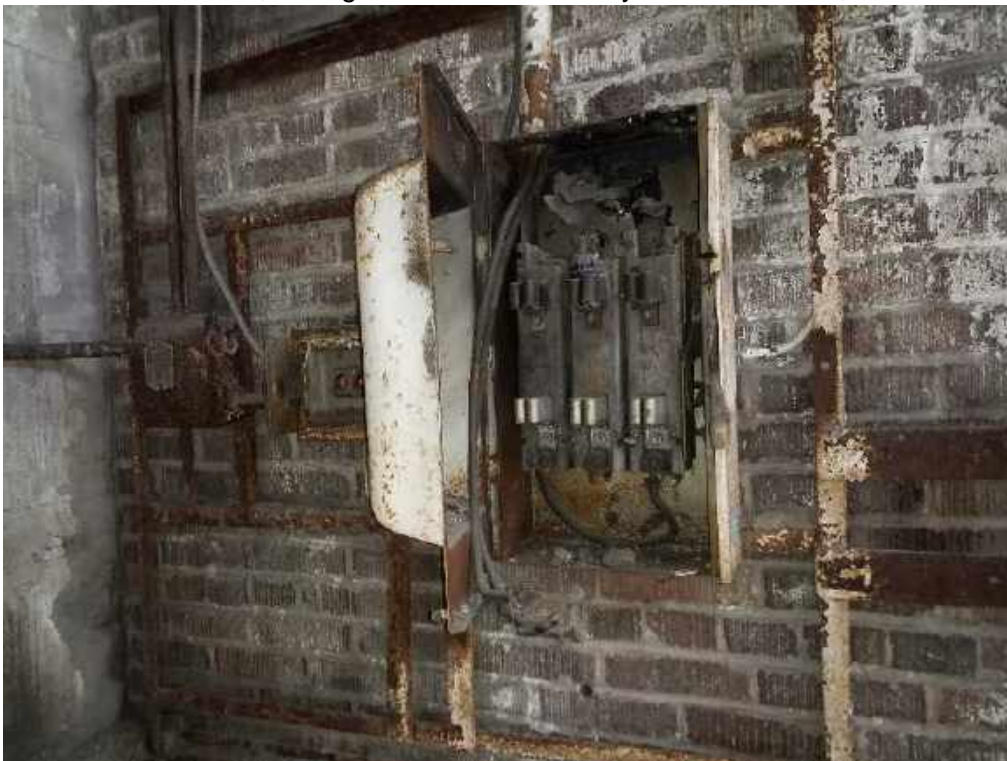
001 - Electrical wire, Garage next to Room 24 by mens restroom, 1st floor under offices

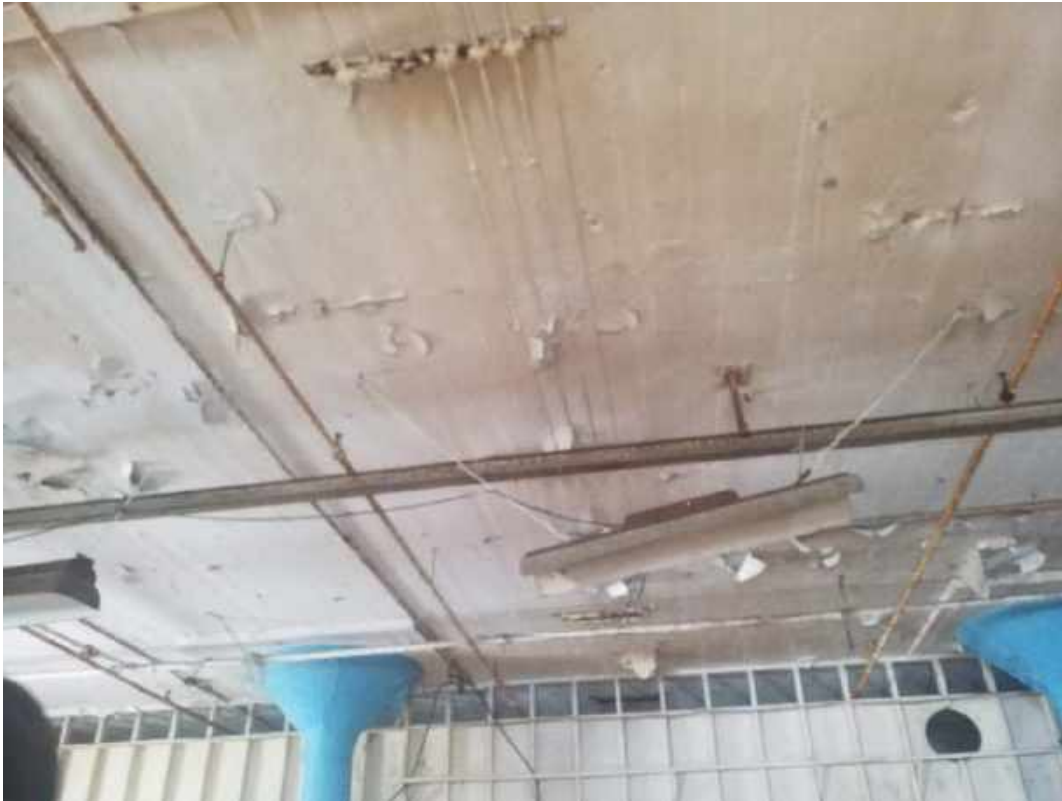
001 - Electrical wire, Room 1, 3rd Floor

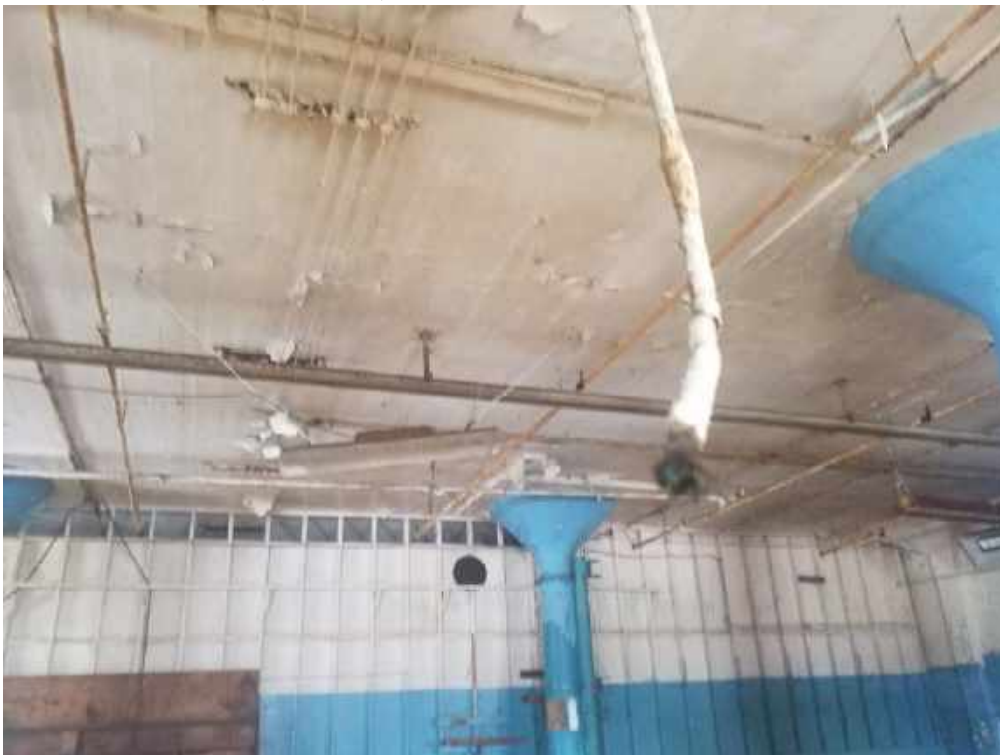
001 - Electrical wire, Room 1, 3rd Floor

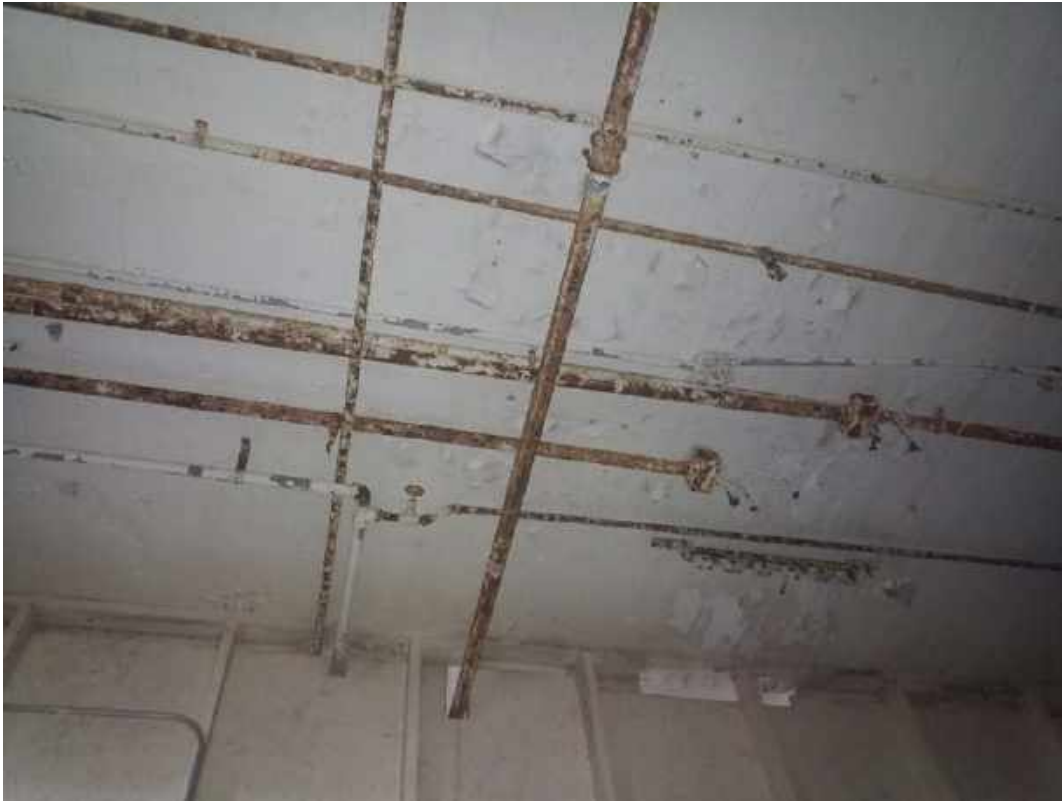
001 - Electrical wire, Room 4, 3rd Floor

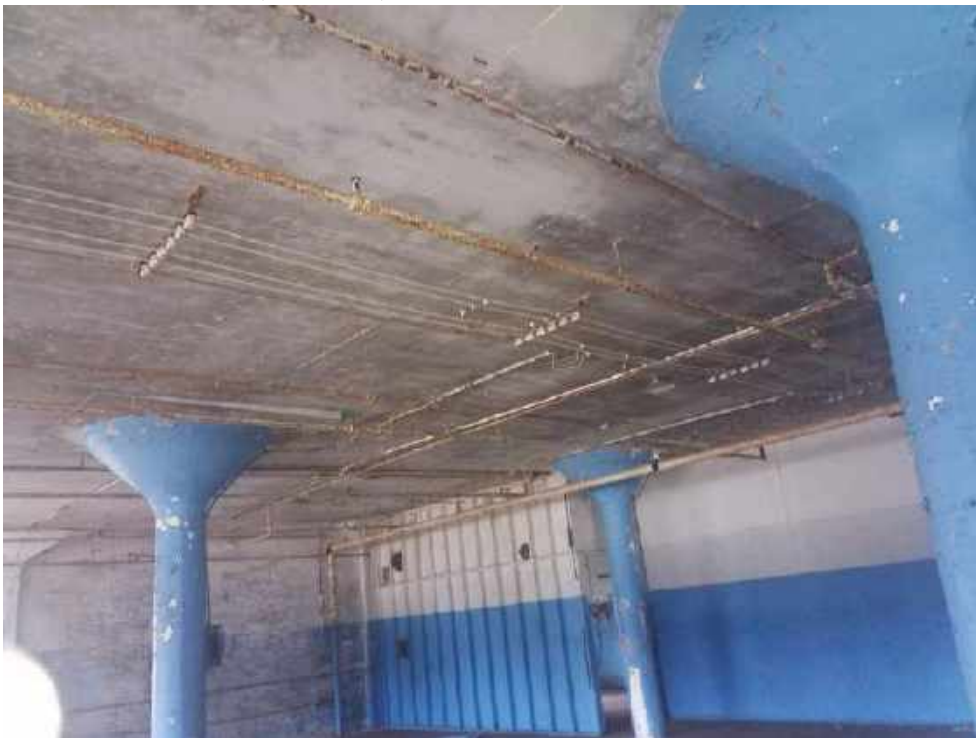
001 - Electrical wire, Room 9, 3rd Floor

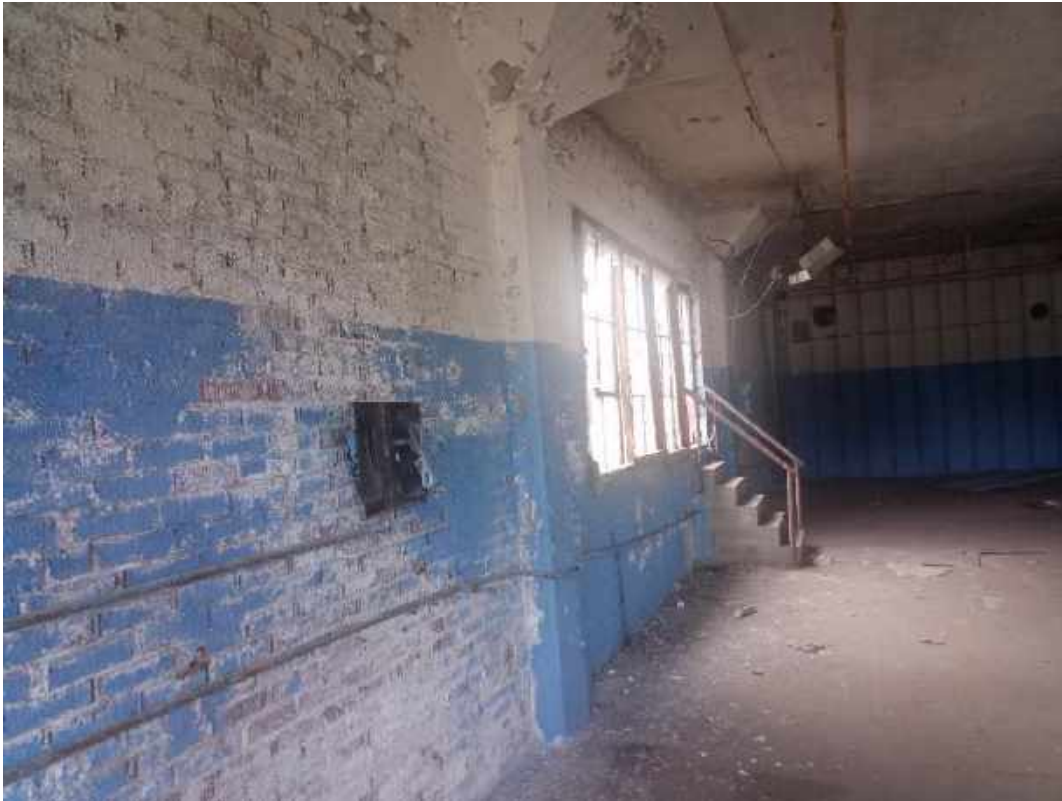
002 - Electrical transite in boxes, Room 9, 3rd Floor

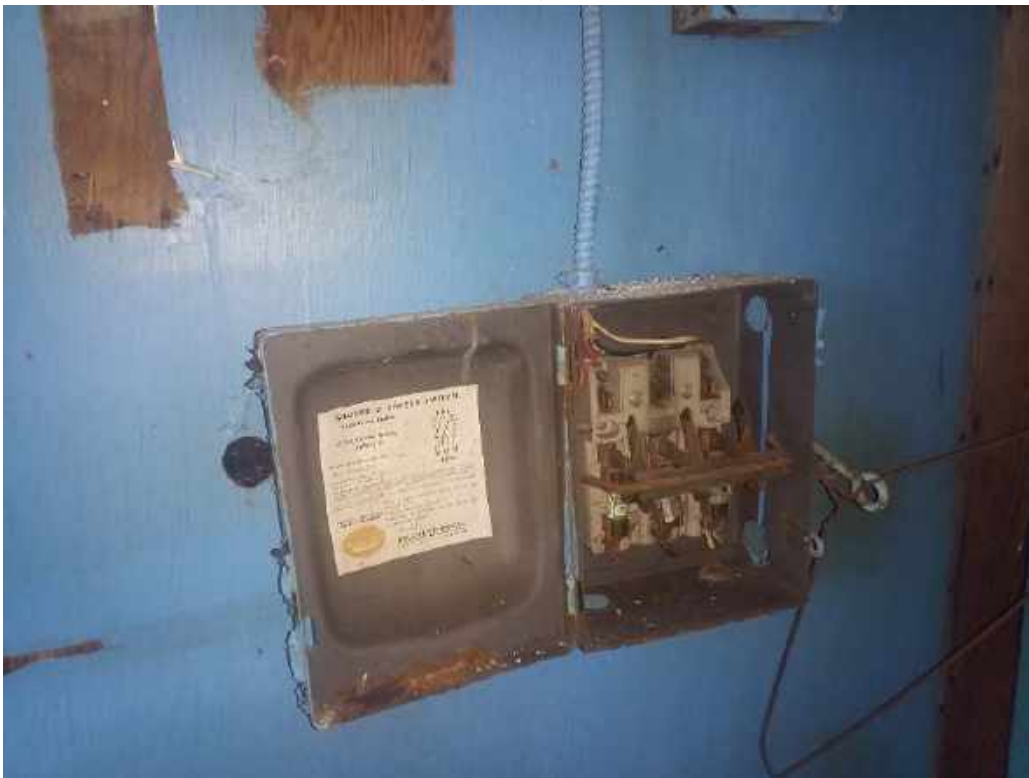
002 - Electrical transite in boxes, Room 5, 3rd Floor

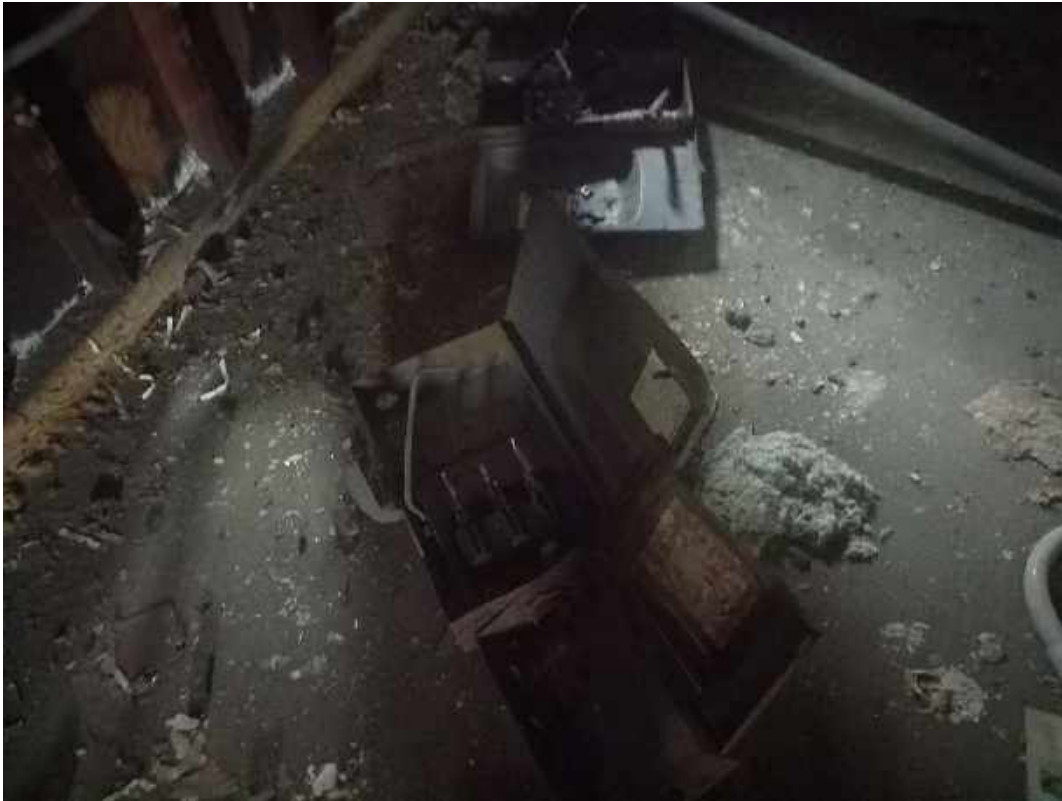
002 - Electrical transite in boxes, Room 2, 3rd Floor

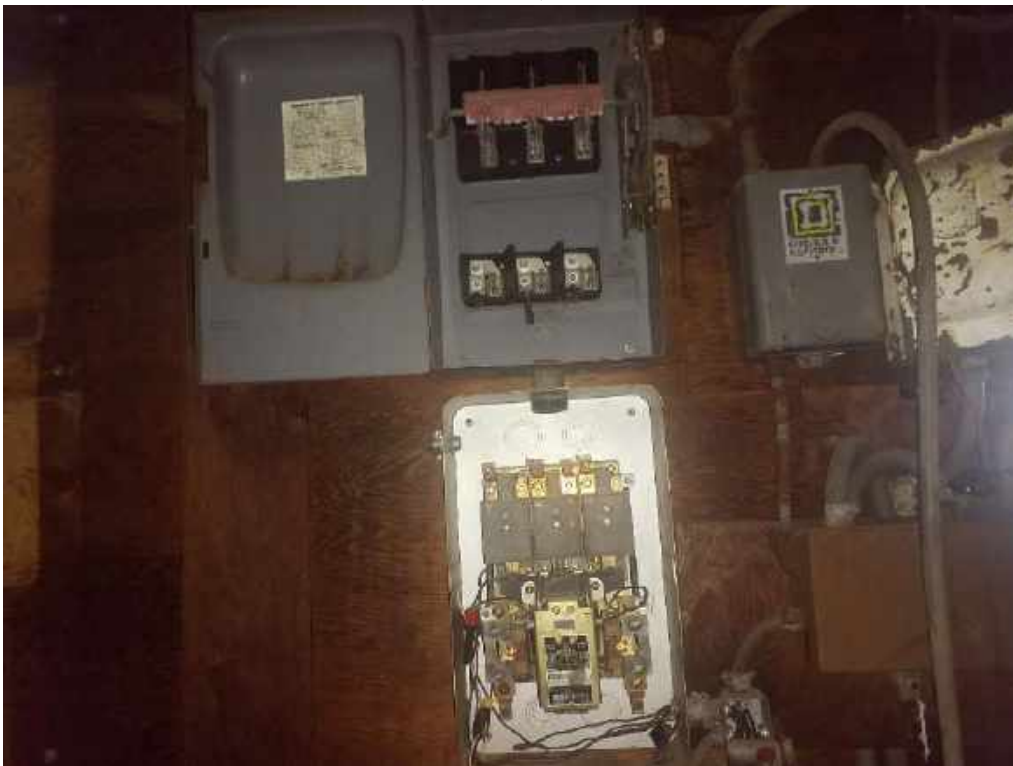
002 - Electrical transite in boxes, Room 2, 3rd Floor

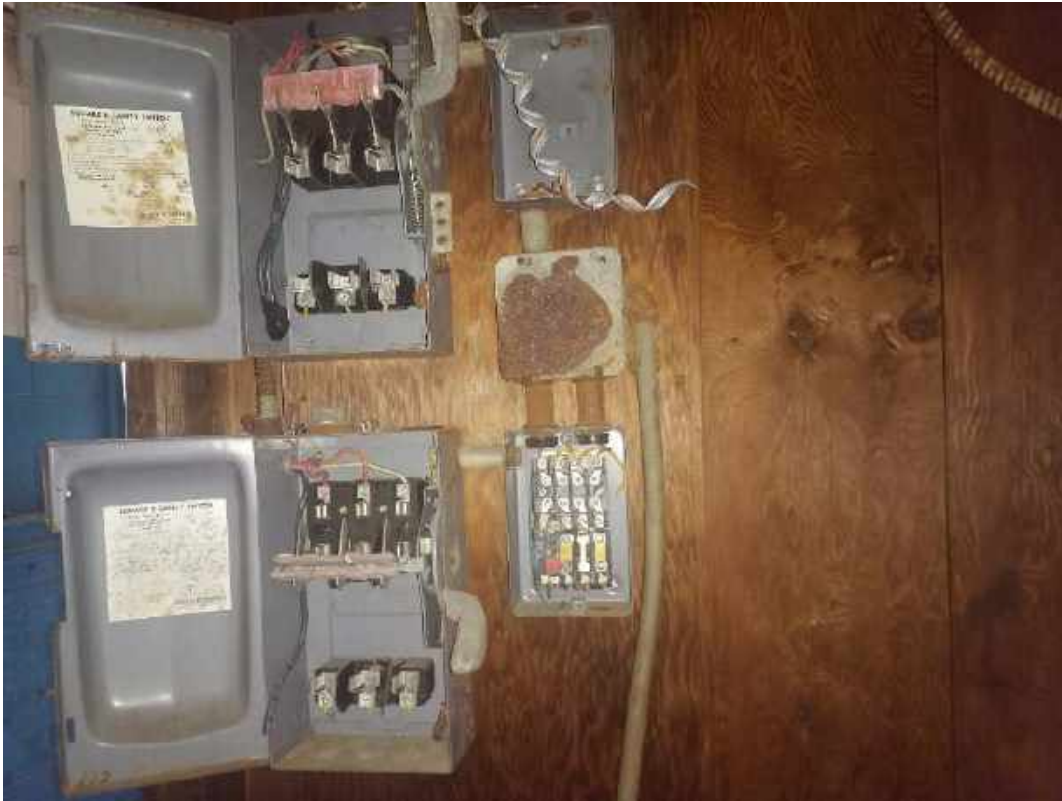
002 - Electrical transite in boxes, Room 2, 3rd Floor

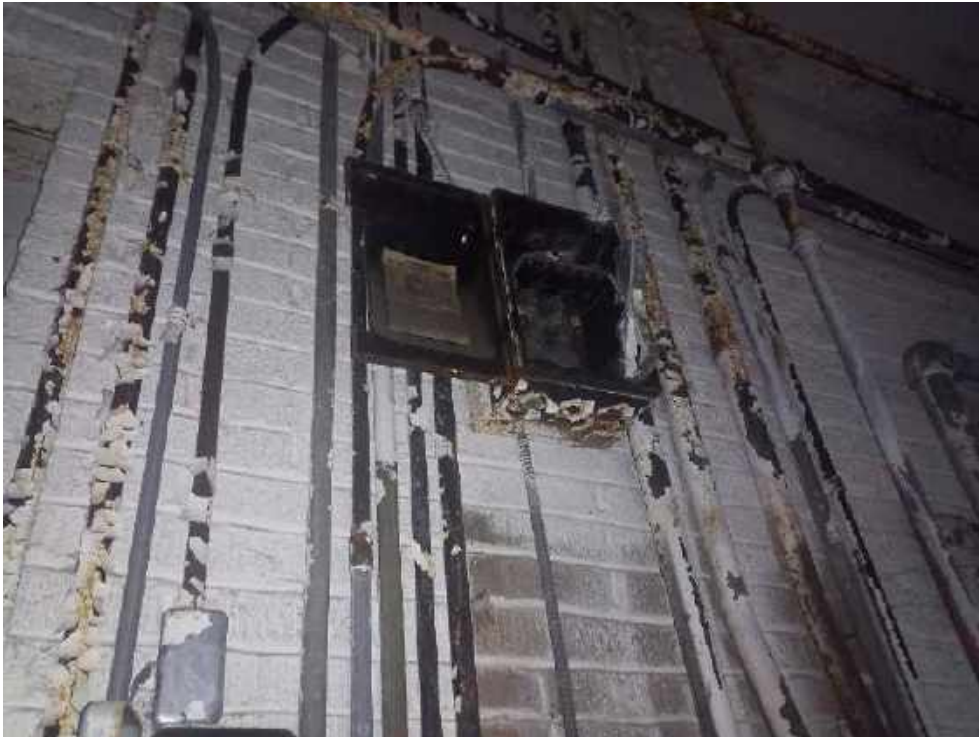
002 - Electrical transite in boxes, Room 3, 3rd Floor

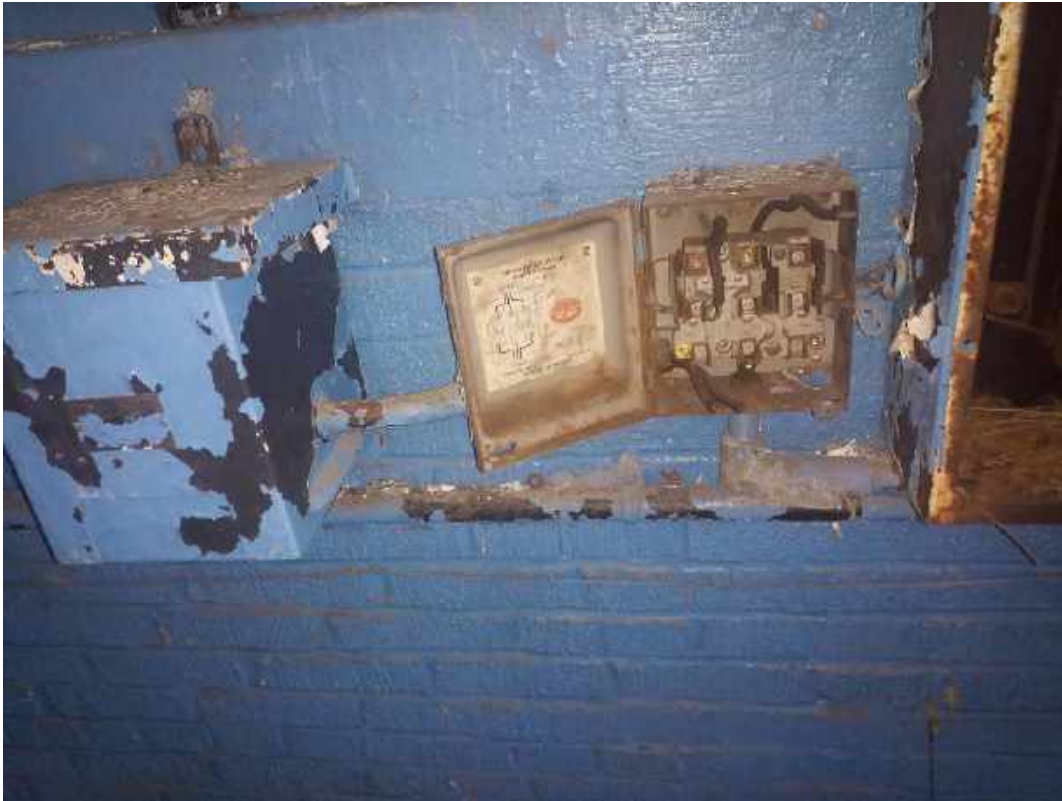
002 - Electrical transite in boxes, Room 3, 3rd Floor

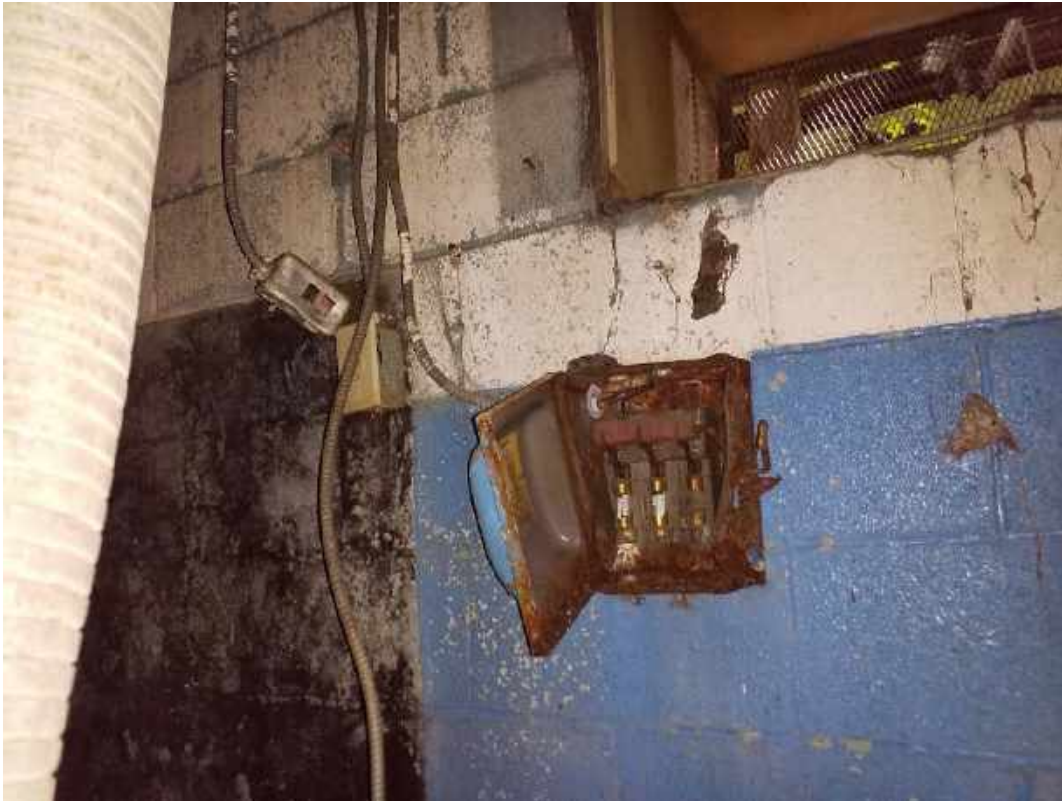
002 - Electrical transite in boxes, Room 39, Warehouse offices area

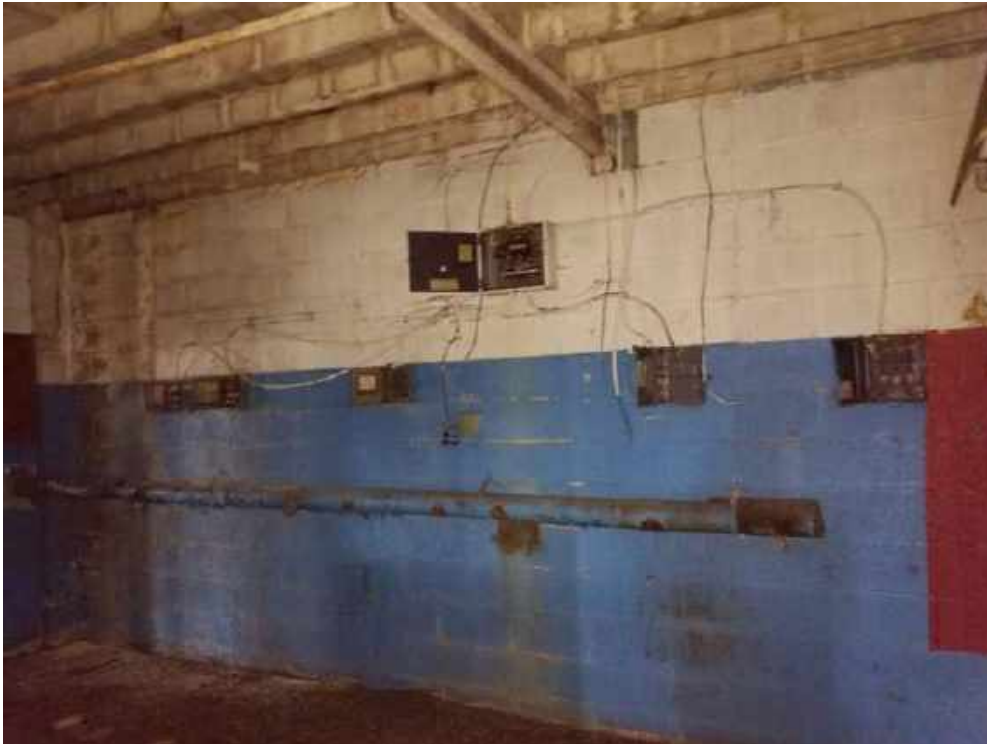
002 - Electrical transite in boxes, Room 41, Large L shaped warehouse

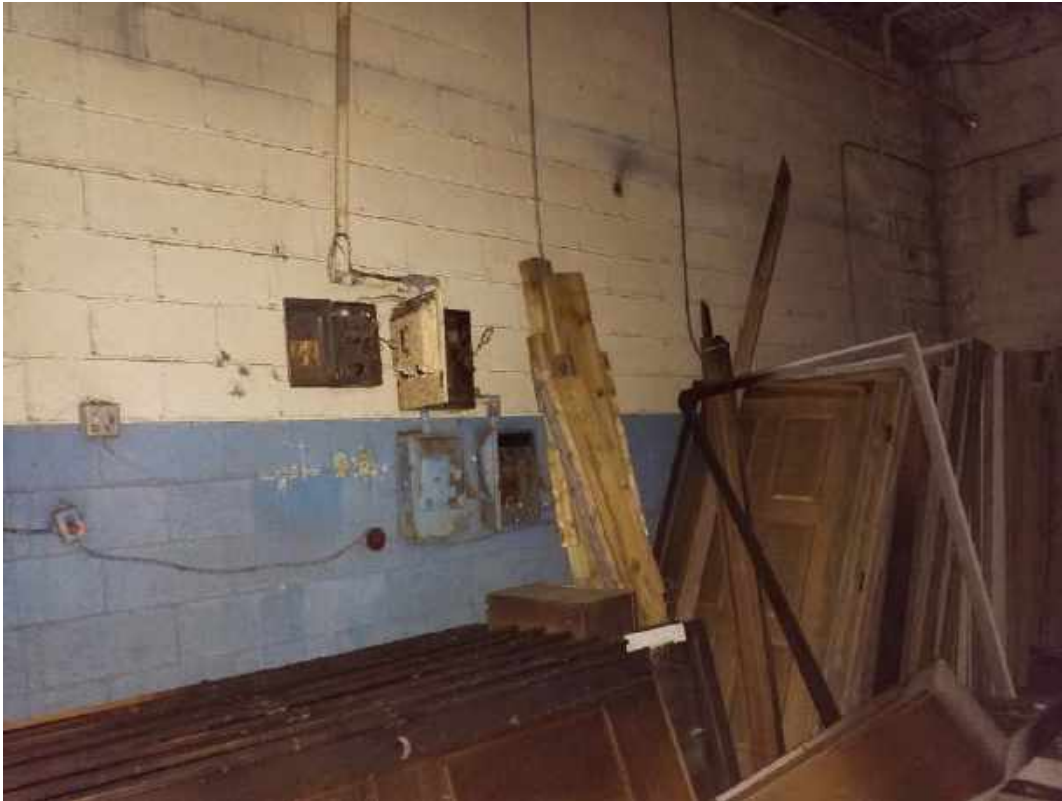
002 - Electrical transite in boxes, Room 41, Large L shaped warehouse

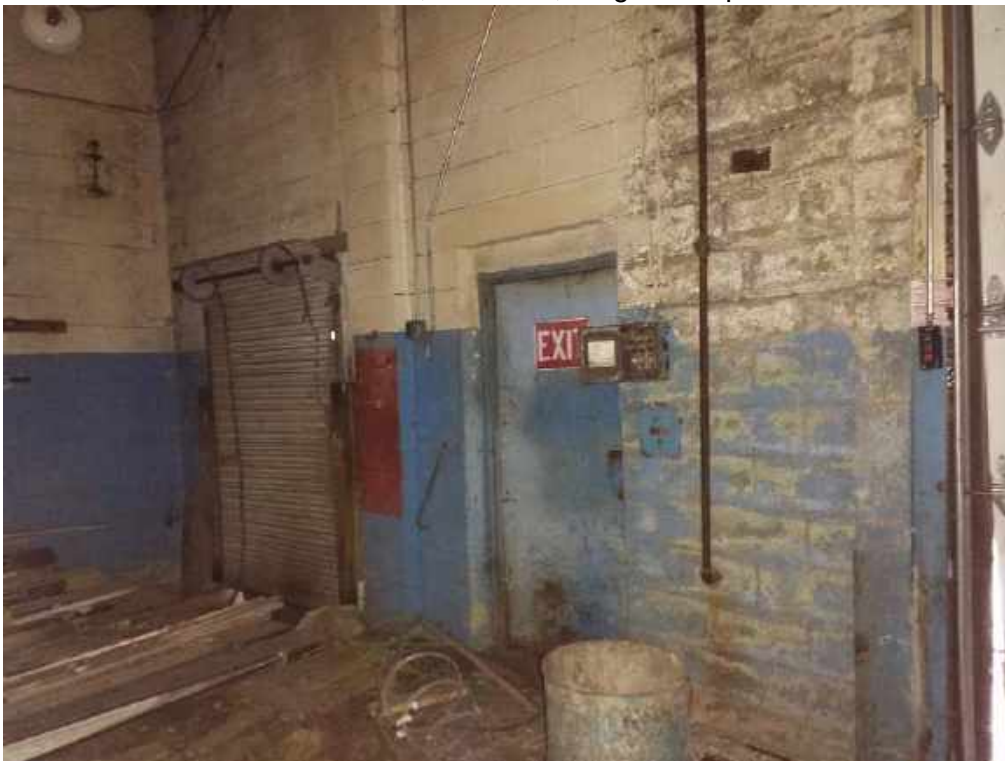
002 - Electrical transite in boxes, Room 45, Large L shaped warehouse

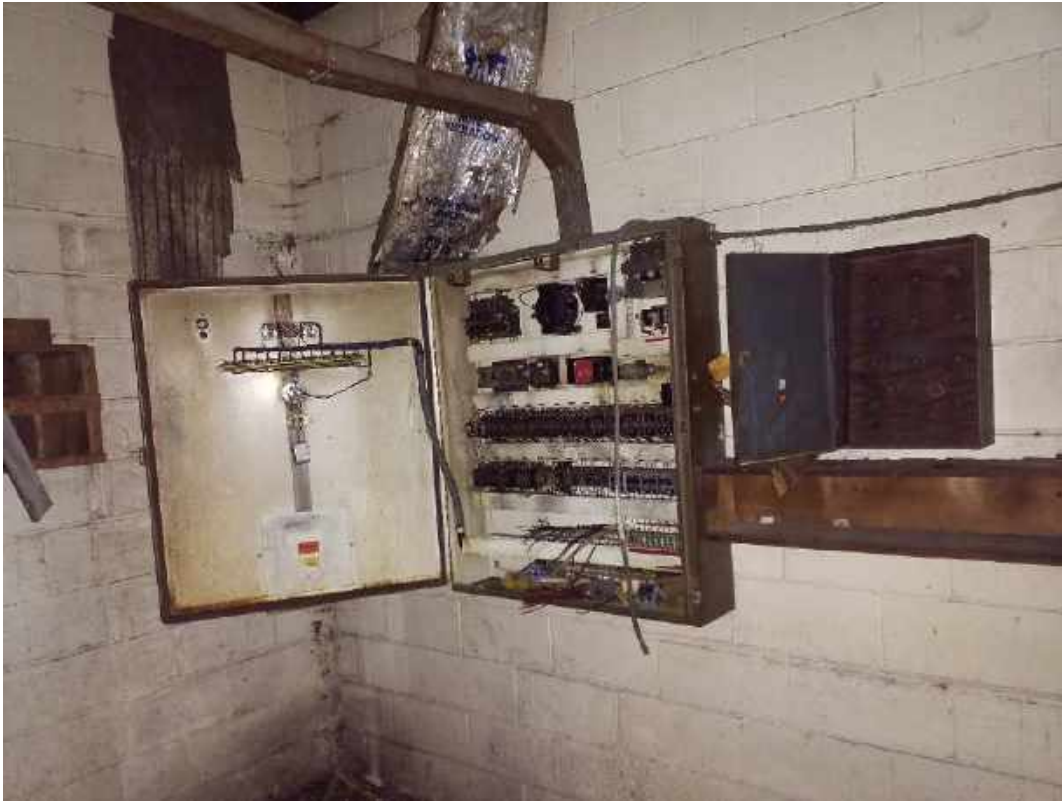
002 - Electrical transite in boxes, Room 45, Large L shaped warehouse

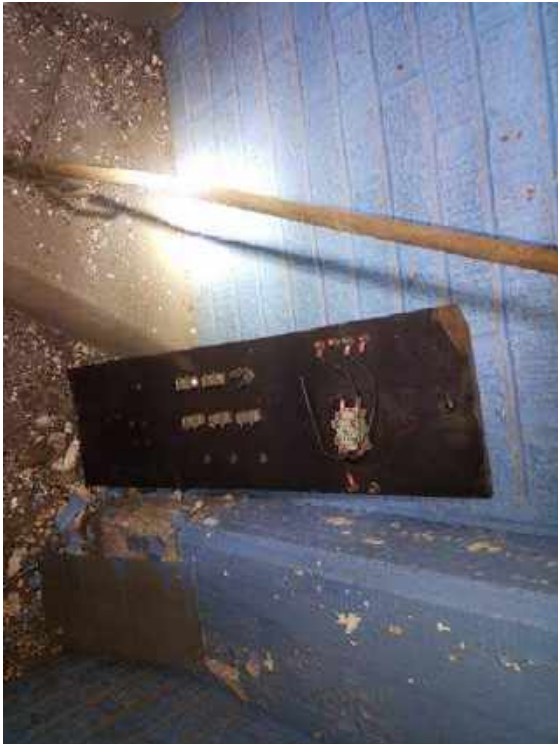
002 - Electrical transite in boxes, Room 47, Back warehouse and lean-to

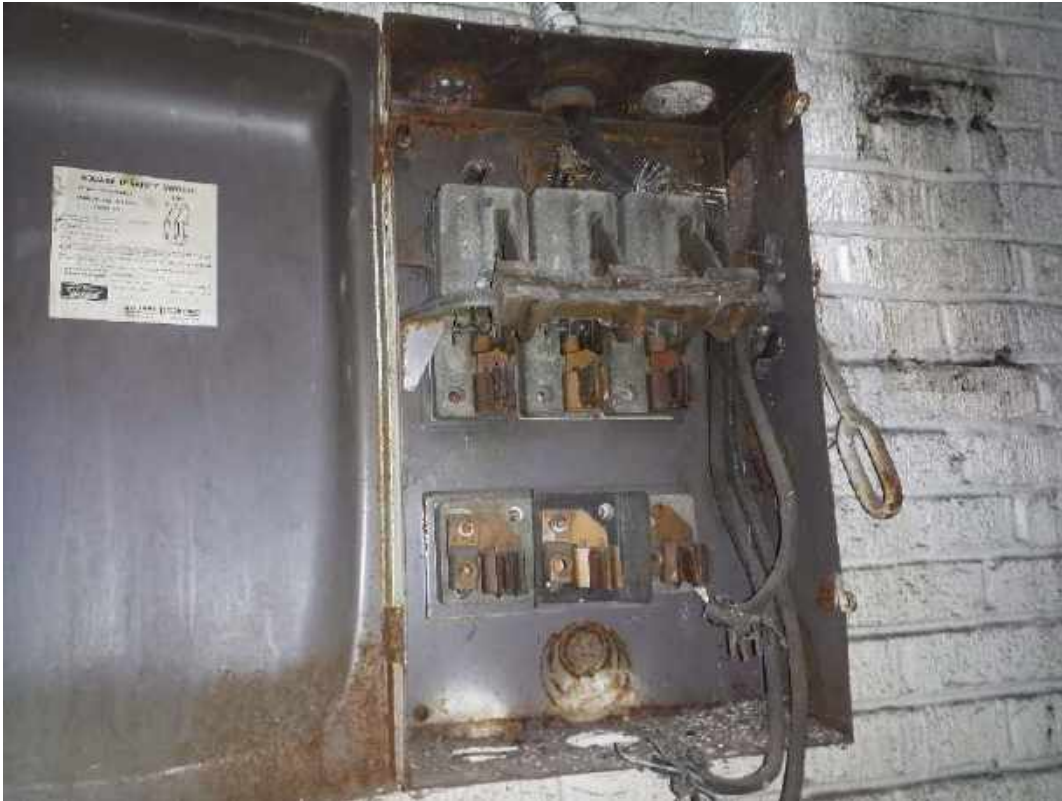
002 - Electrical transite in boxes, Room 17, 2nd Floor

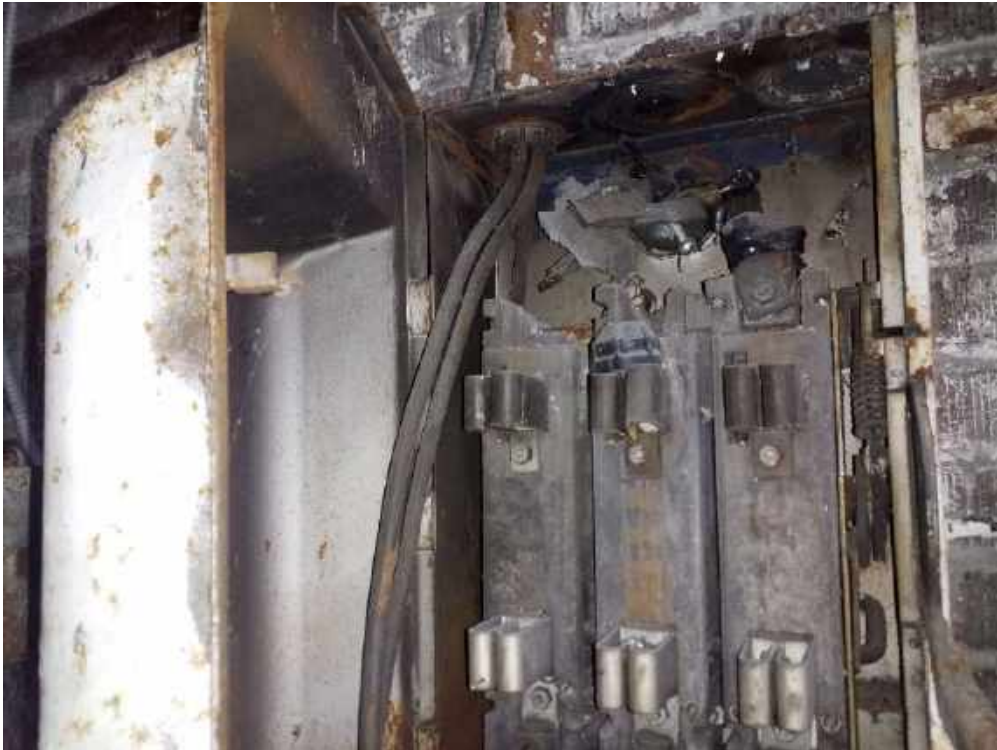
002 - Electrical transite in boxes, Garage next to Room 24 by mens restroom, 1st floor under offices

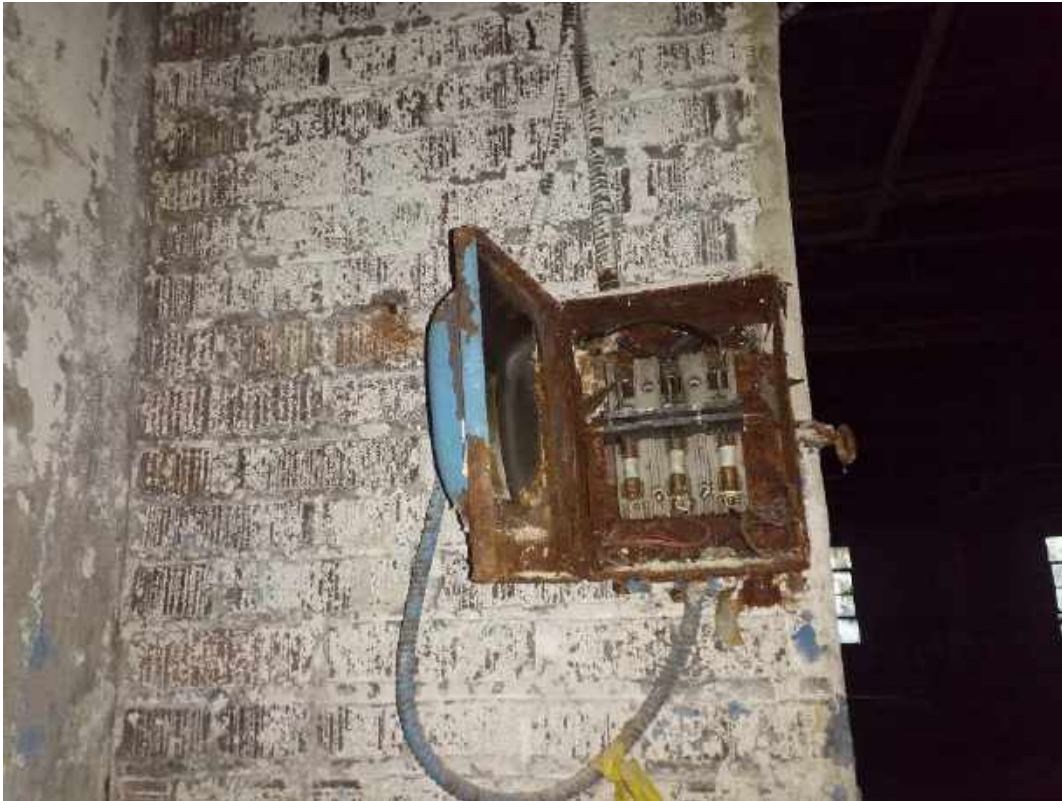
002 - Electrical transite in boxes, Garage next to Room 24 by mens restroom, 1st floor under offices

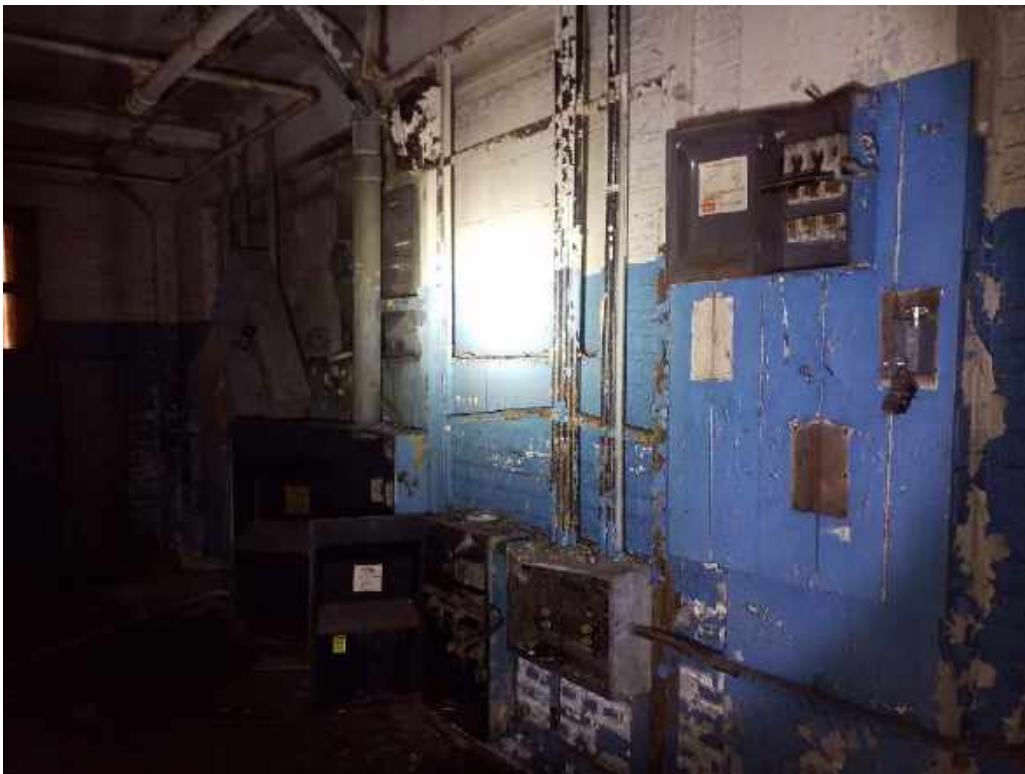
002 - Electrical transite in boxes, Room 27, 1st floor under offices

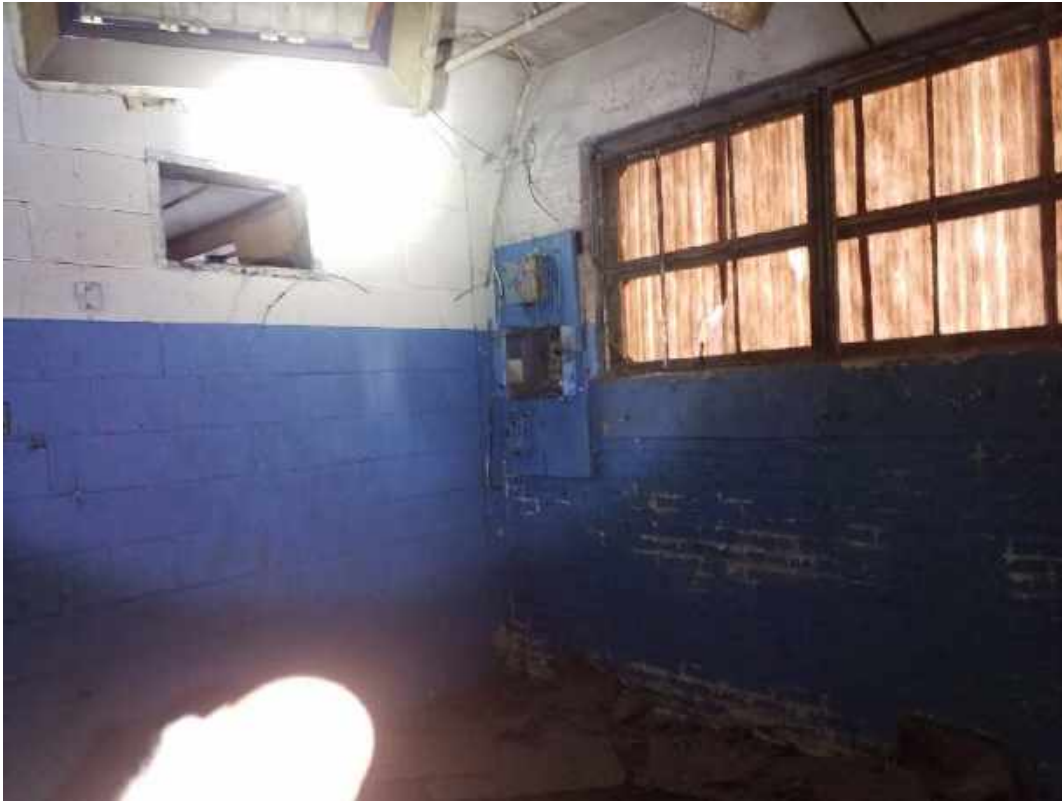
002 - Electrical transite in boxes, Room 27, 1st floor under offices

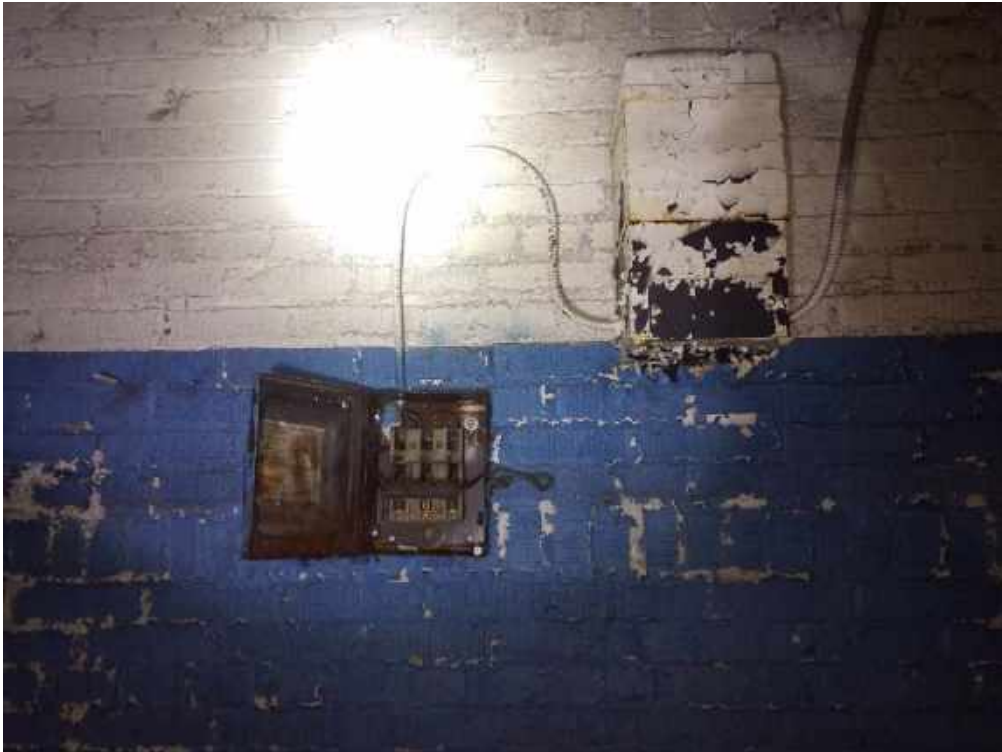
002 - Electrical transite in boxes, Room 27, 1st floor under offices

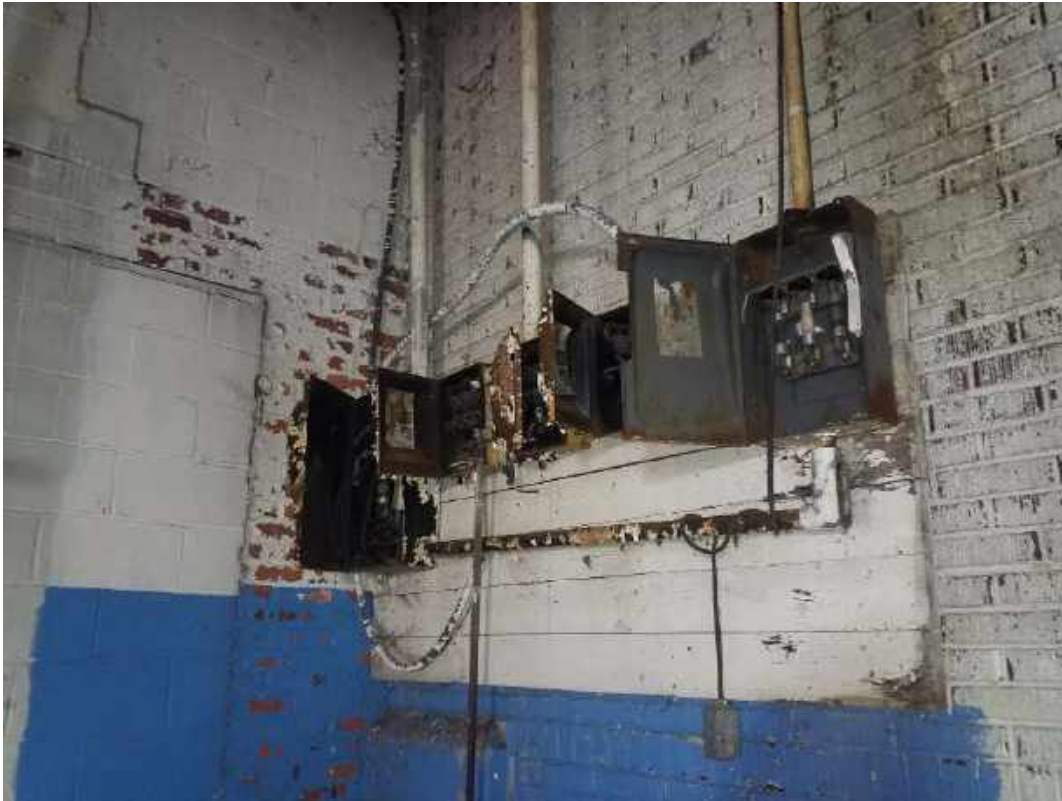
002 - Electrical transite in boxes, Room 27, 1st floor under offices

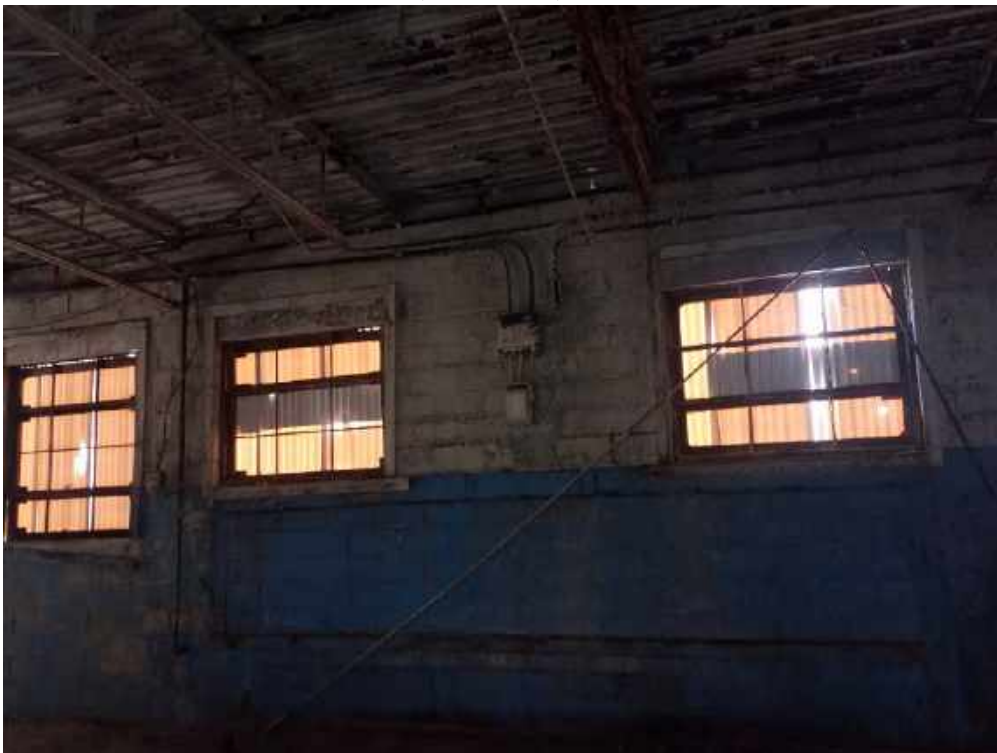
002 - Electrical transite in boxes, Room 28, North 1st Floor

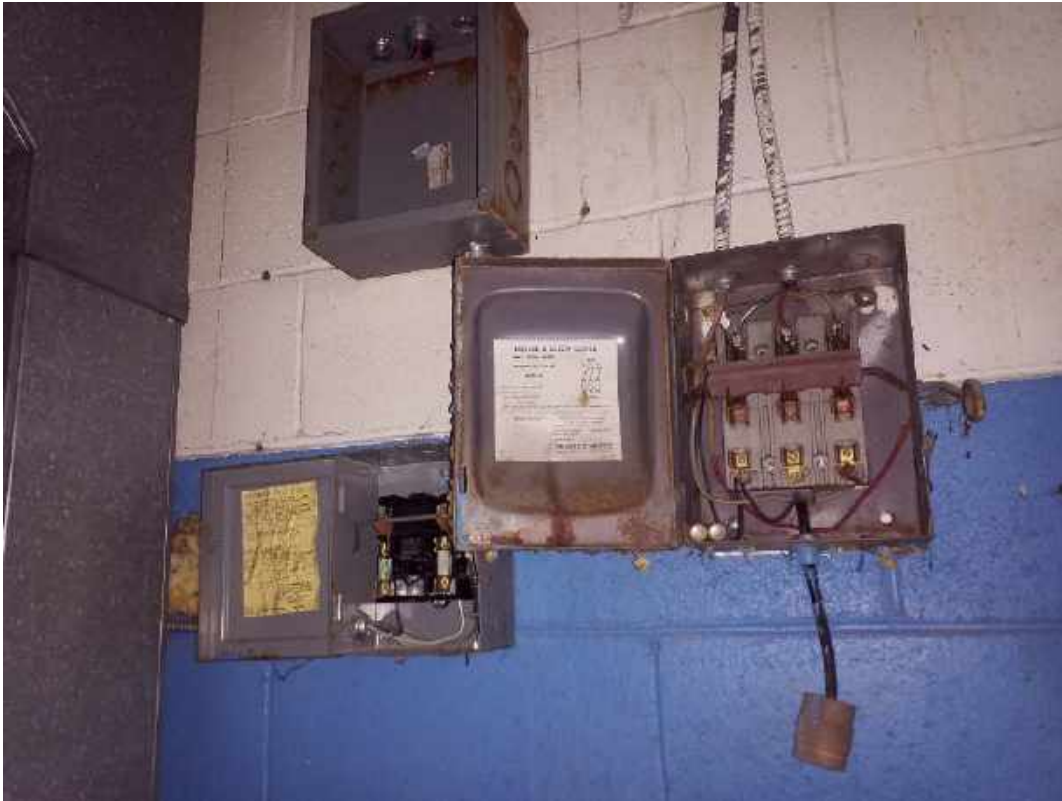
002 - Electrical transite in boxes, Room 31, Warehouse offices area
