**NESHAP COMPLIANCE (PRE-DEMOLITION) LIMITED (SOME AREAS
WERE NOT ACCESSIBLE) ASBESTOS INSPECTION**

526 S. Main
New Lexington, Ohio 43756

Lepi Enterprises, Inc.
640 G.W. Morse Street
Zanesville, Ohio 43701
(740) 453-2980

September 21, 2023 - September 22, 2023

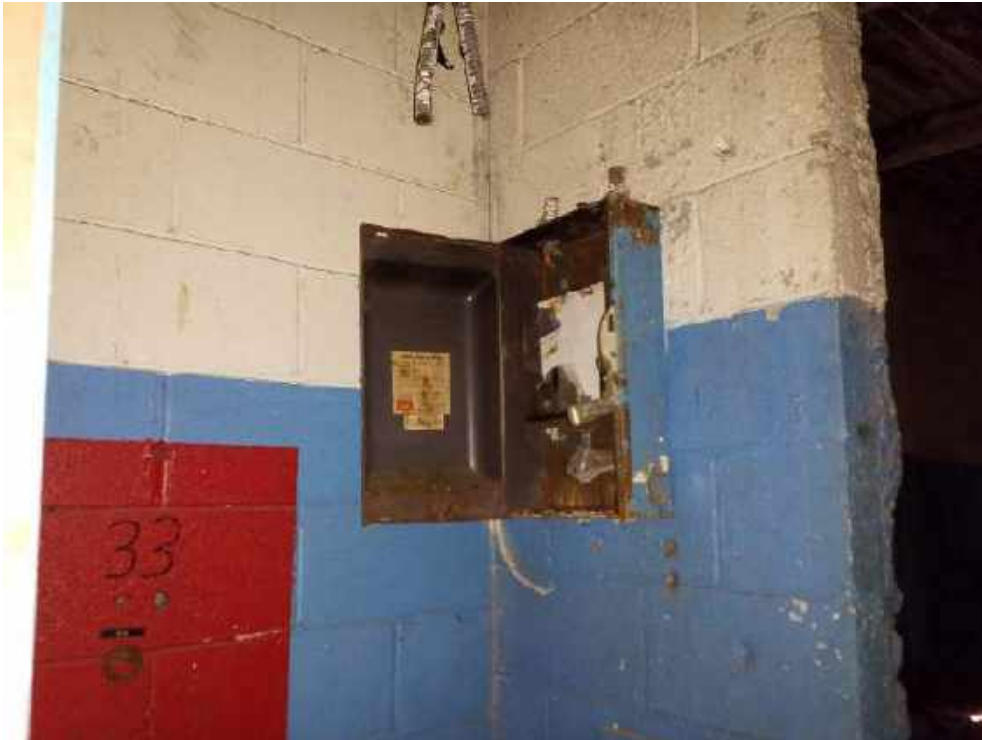
002 - Electrical transite in boxes, Room 31, Warehouse offices area

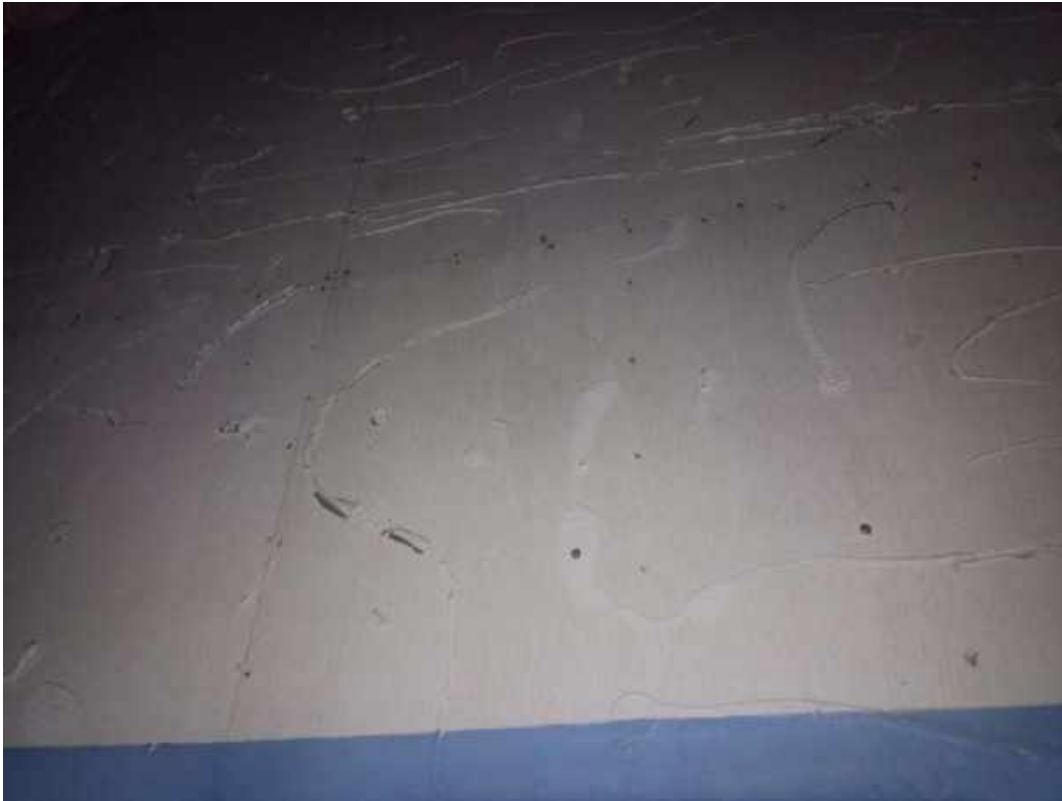
002 - Electrical transite in boxes, Room 31, Warehouse offices area

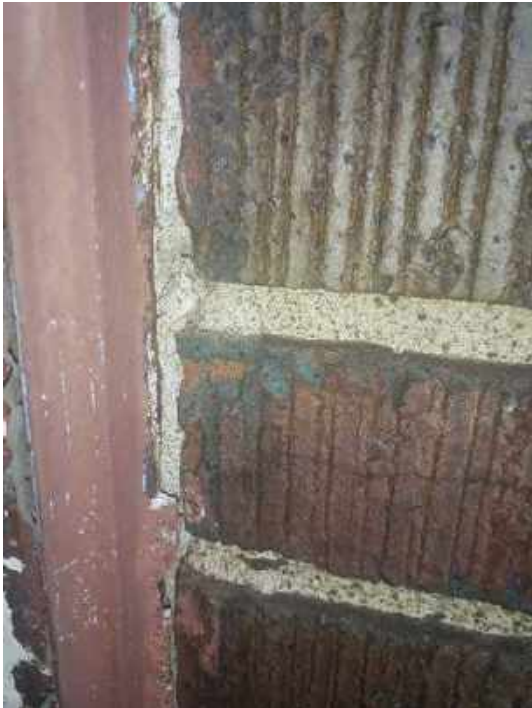
003 - Adhesive on wall, Room 4, 3rd Floor

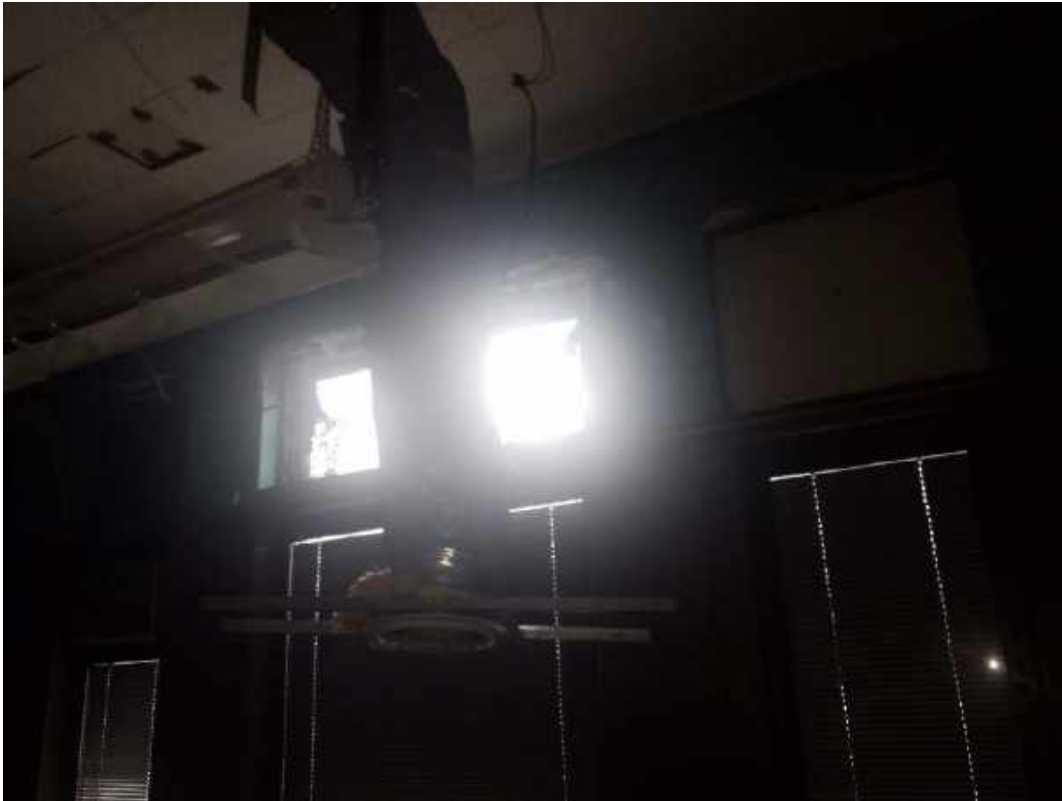
004 - Caulk, Window, Room 8, 3rd Floor

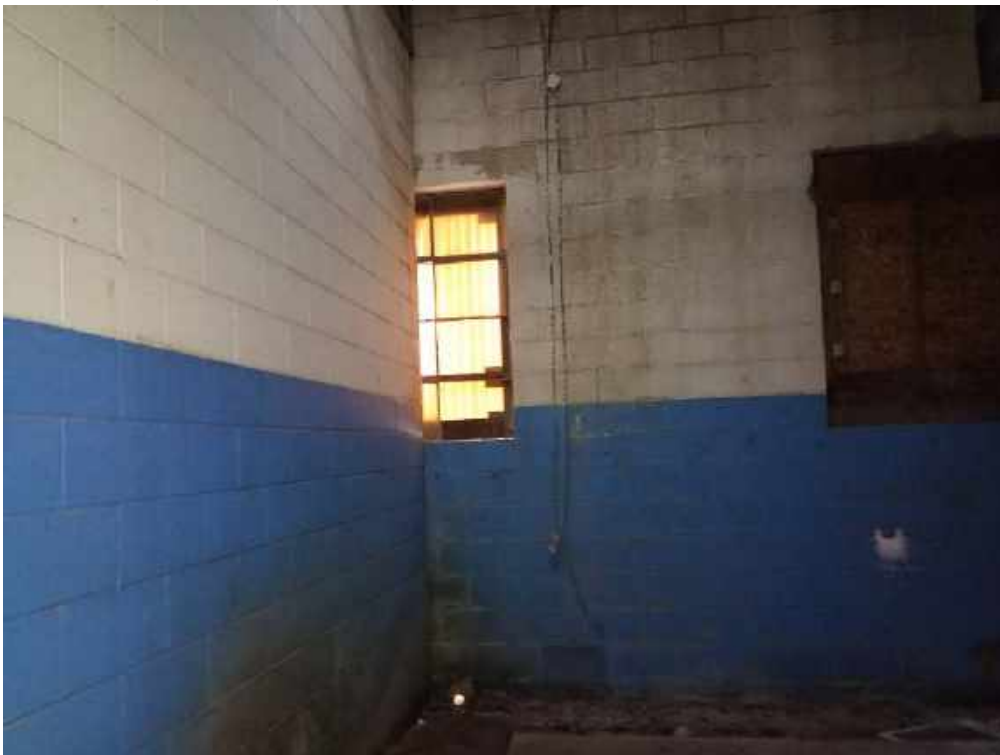
004 - Caulk, Window, Room 10, 2nd Floor

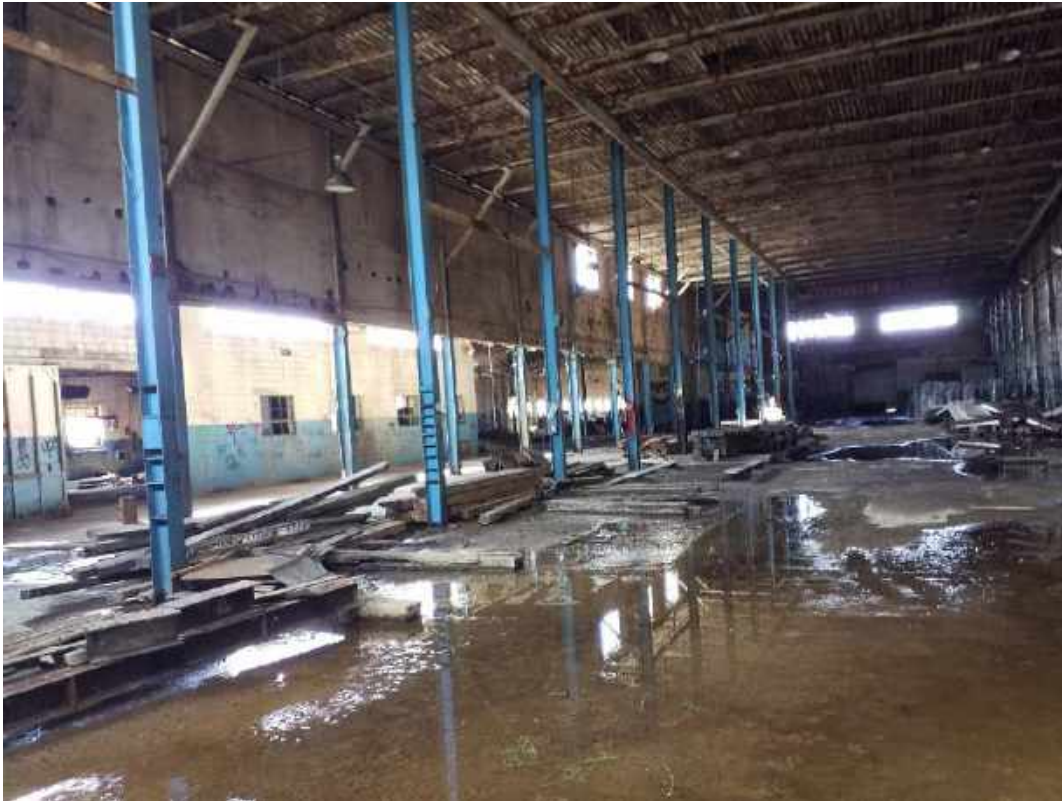
004 - Caulk, Window, Room 43, Large L shaped warehouse

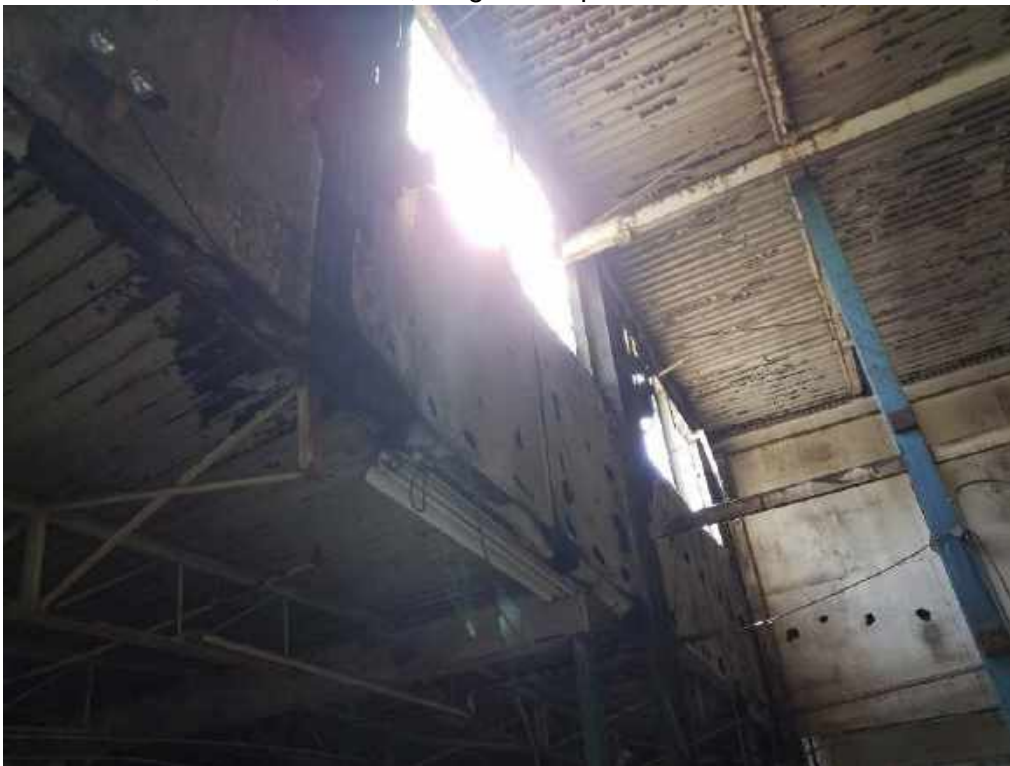
004 - Caulk, Window, Room 44, Large L shaped warehouse

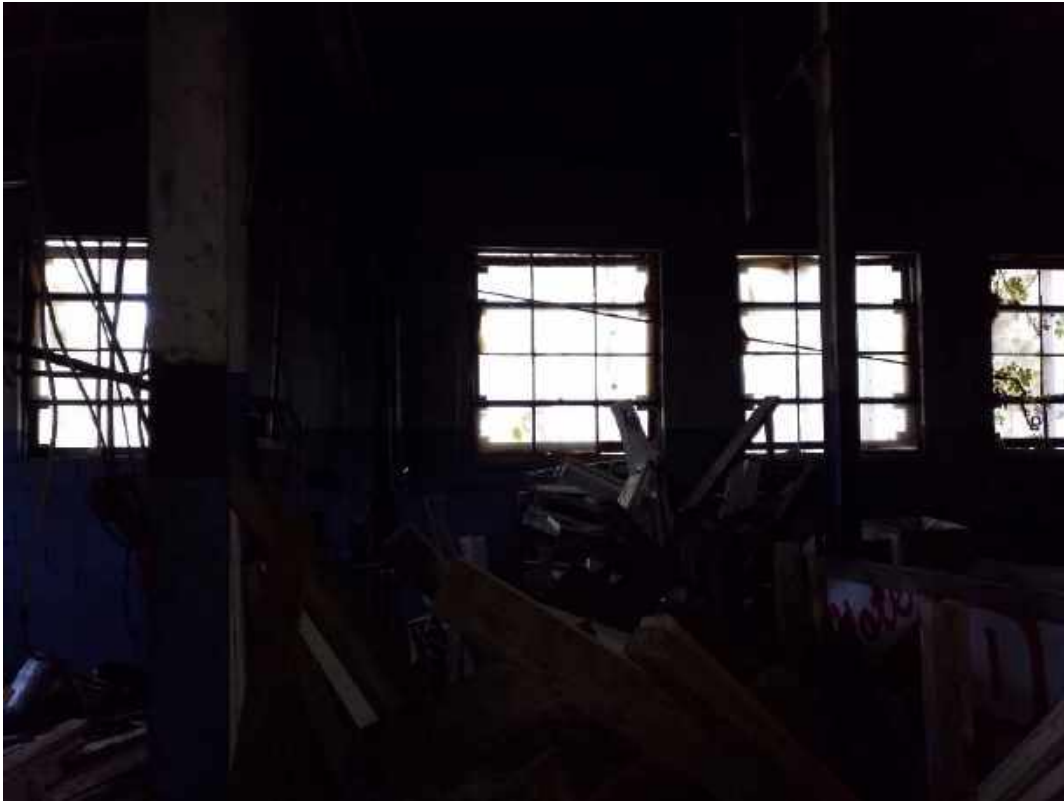
004 - Caulk, Window, Room 44, Large L shaped warehouse

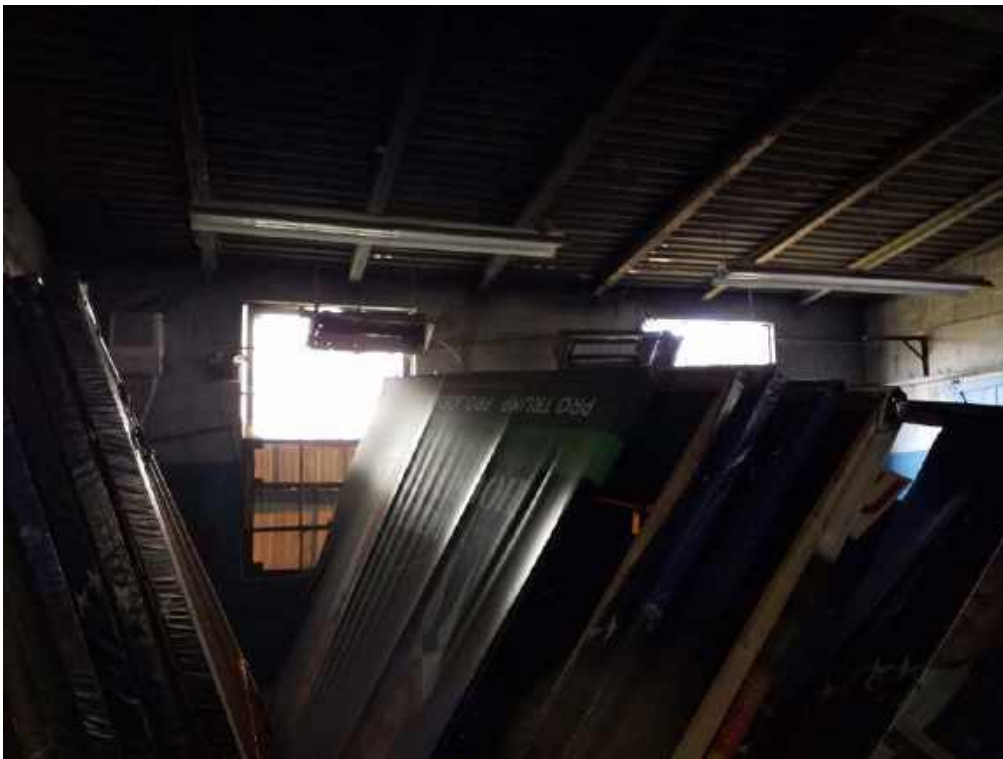
004 - Caulk, Window, Room 49, Back warehouse and lean-to

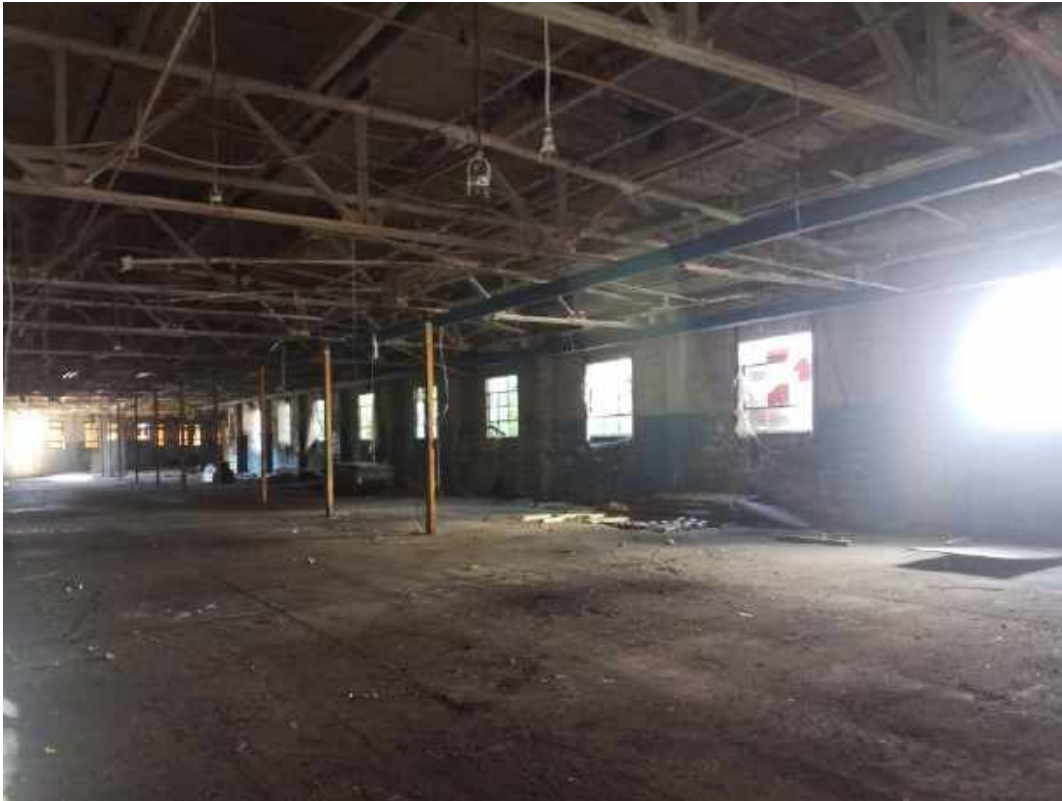
004 - Caulk, Window, Room 49, Back warehouse and lean-to

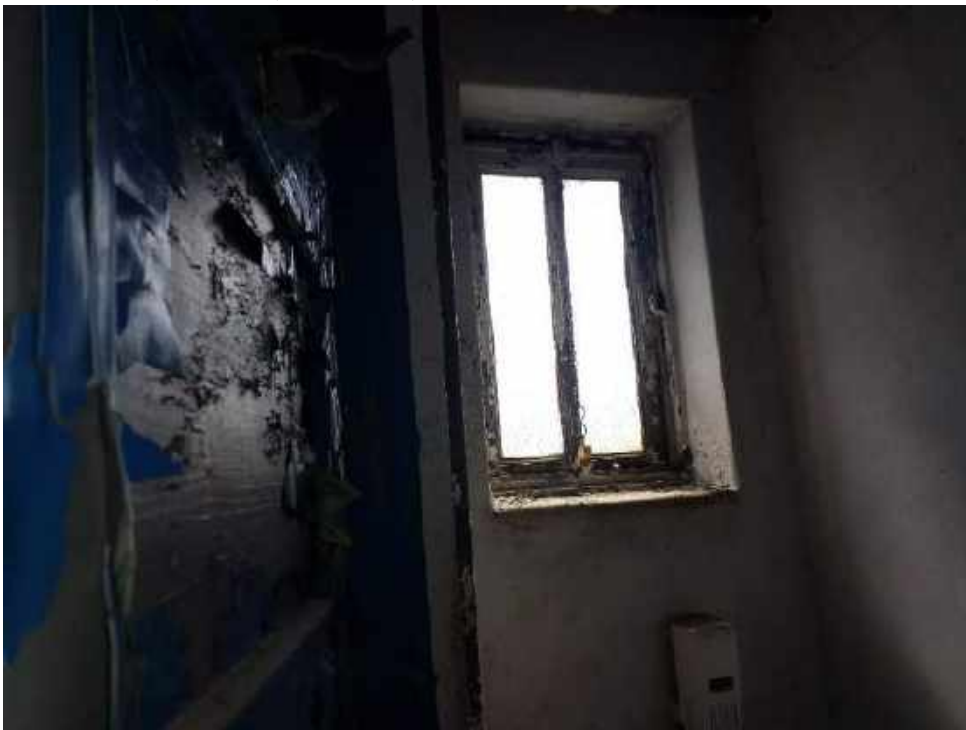
004 - Caulk, Window, Room 28, North 1st Floor

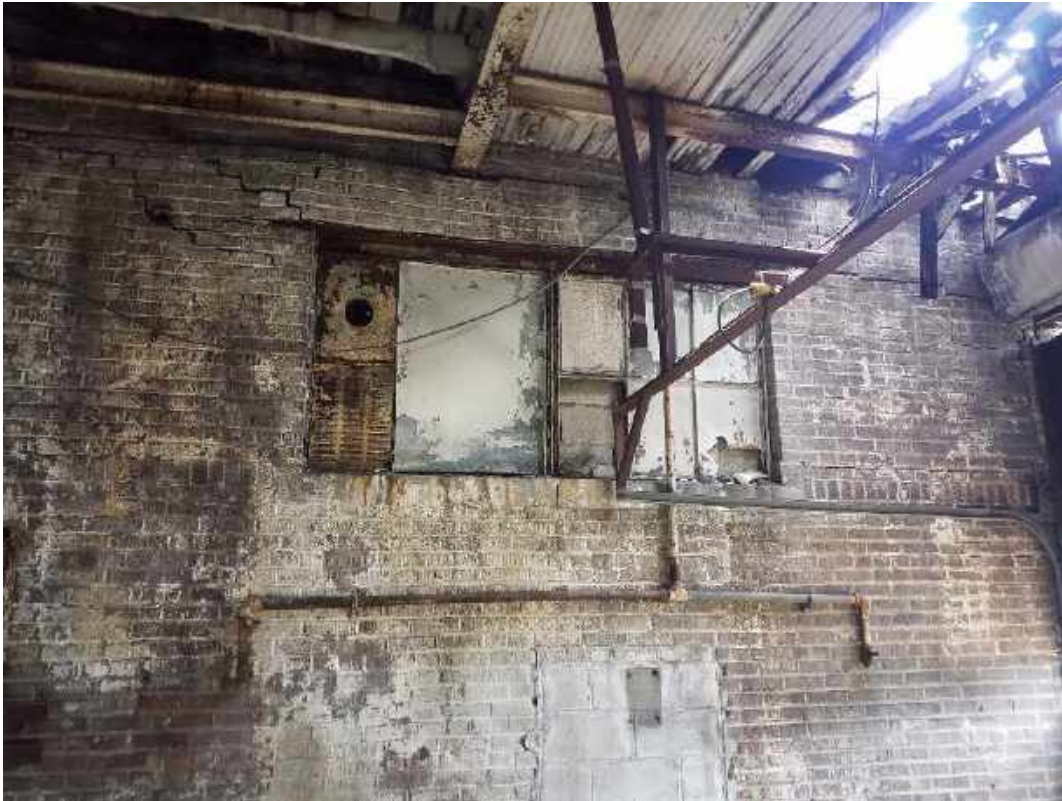
004 - Caulk, Window, Room 19, 2nd Floor

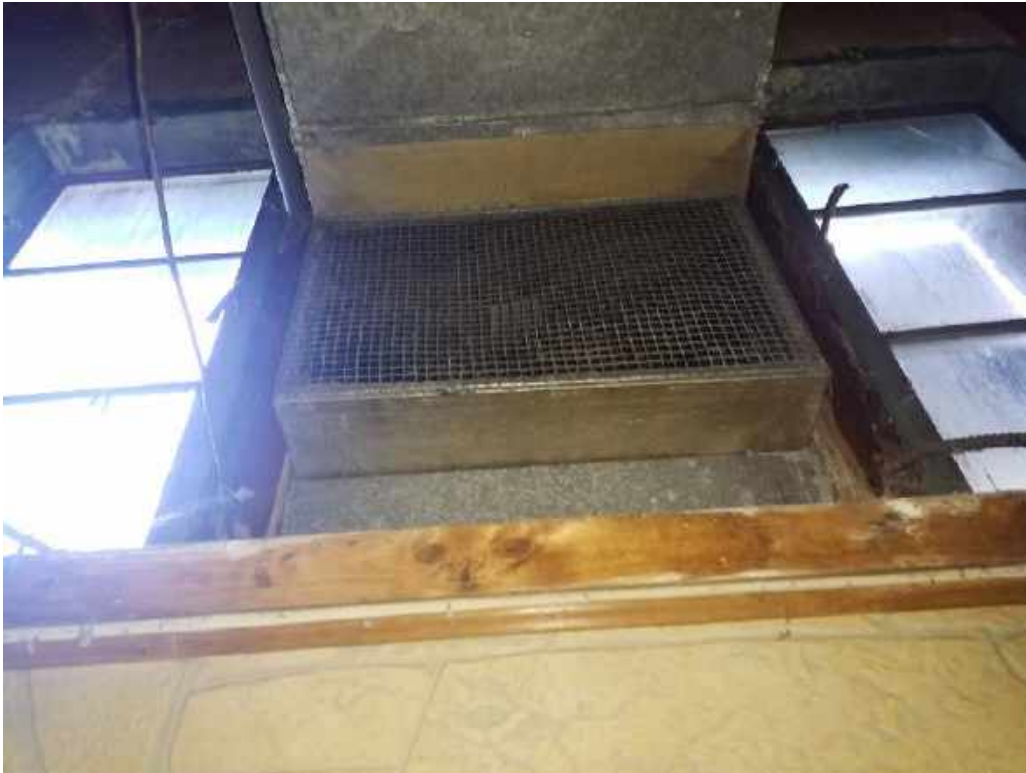
004 - Caulk, Window, Garage next to Room 24 by mens restroom, 1st floor under offices

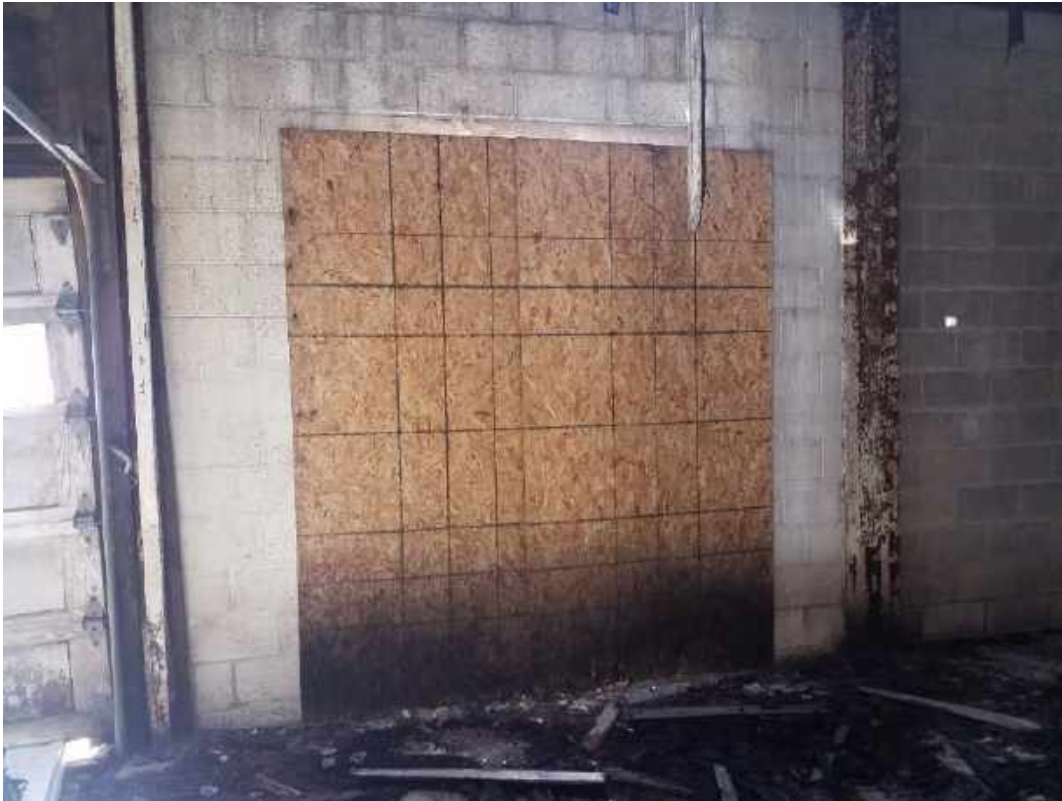
005 - Window Glazing, Room 13, 2nd Floor

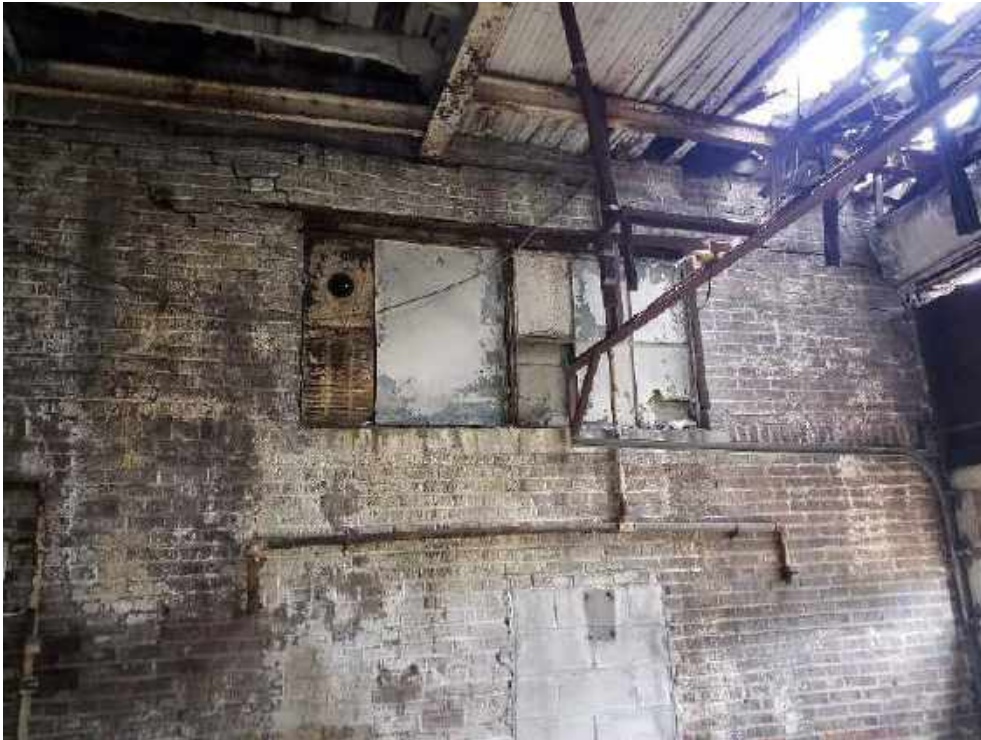
005 - Window Glazing, Garage next to Room 24 by mens restroom, 1st floor under offices

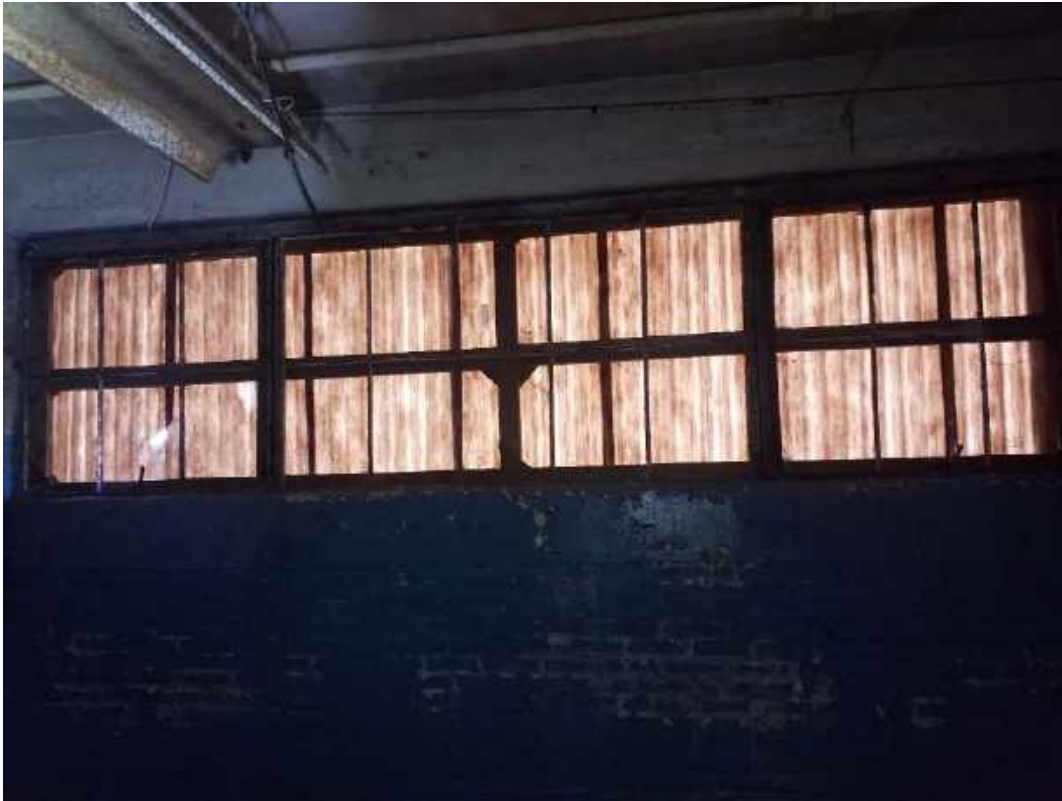
005 - Window Glazing, Garage next to Room 24 by mens restroom, 1st floor under offices

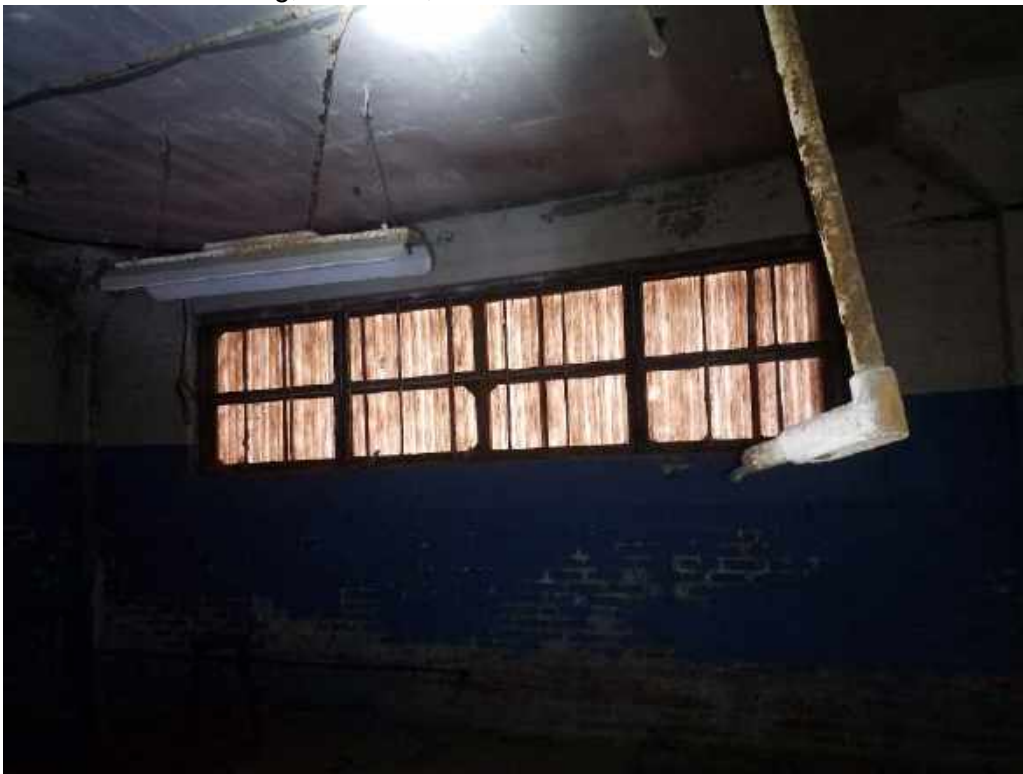
005 - Window Glazing, Room 27, 1st floor under offices

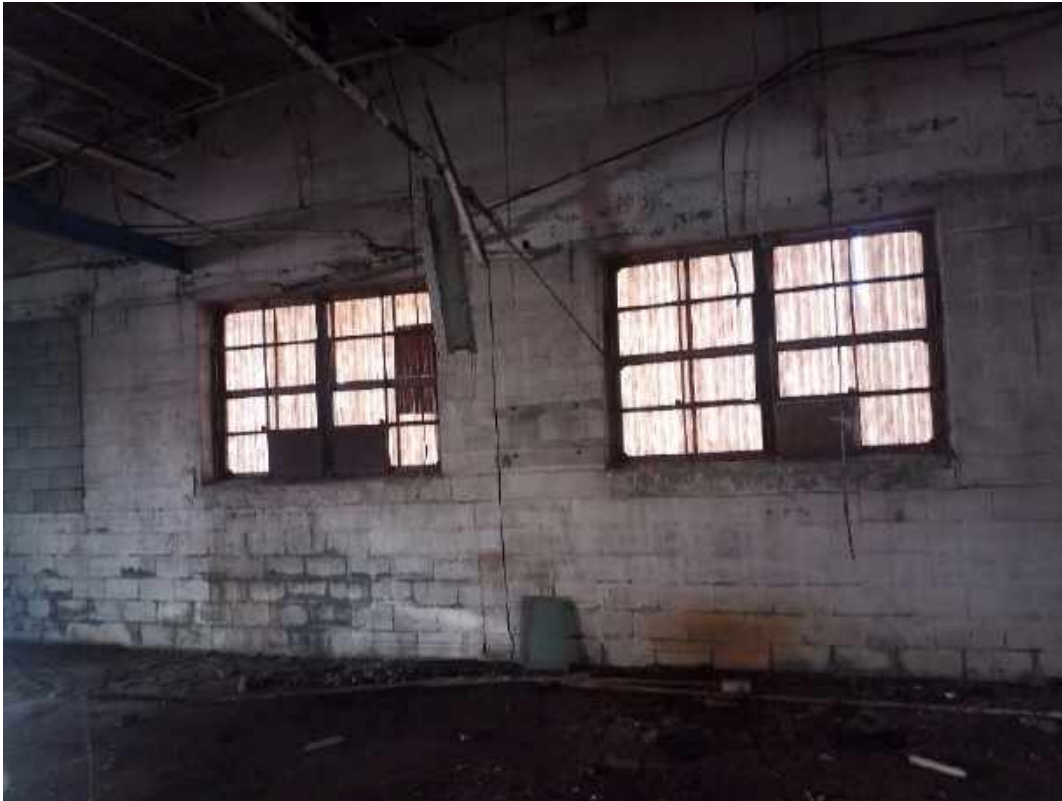
005 - Window Glazing, Room 27, 1st floor under offices

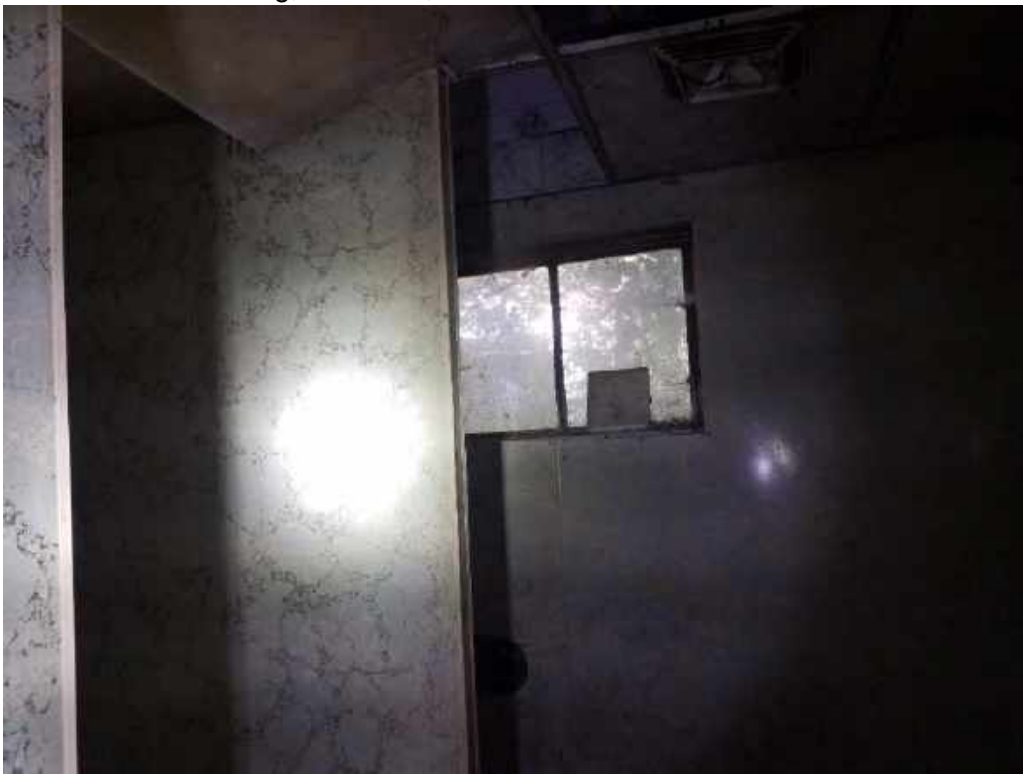
005 - Window Glazing, Room 28, North 1st Floor

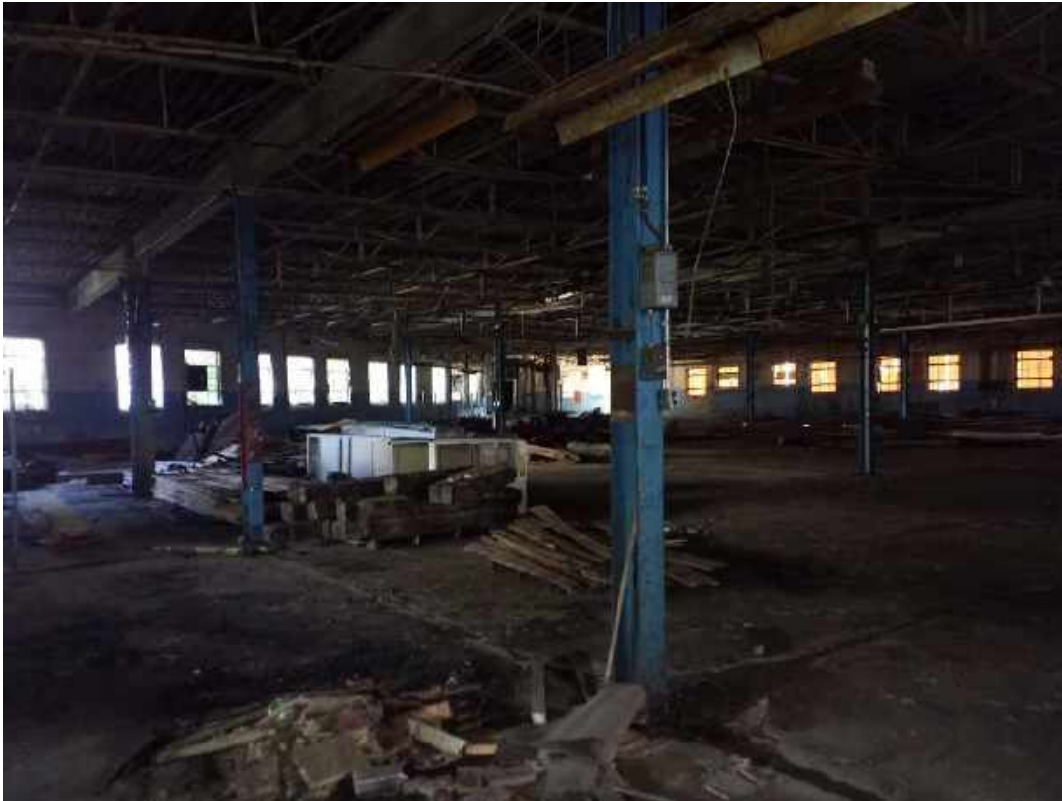
005 - Window Glazing, Room 29, North 1st Floor

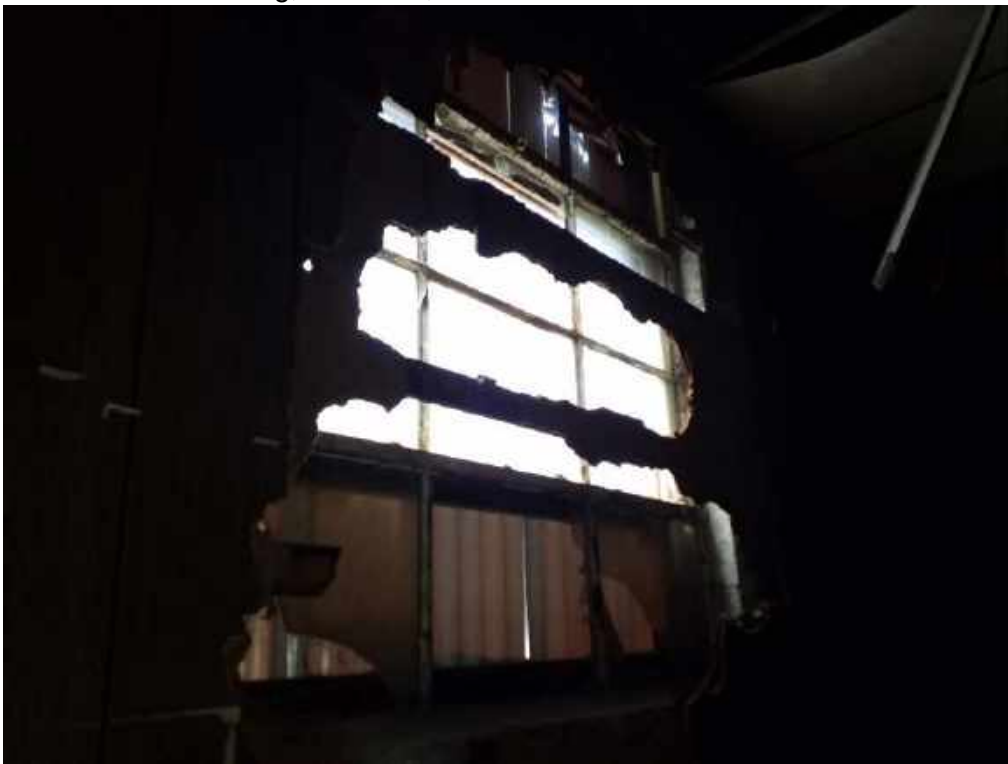
005 - Window Glazing, Room 31, Warehouse offices area

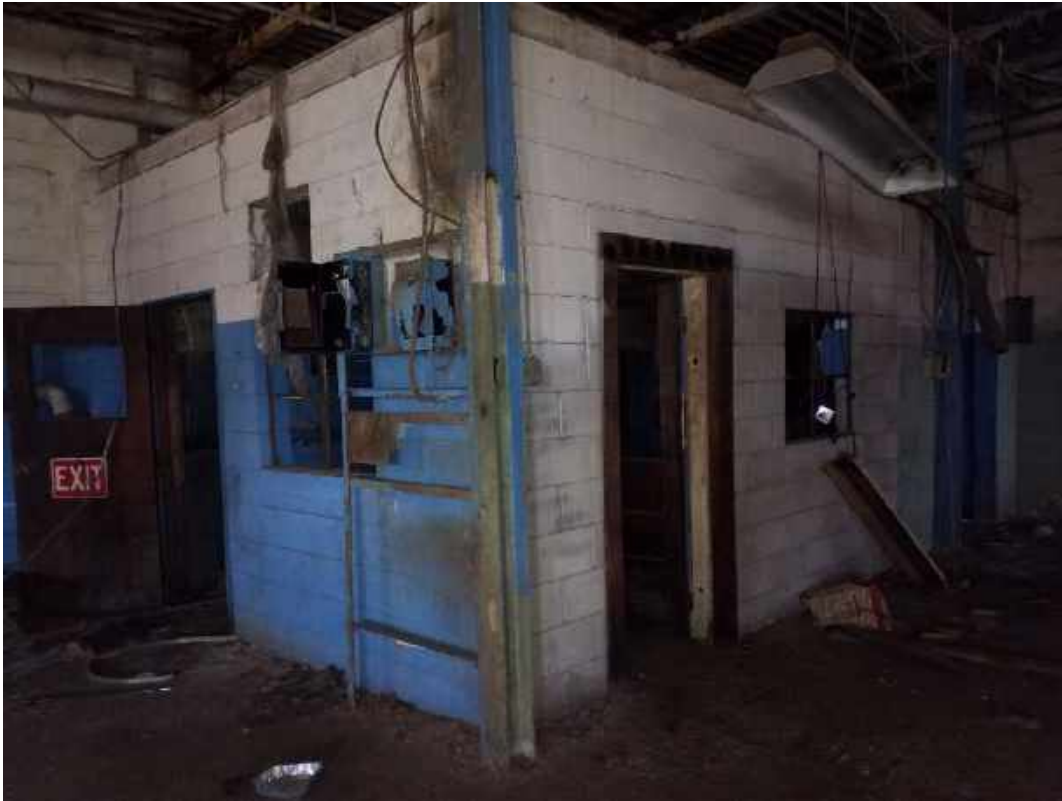
005 - Window Glazing, Room 39, Warehouse offices area

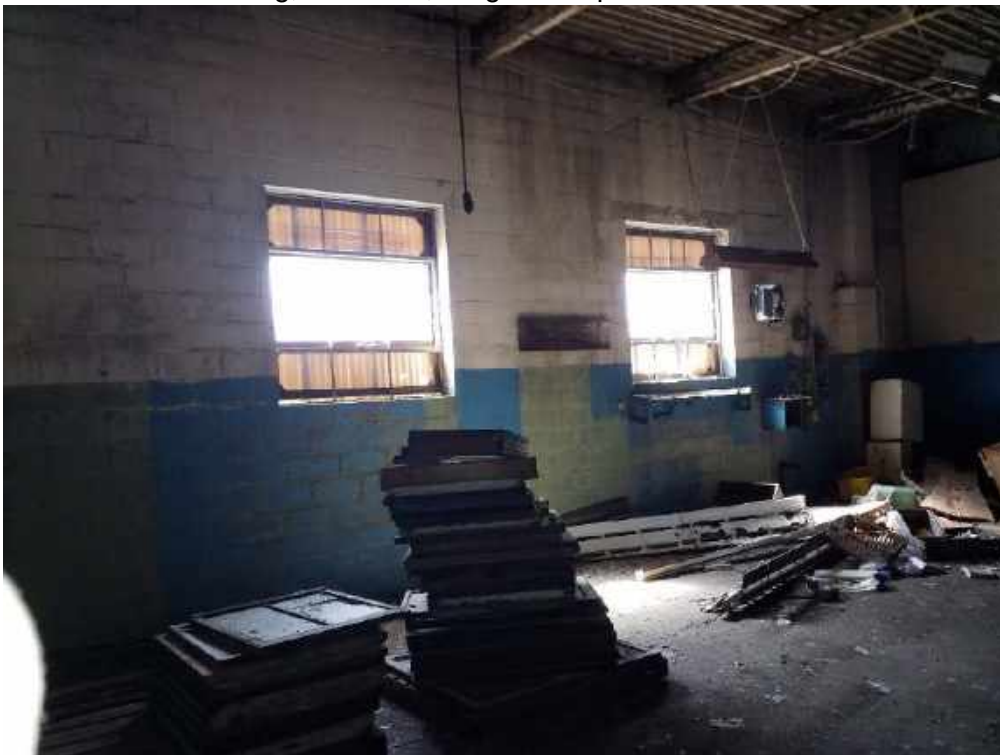
005 - Window Glazing, Room 41, Large L shaped warehouse

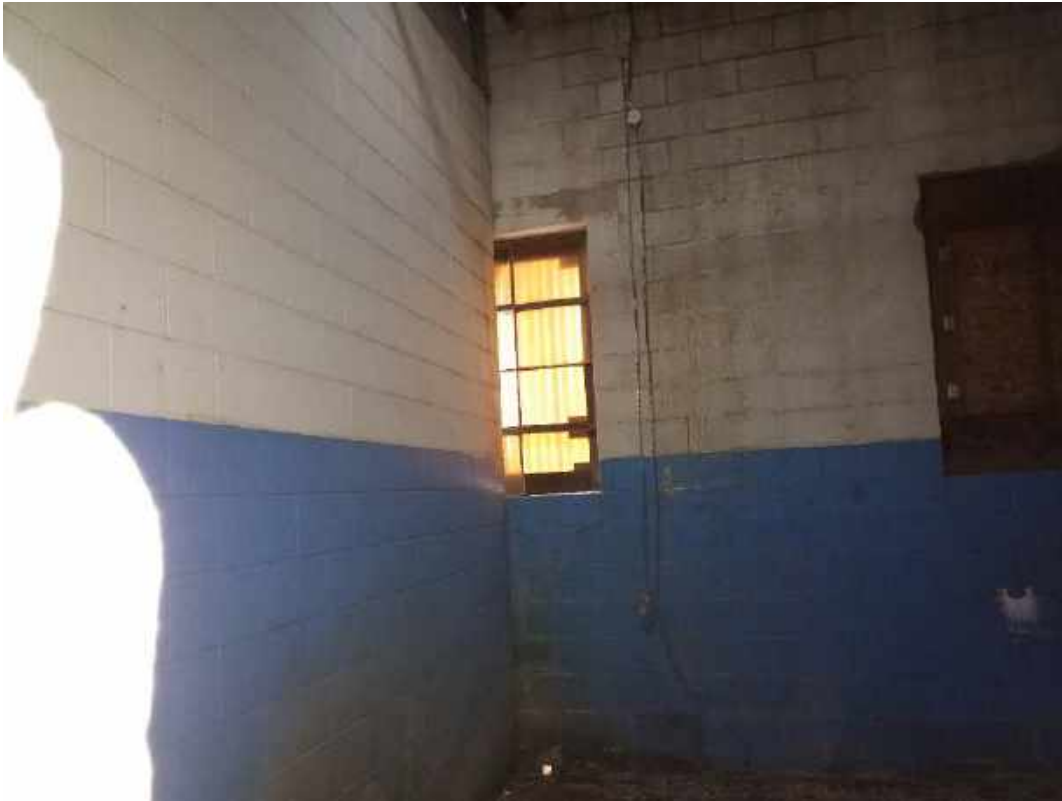
005 - Window Glazing, Room 42, Large L shaped warehouse

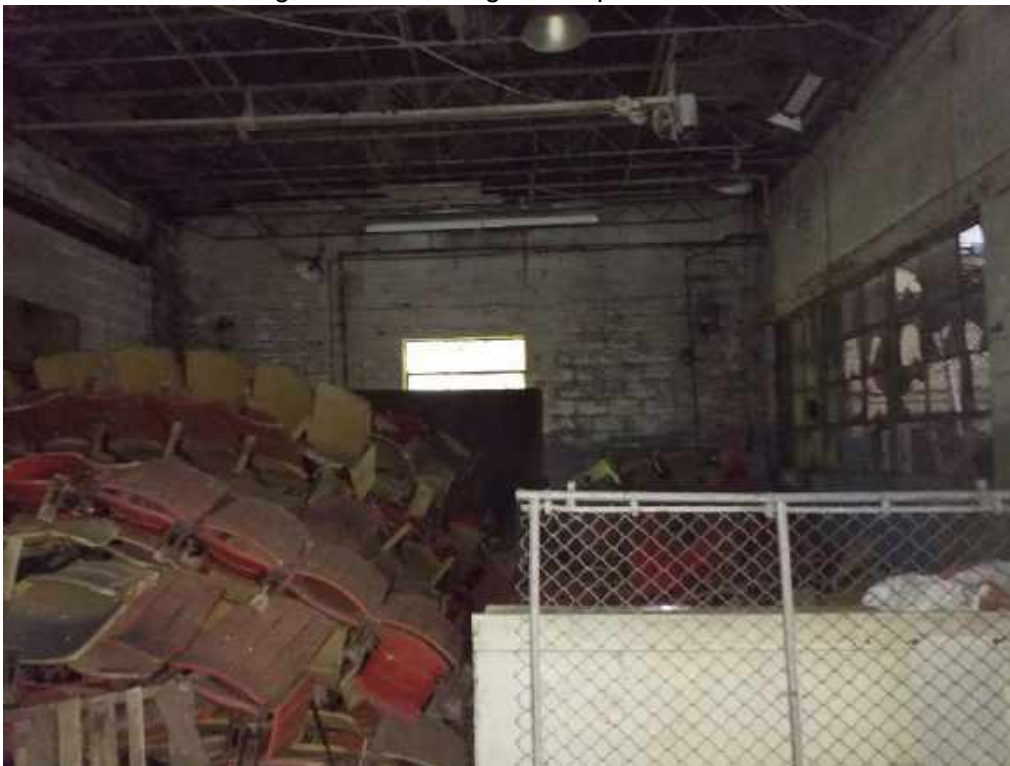
005 - Window Glazing, Room 45, Large L shaped warehouse

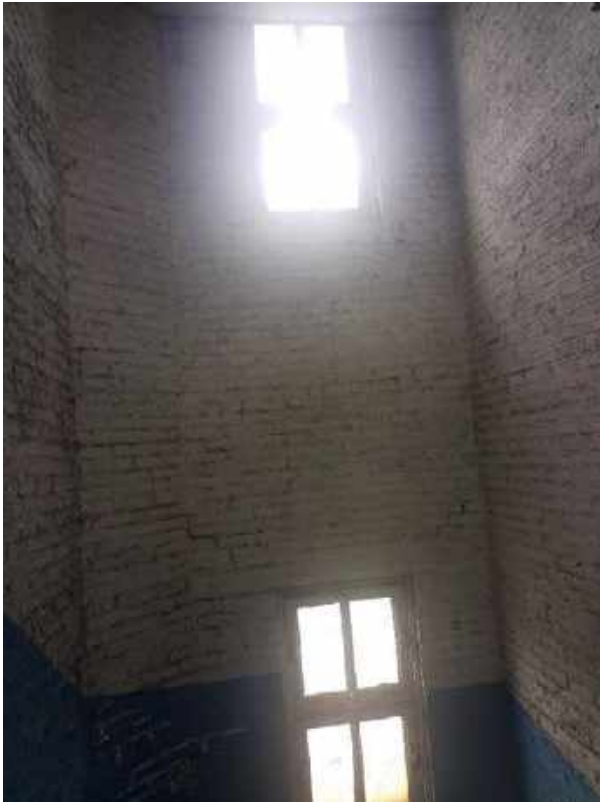
005 - Window Glazing, Room 6, 3rd Floor

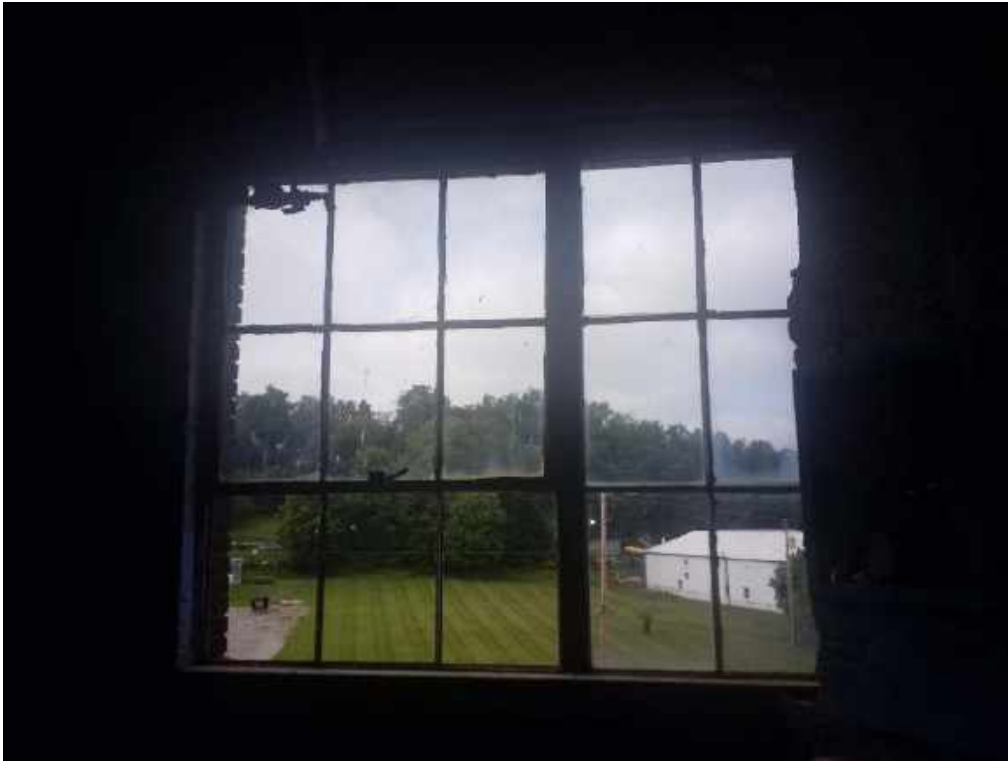
005 - Window Glazing, Room 8, 3rd Floor

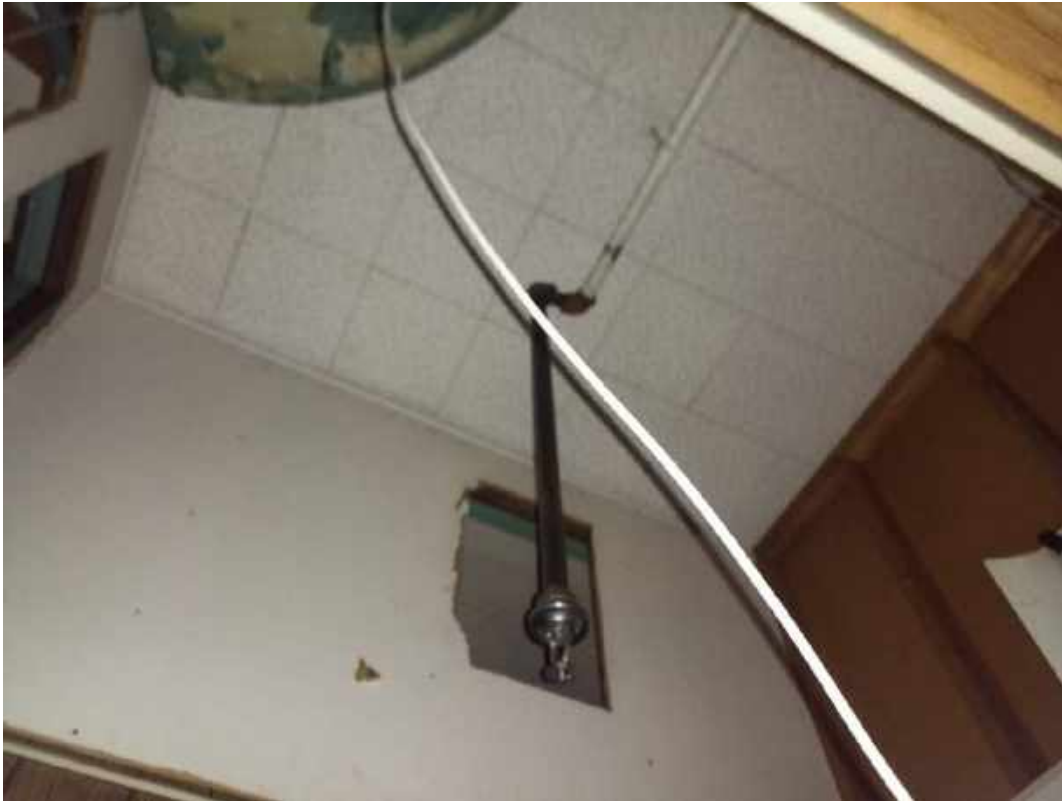
006 - Ceiling tile masonite, Room 11, 2nd Floor

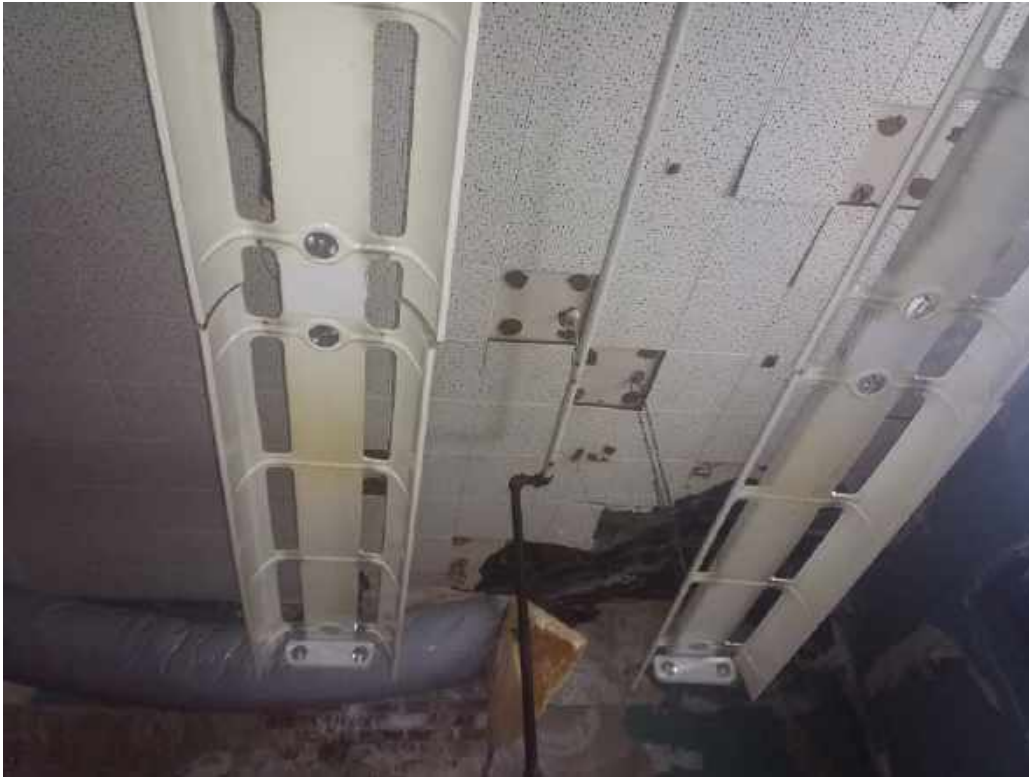
007 - Brown Ceiling tile mastic, Room 10, 2nd Floor
