**NESHAP COMPLIANCE (PRE-DEMOLITION) LIMITED (SOME AREAS
WERE NOT ACCESSIBLE) ASBESTOS INSPECTION**

526 S. Main
New Lexington, Ohio 43756

Lepi Enterprises, Inc.
640 G.W. Morse Street
Zanesville, Ohio 43701
(740) 453-2980

September 21, 2023 - September 22, 2023

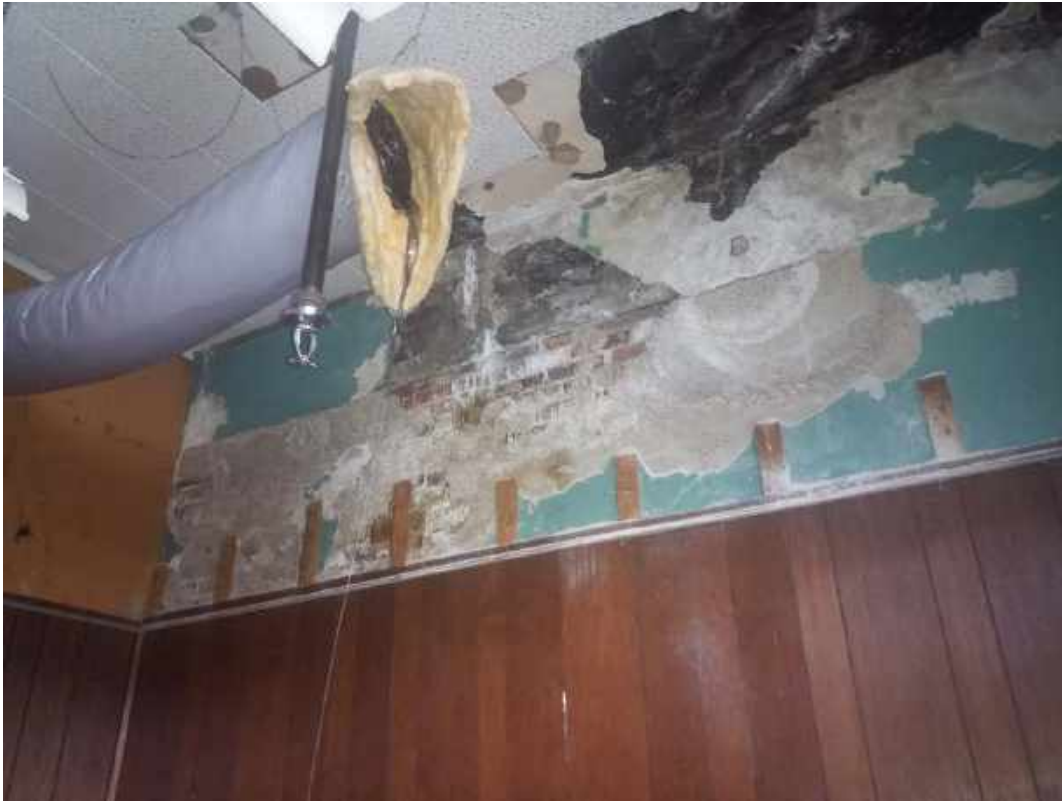
008 - Hard Plaster , Room 10, 2nd Floor

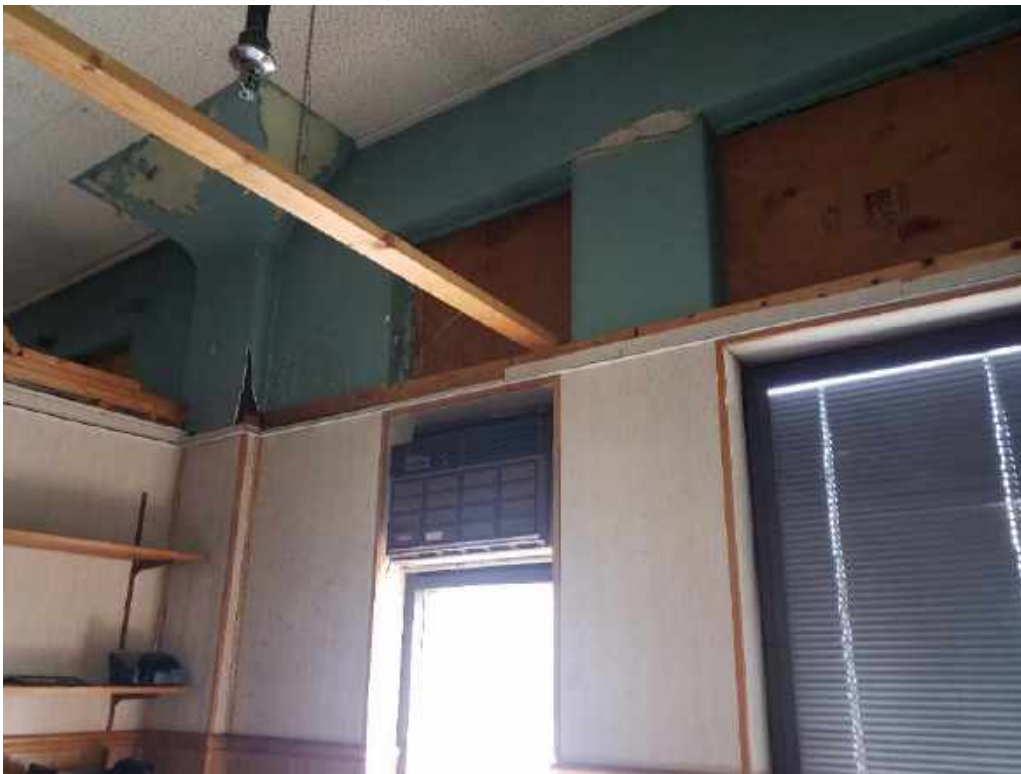
008 - Hard Plaster , Room 15, 2nd Floor

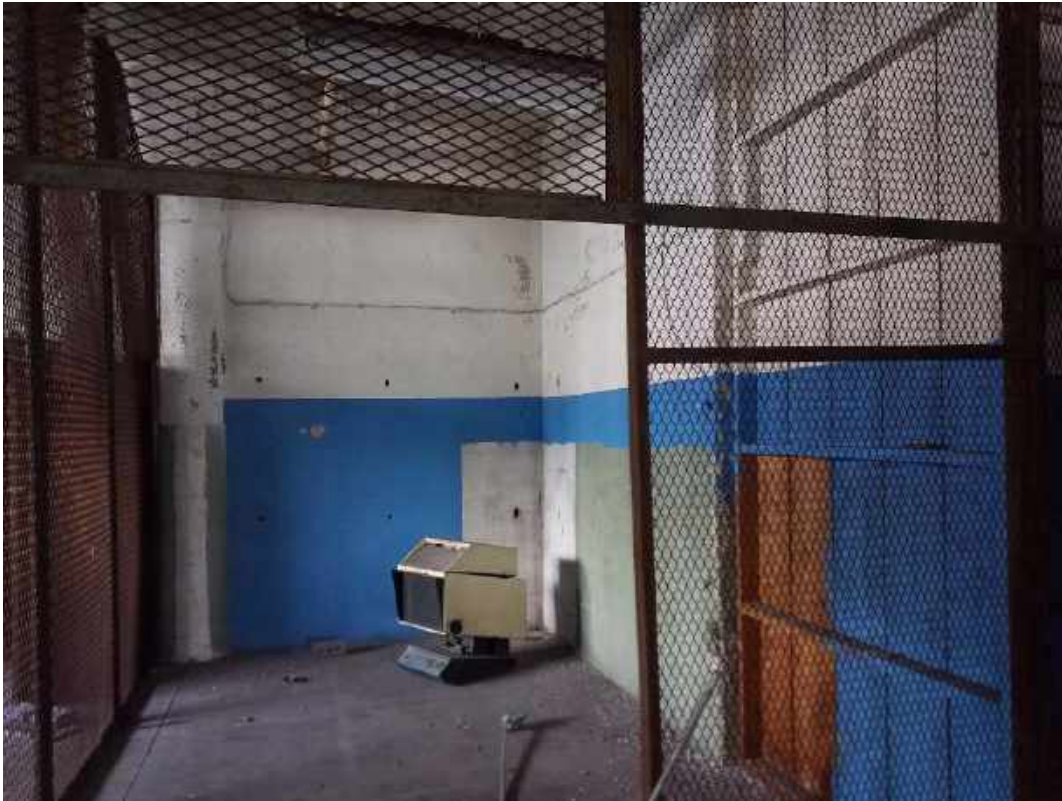
008 - Hard Plaster , Room 22, 2nd Floor

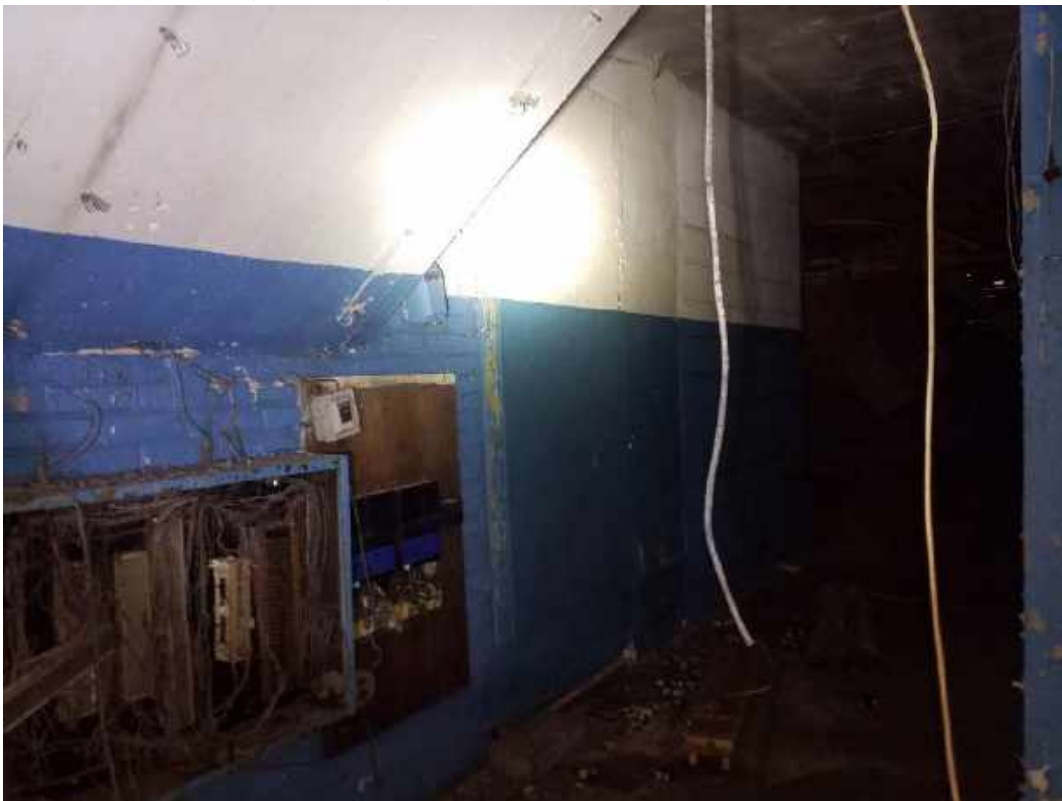
008 - Hard Plaster , Room 27, 1st floor under offices

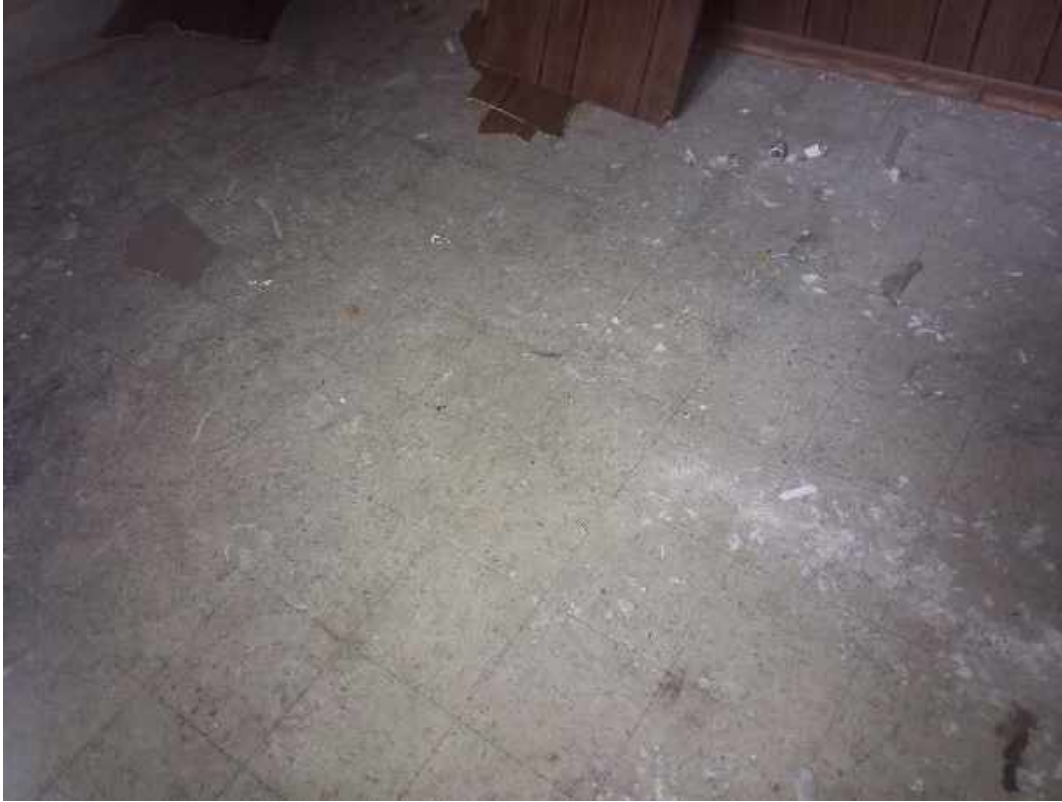
009 - 9"x9" Beige Floor Tile and Mastic, Room 10, 2nd Floor

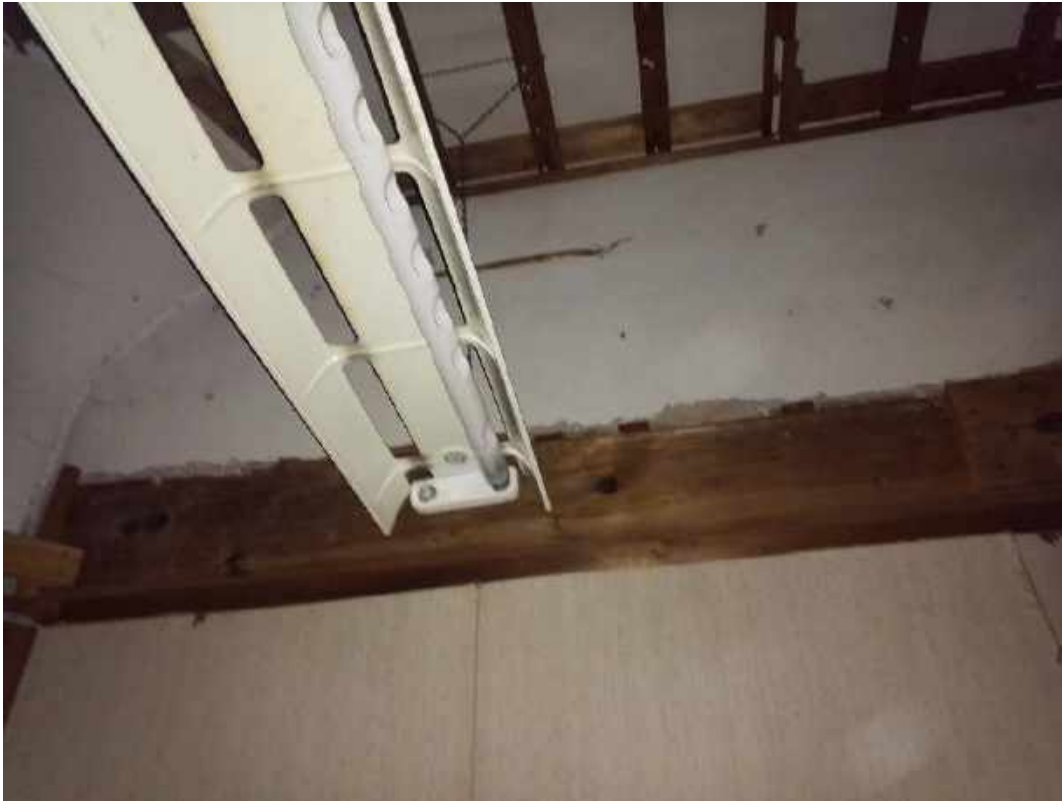
010 - Textured plaster, Room 12, 2nd Floor

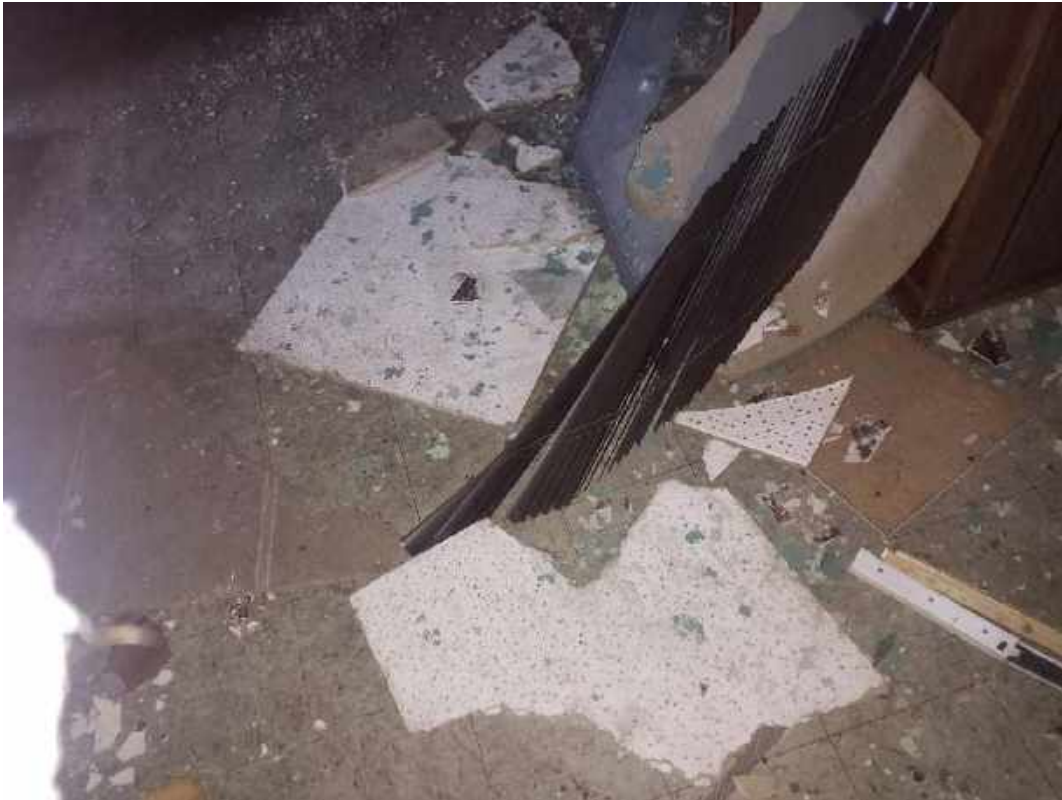
011 - ceiling tile chicken foot, Room 14, 2nd Floor

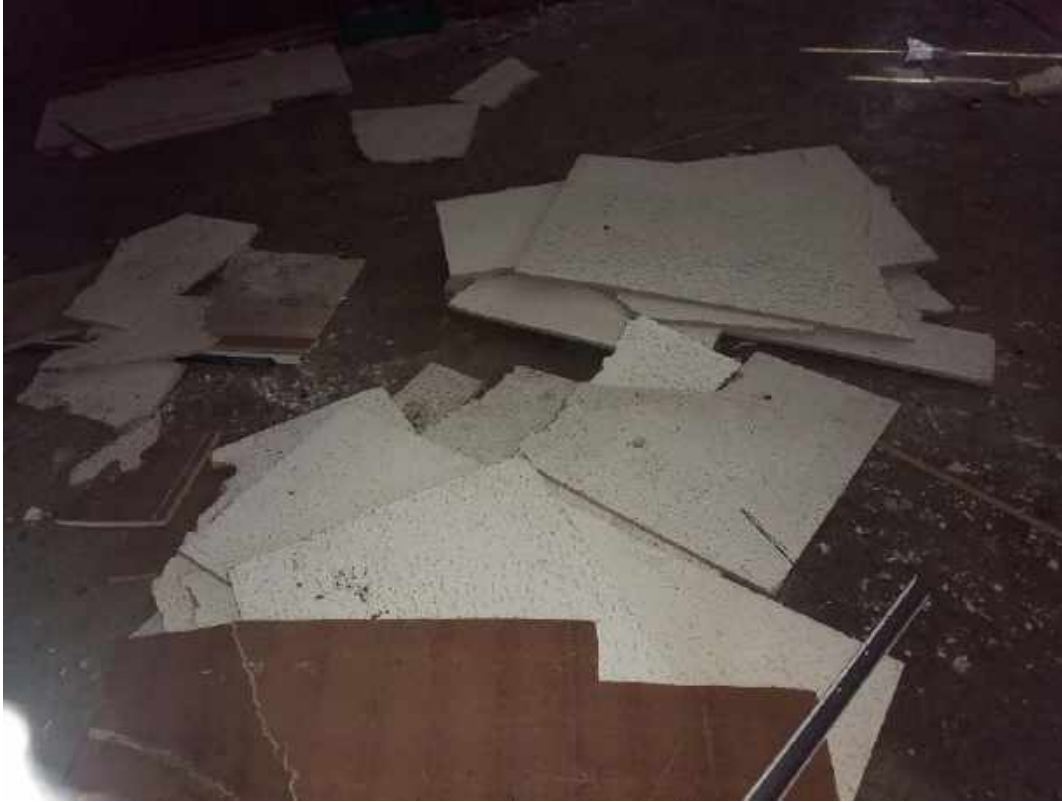
| Material ID | Material Category | Material | Space Name | Section Name | Suspect/Non-Suspect | Friability | Result | Quantity | Material Name |
|---|---|--|---|---|---|---|---|---|--|
| 012 | Miscellaneous | 012 - Ceiling tile vertical fissure pin hole | Room 14 | 2nd Floor | Suspect | Friable (RACM) | Tested Negative by Lab (No Asbestos Detected) | 1542 sq. ft. | Ceiling tile vertical fissure pin hole |

012 - Ceiling tile vertical fissure pin hole, Room 14, 2nd Floor

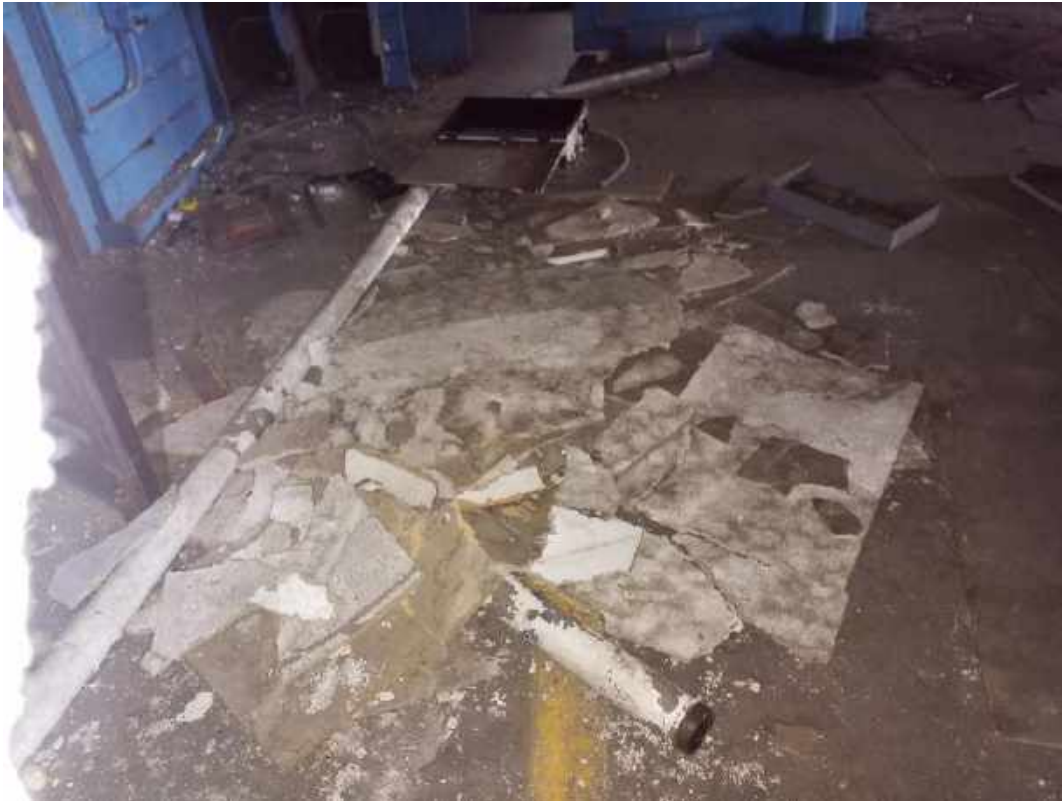
| Material ID | Material Category | Material | Space Name | Section Name | Suspect/Non-Suspect | Friability | Result | Quantity | Material Name |
|---|---|--|---|---|---|---|---|---|--|
| 012 | Miscellaneous | 012 - Ceiling tile vertical fissure pin hole | Room 22 | 2nd Floor | Suspect | Friable (RACM) | Tested Negative by Lab (No Asbestos Detected) | 200 sq. ft. | Ceiling tile vertical fissure pin hole |

012 - Ceiling tile vertical fissure pin hole, Room 22, 2nd Floor

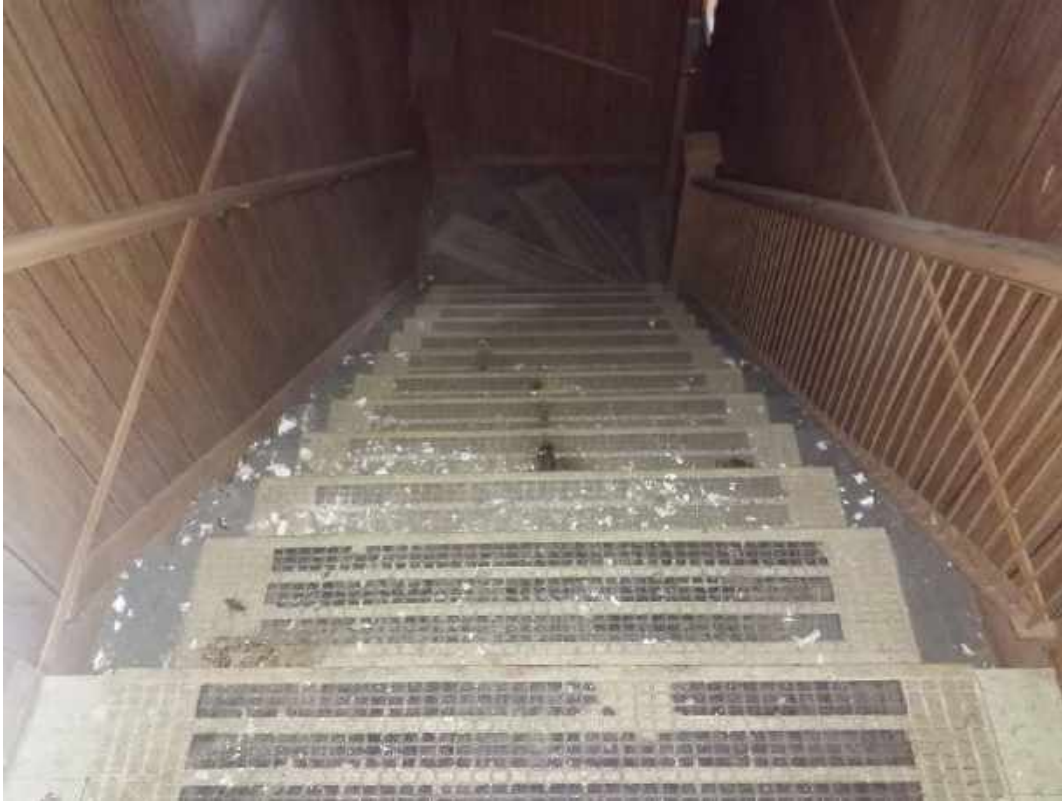
014 - Stair treads, Room 14, 2nd Floor

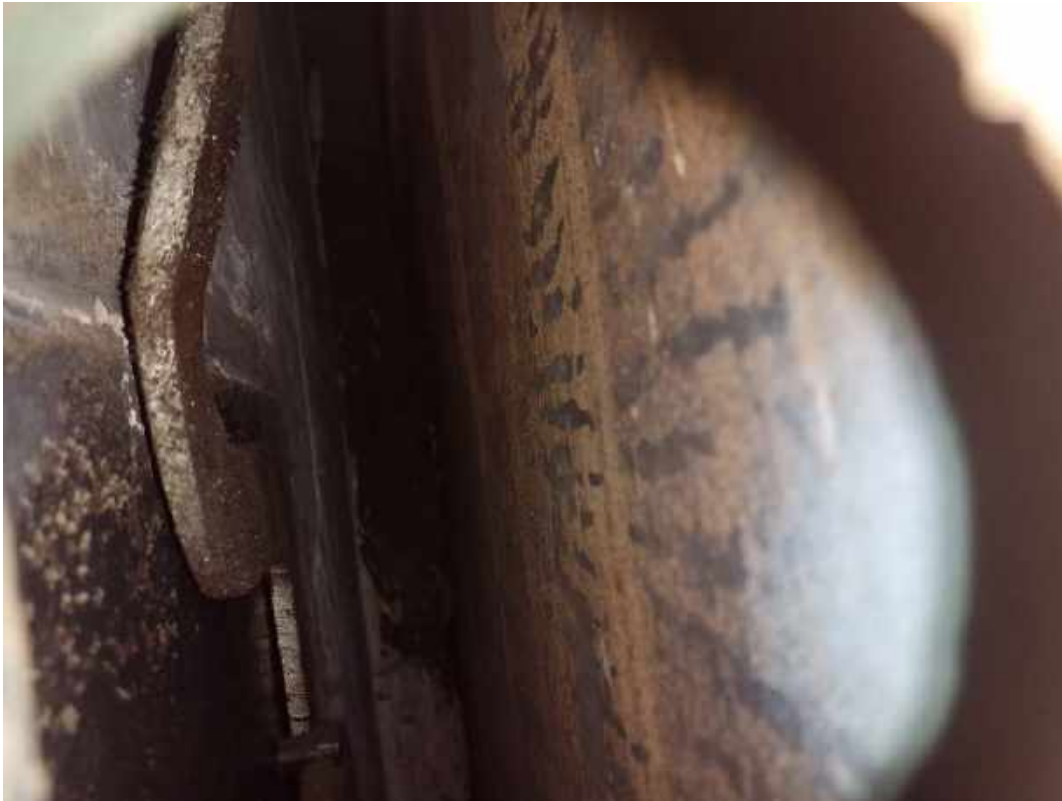
015 - Safe insulation , Room 14B, 2nd Floor

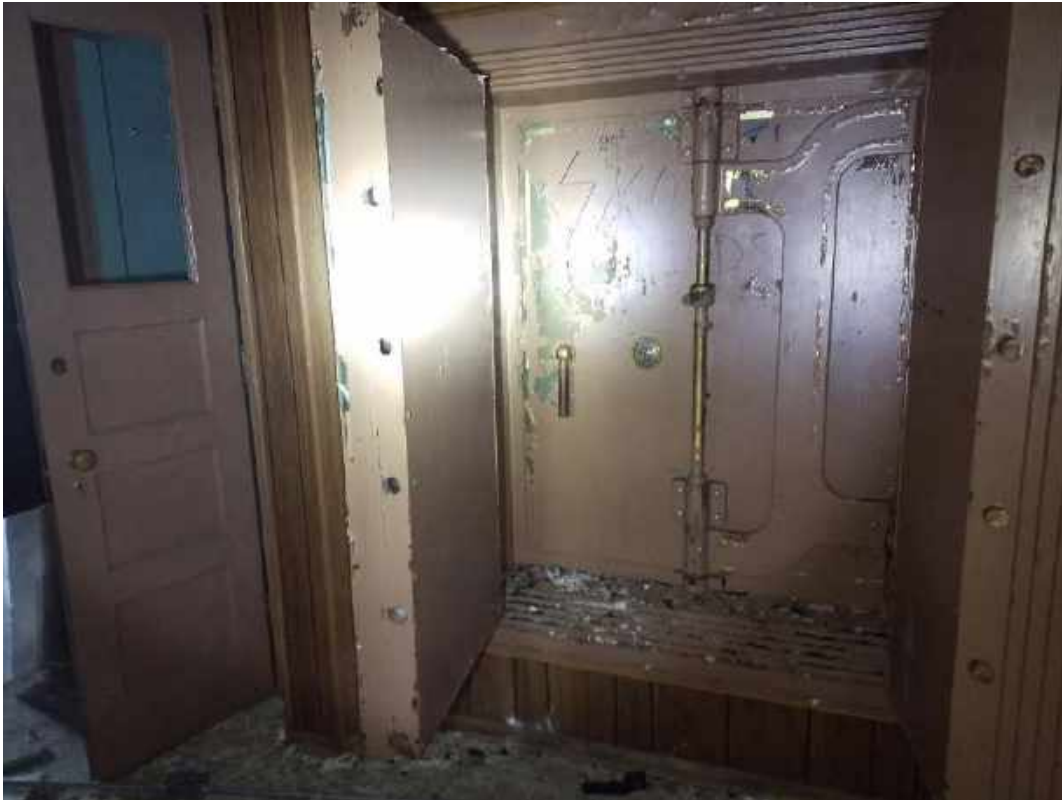
015 - Safe insulation , Room 14B, 2nd Floor

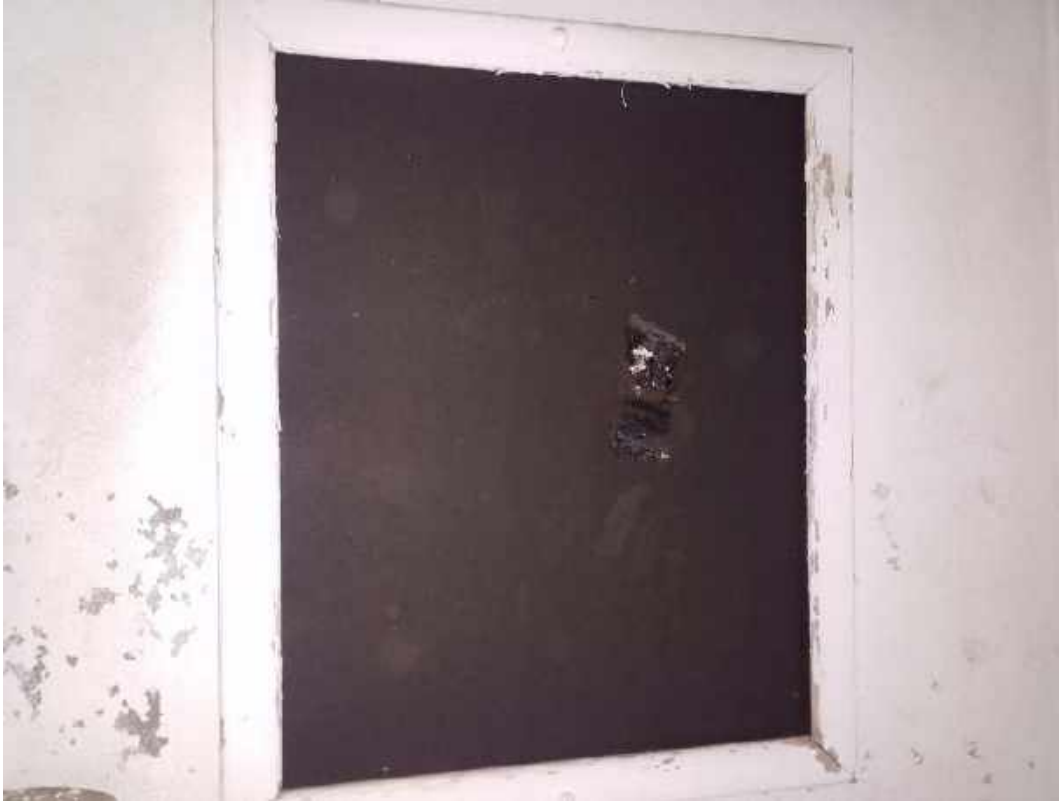
018 - Tac Board 2, Room 19, 2nd Floor

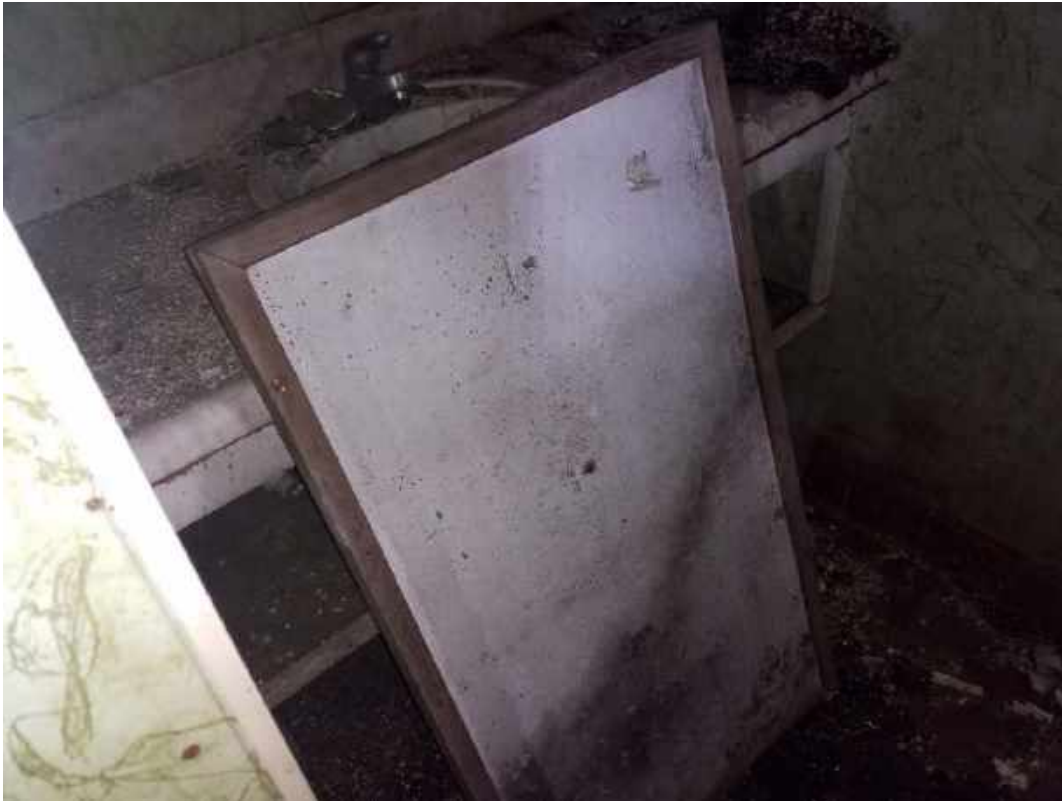
018 - Tac Board 2, Mens Restroom behind room 24, 1st floor under offices

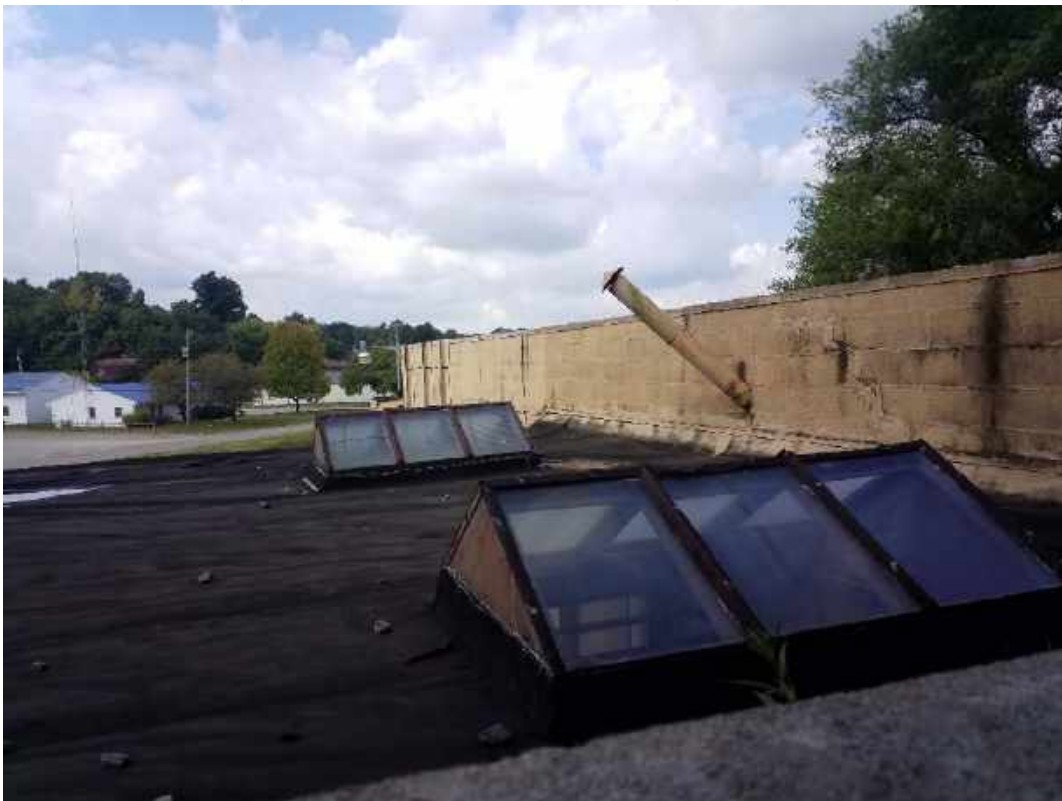
019 - Skylight glazing, Roof, Street View

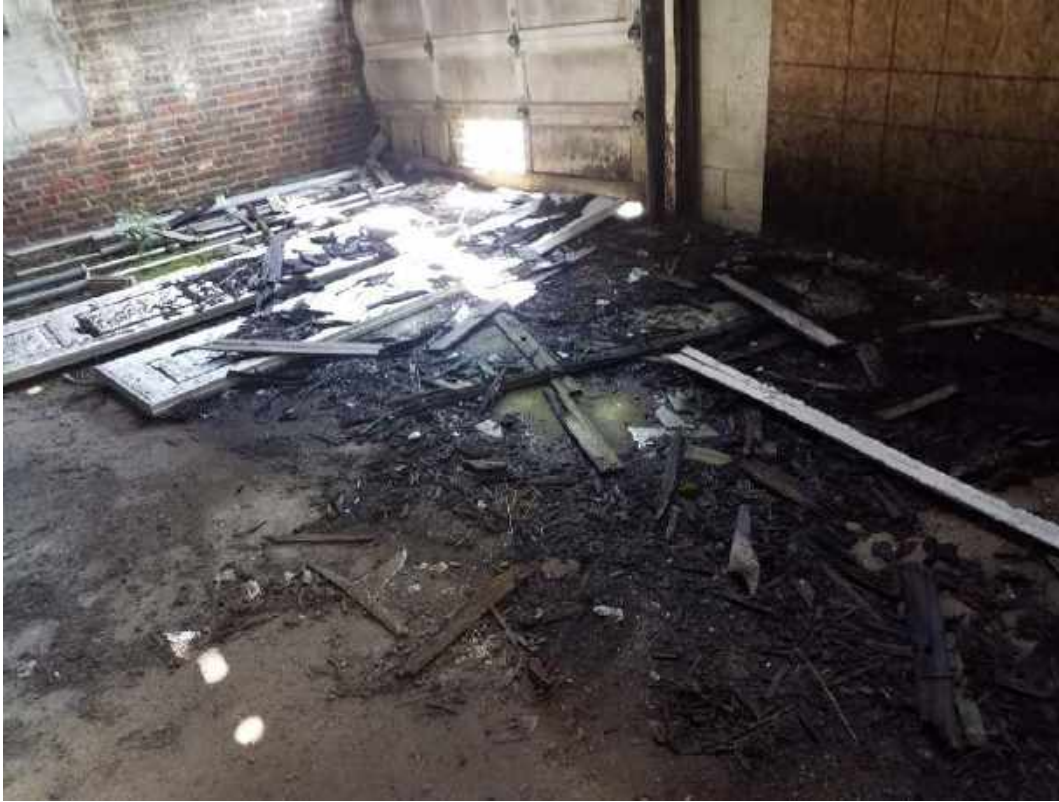
020 - Roofing debris, Garage next to Room 24 by mens restroom, 1st floor under offices

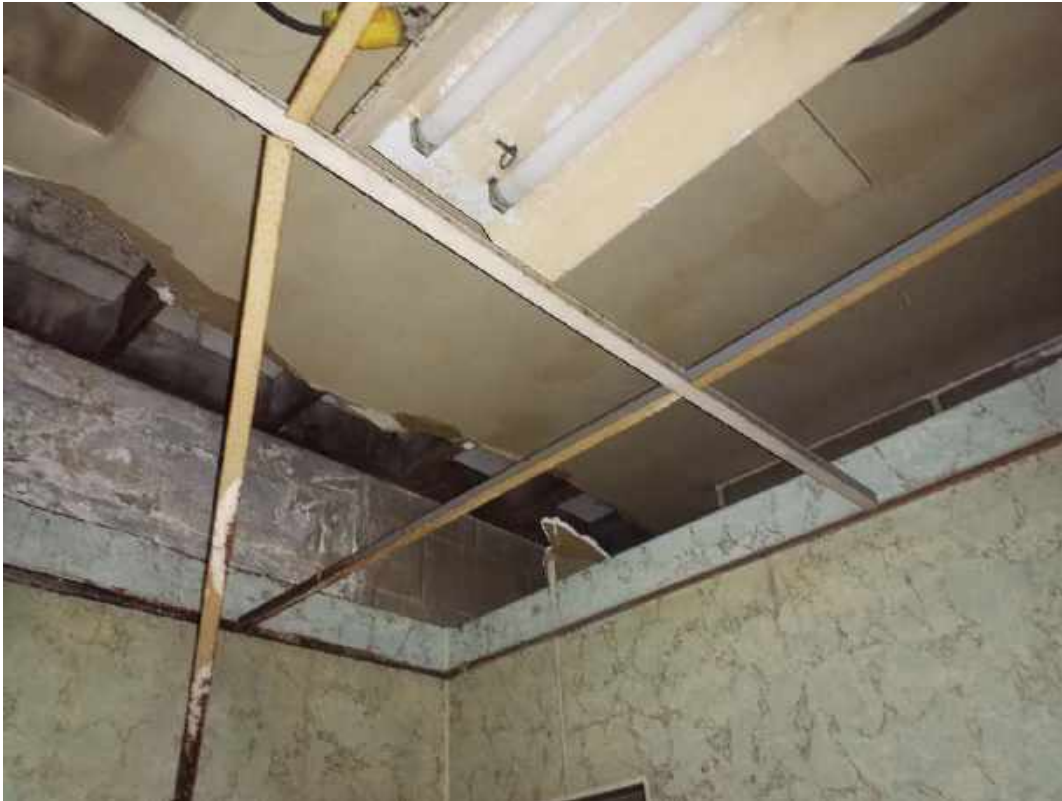
021 - Gypsum Wallboard System (Wallboard, Joint Tape, and Joint Compound), Room 32, Warehouse offices area

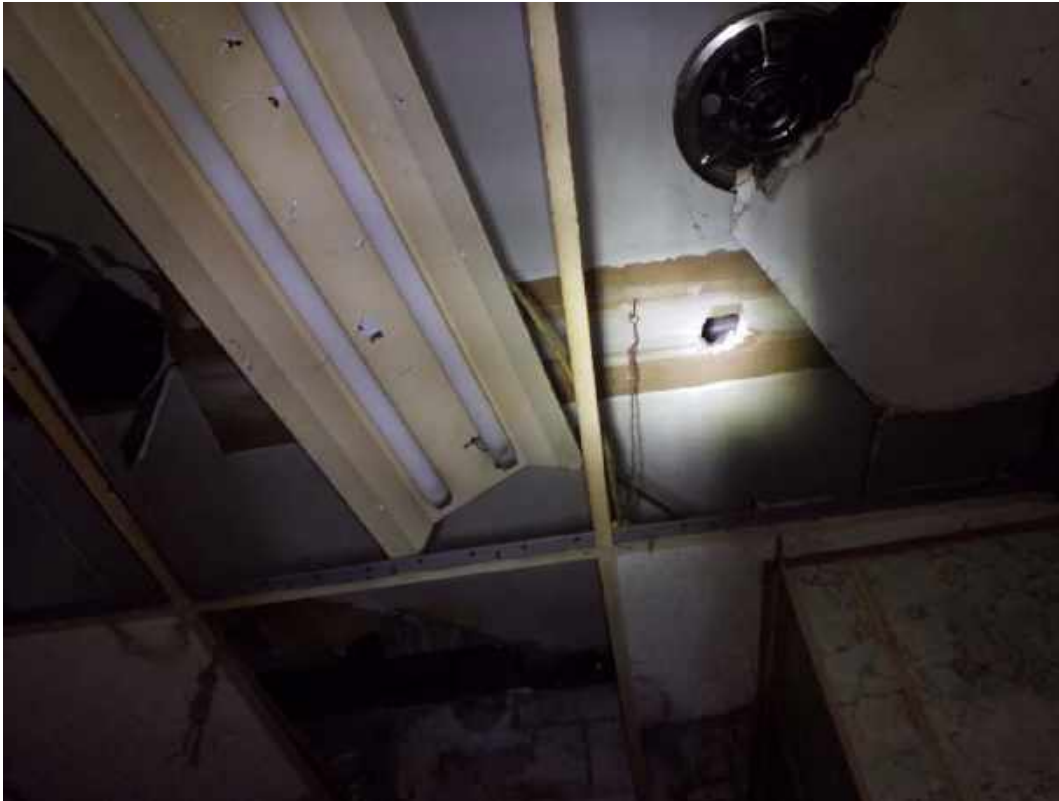
021 - Gypsum Wallboard System (Wallboard, Joint Tape, and Joint Compound), Room 33, Warehouse offices area

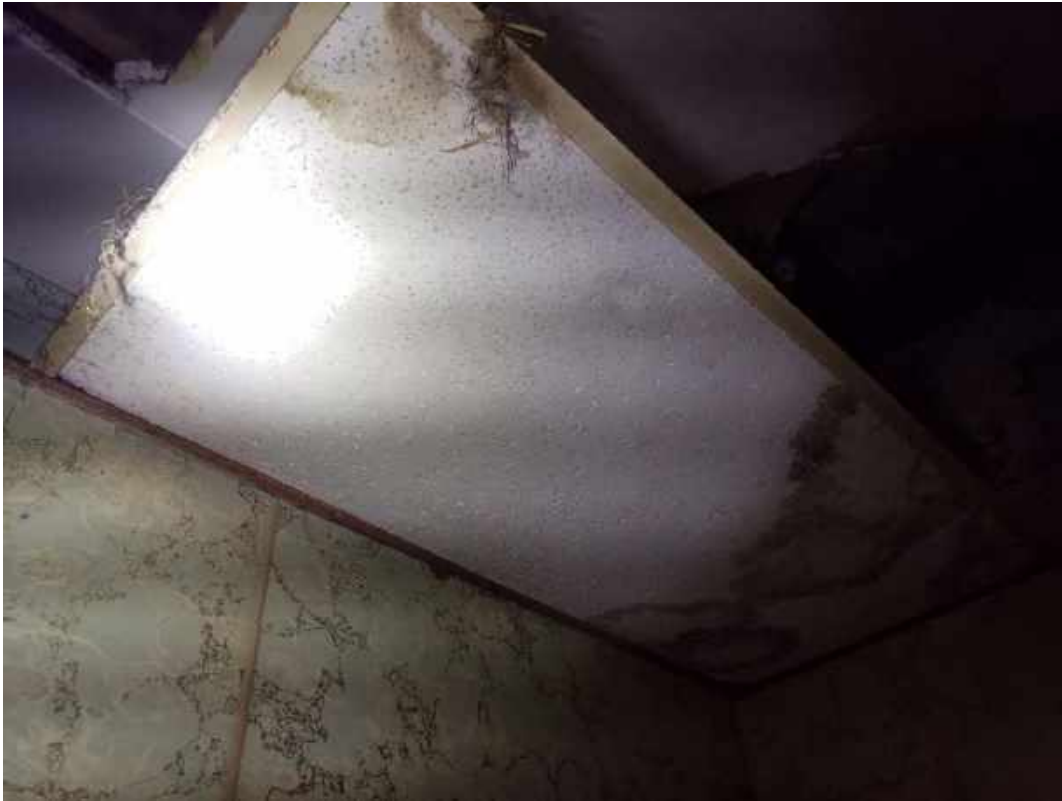
022 - Ceiling tile, Room 33, Warehouse offices area

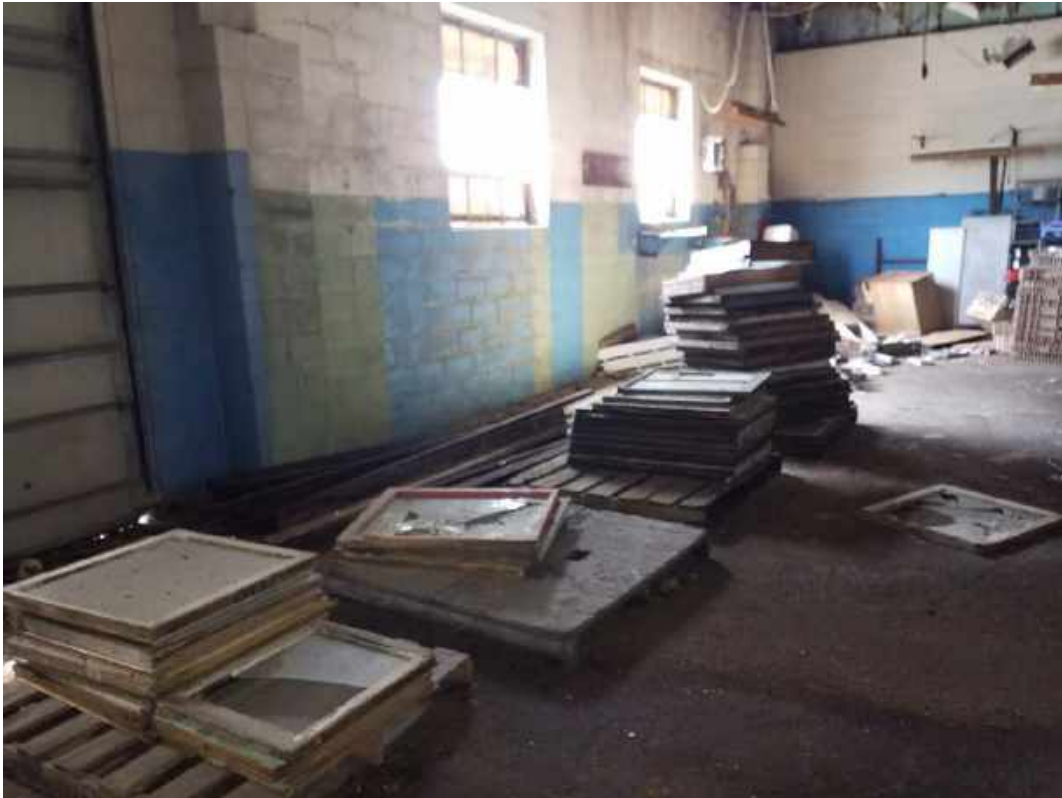
024 - Wood window sash glazing in storage, Room 42, Large L shaped warehouse

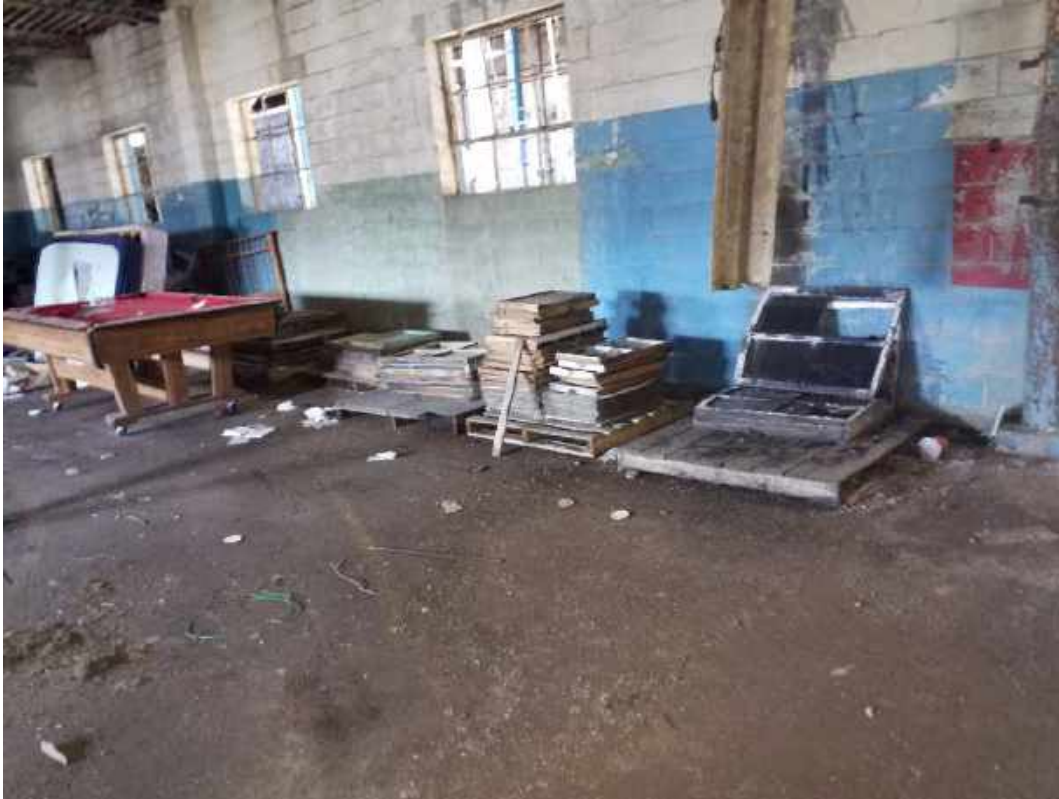
024 - Wood window sash glazing in storage, Room 42, Large L shaped warehouse

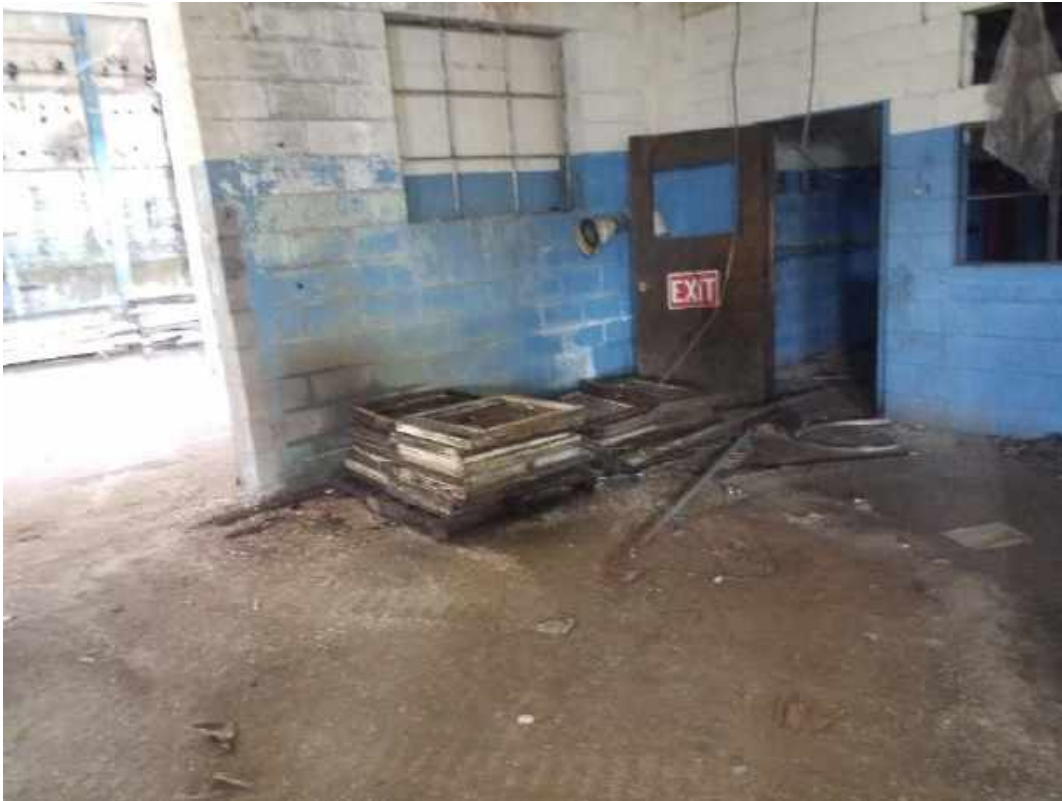
024 - Wood window sash glazing in storage, Room 42, Large L shaped warehouse

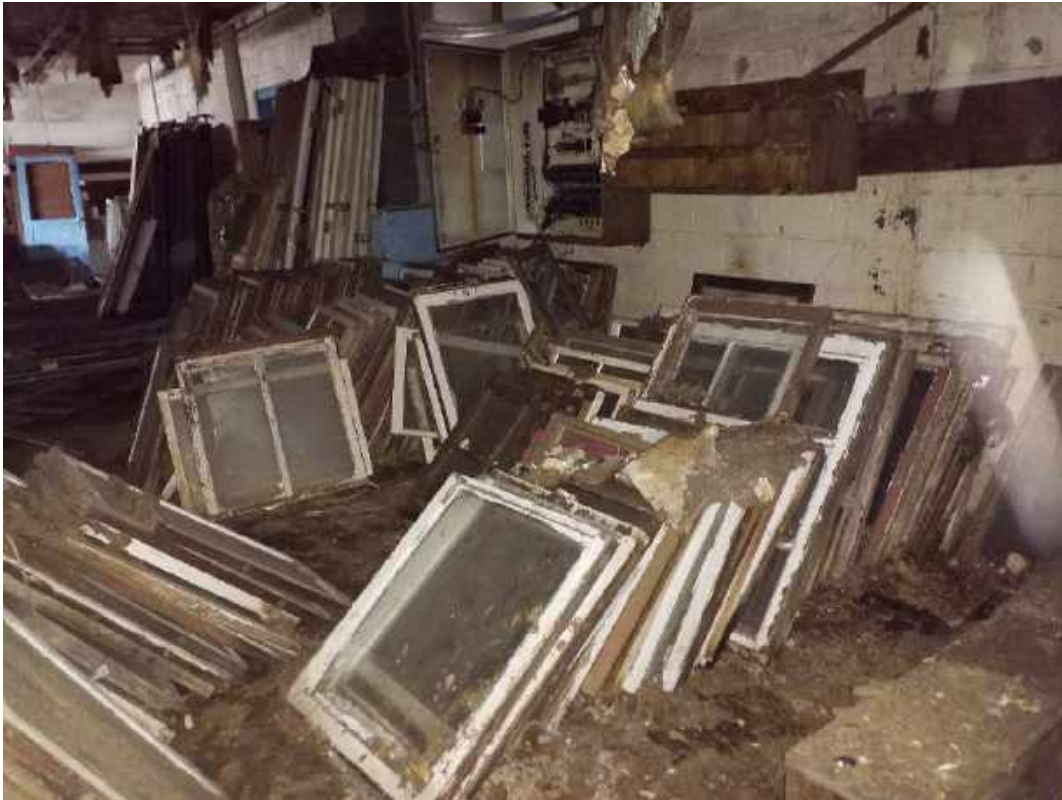
024 - Wood window sash glazing in storage, Room 47, Back warehouse and lean-to

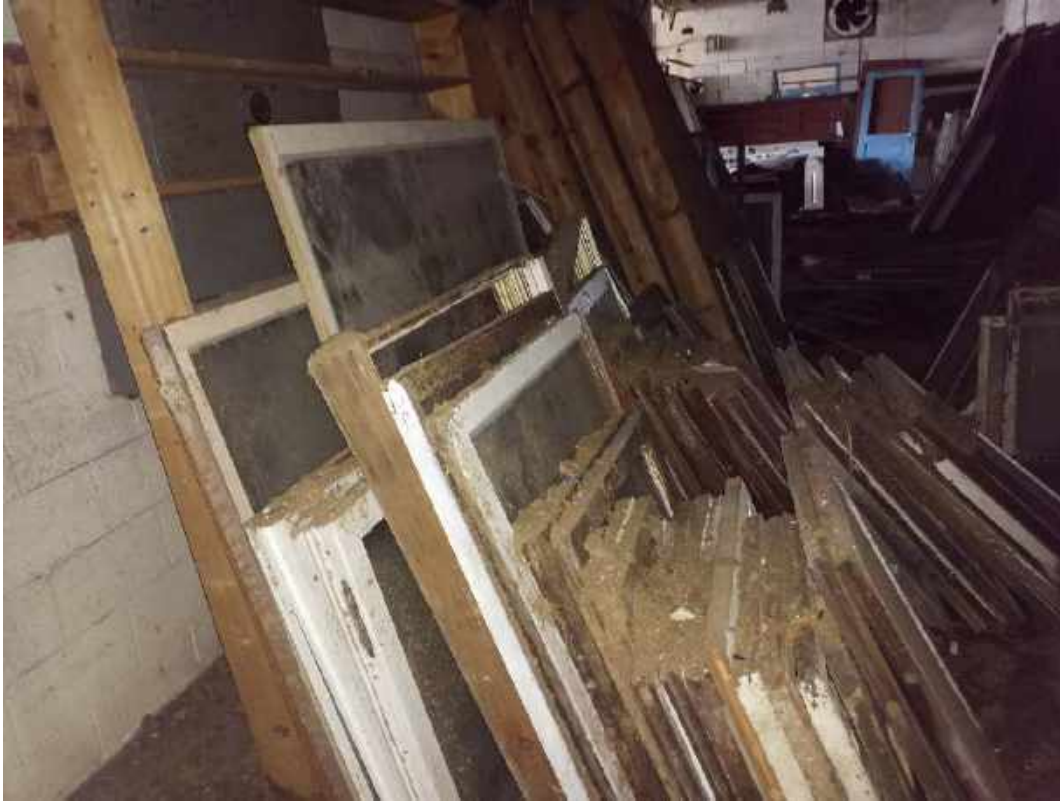
024 - Wood window sash glazing in storage, Room 47, Back warehouse and lean-to

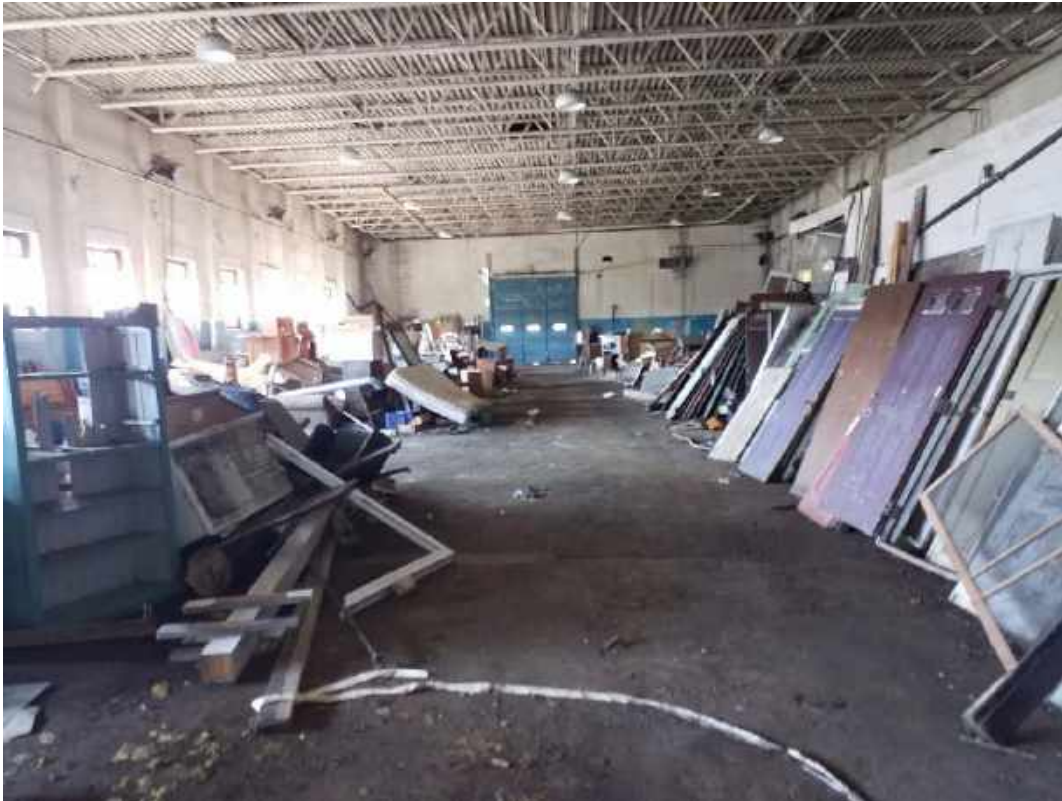
024 - Wood window sash glazing in storage, Room 48, Back warehouse and lean-to

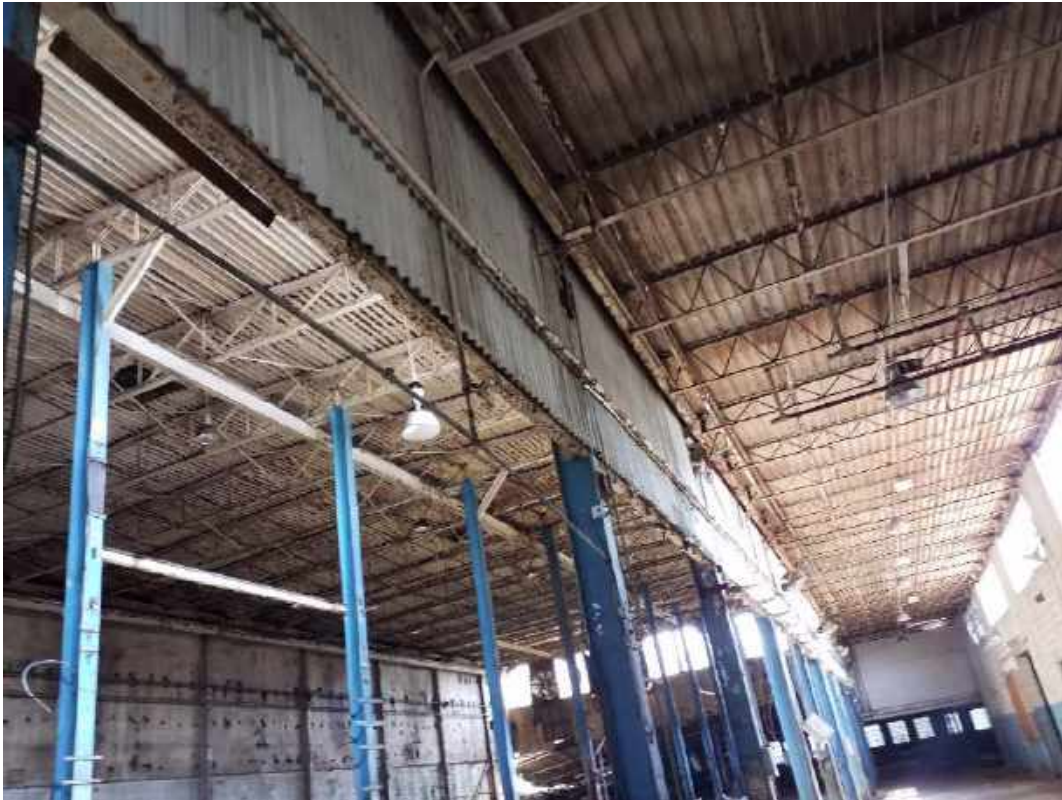
025 - corrugated transite, Room 44, Large L shaped warehouse
