**NESHAP COMPLIANCE (PRE-DEMOLITION) LIMITED (SOME AREAS
WERE NOT ACCESSIBLE) ASBESTOS INSPECTION**

526 S. Main
New Lexington, Ohio 43756

Lepi Enterprises, Inc.
640 G.W. Morse Street
Zanesville, Ohio 43701
(740) 453-2980

September 21, 2023 - September 22, 2023

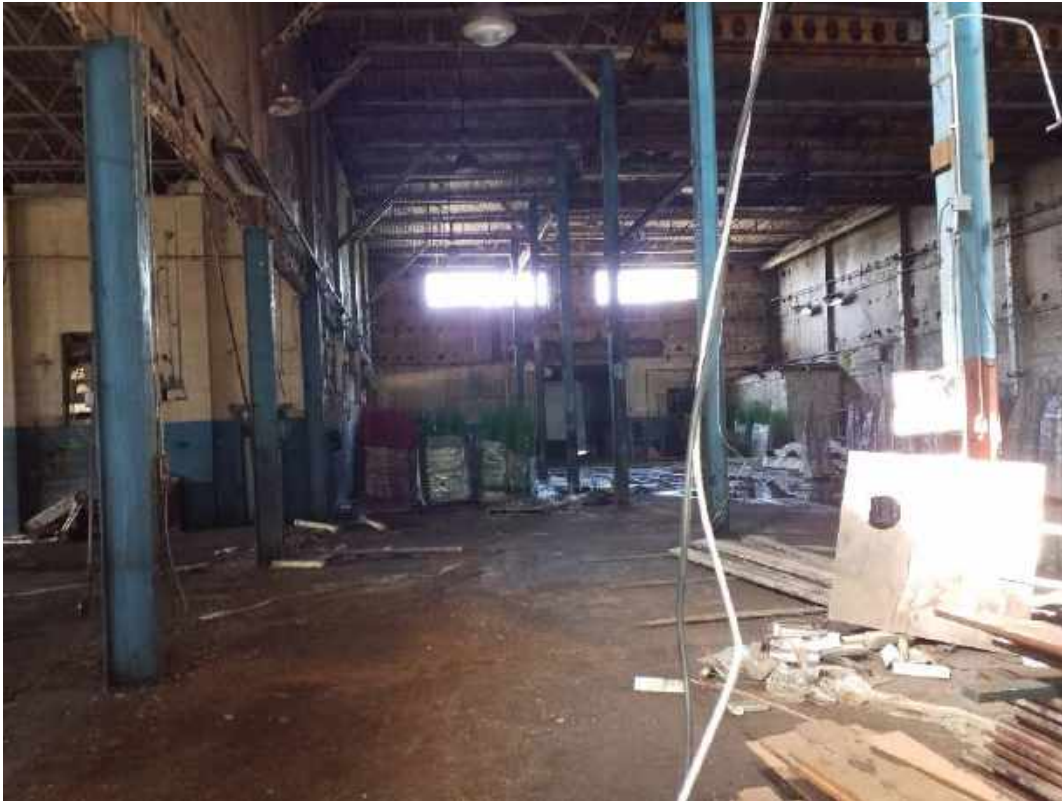
025 - corrugated transite, Room 44, Large L shaped warehouse

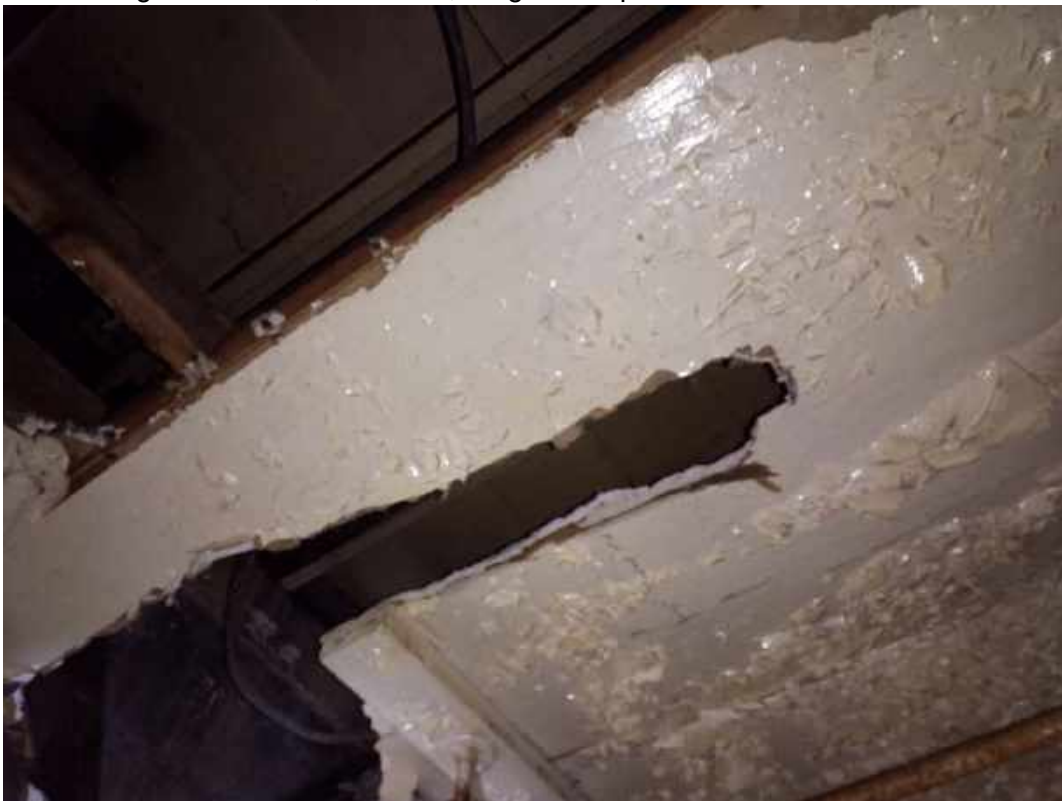
026 - Gypsum Wallboard , Room 46, Large L shaped warehouse

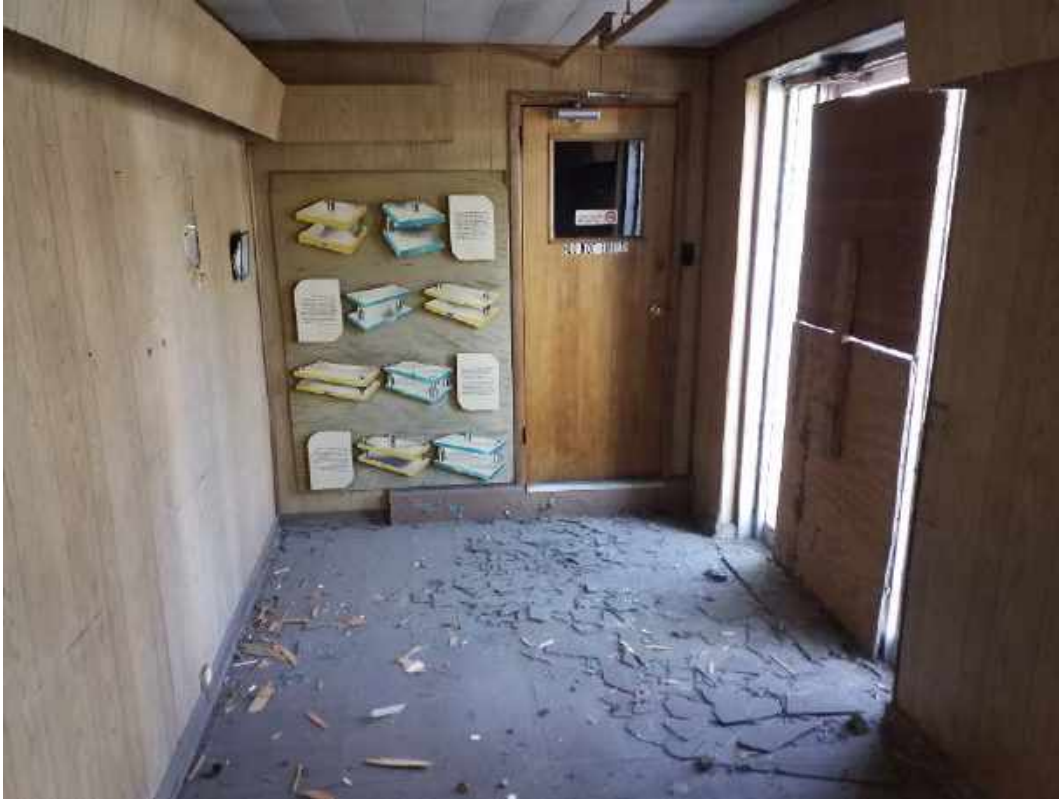
027 - Floor Tile and Mastic, Offices next to 27, 1st floor under offices

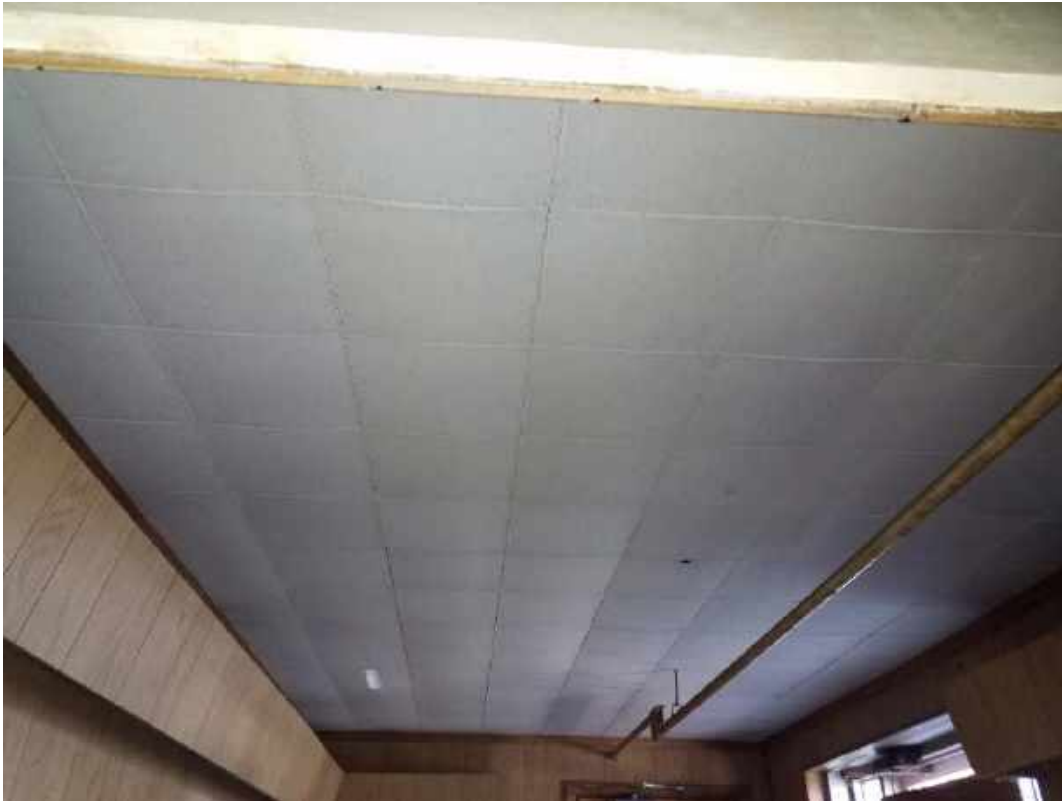
028 - Ceiling Tile, Offices next to 27, 1st floor under offices

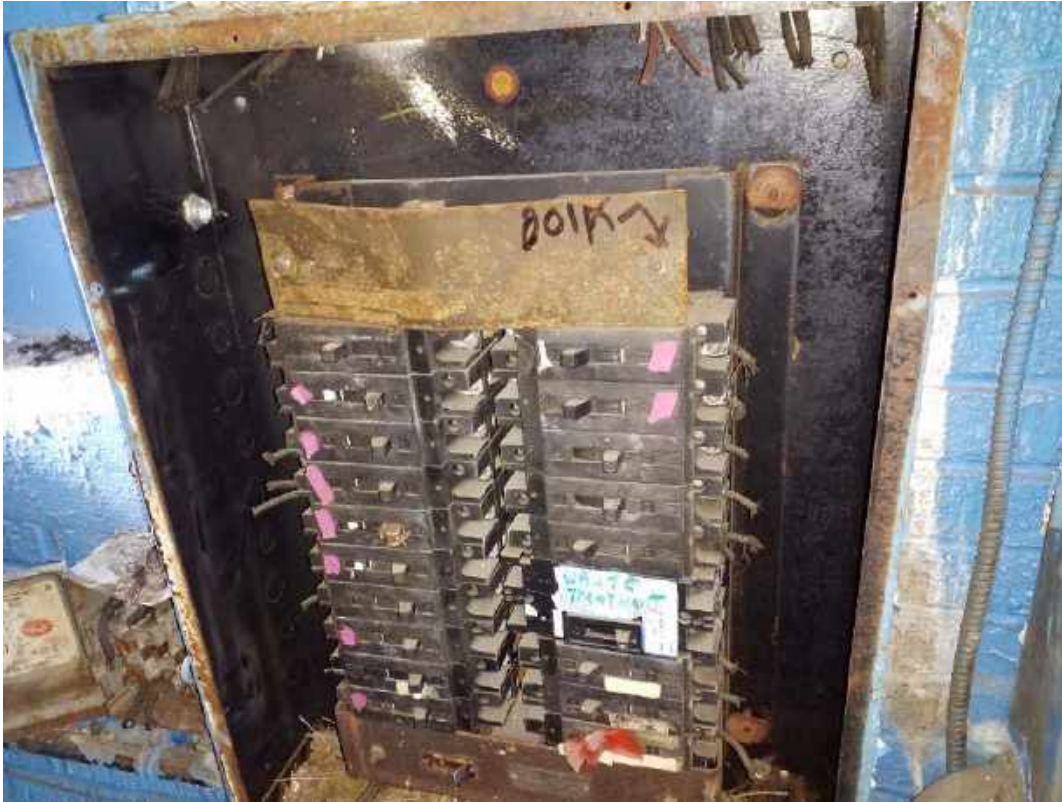
001A, 001 - Electrical wire, Room 9, 3rd Floor

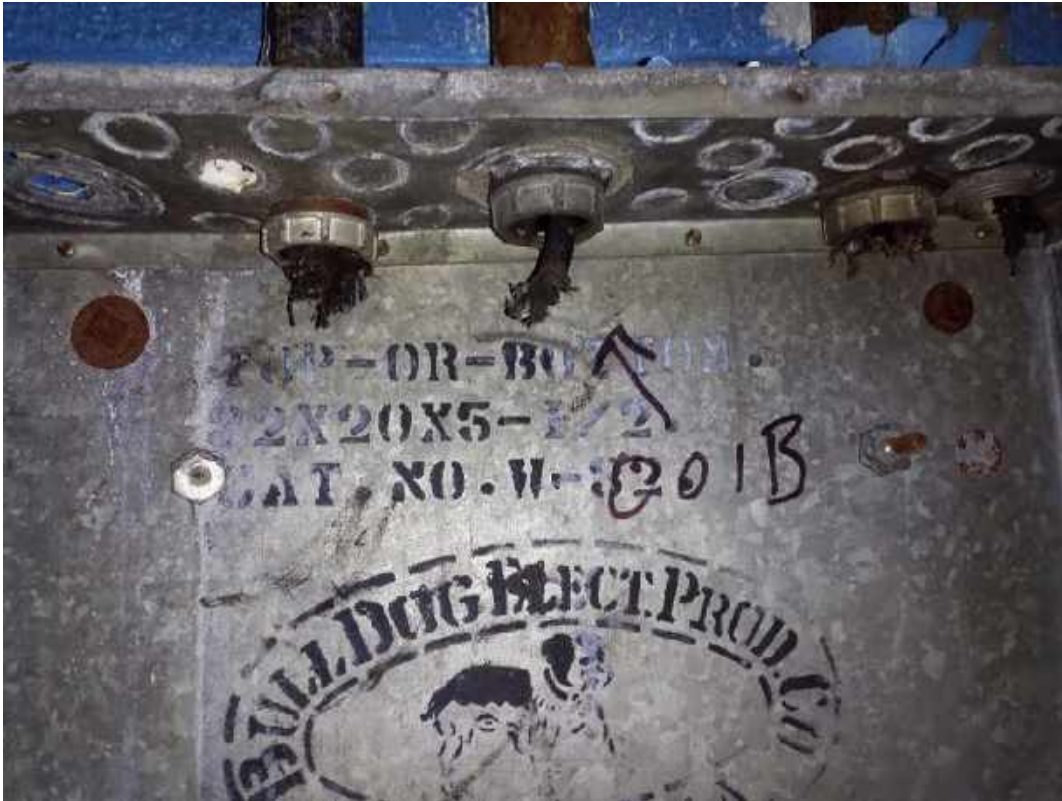
001B, 001 - Electrical wire, Room 9, 3rd Floor

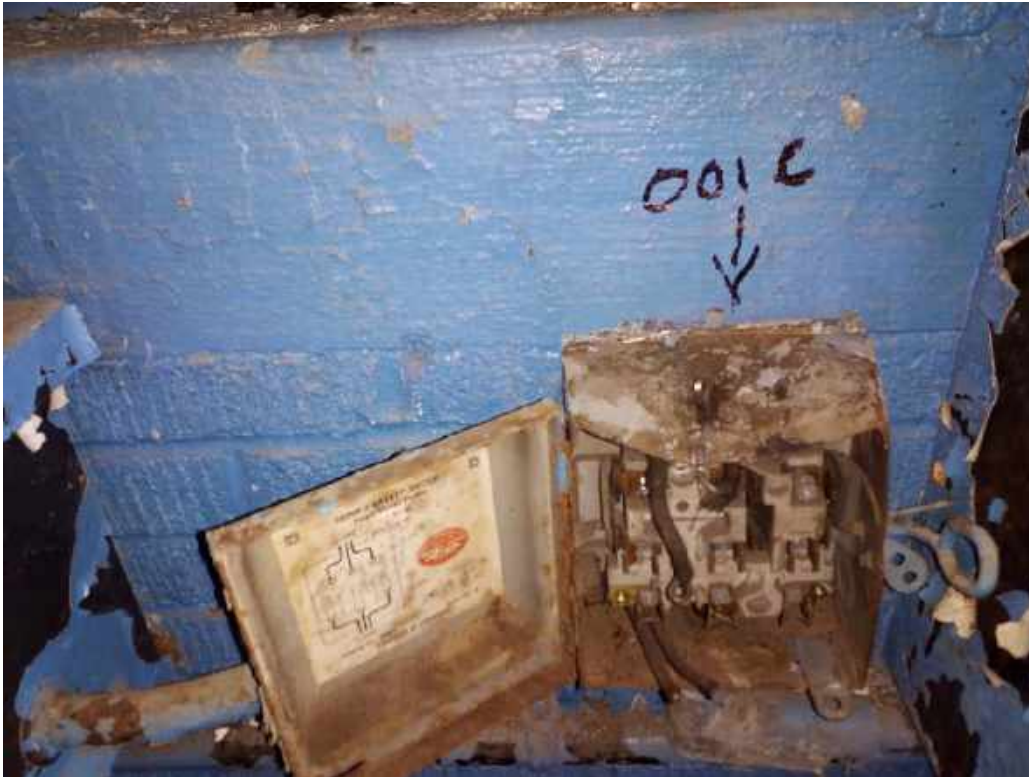
001C, 001 - Electrical wire, Room 9, 3rd Floor

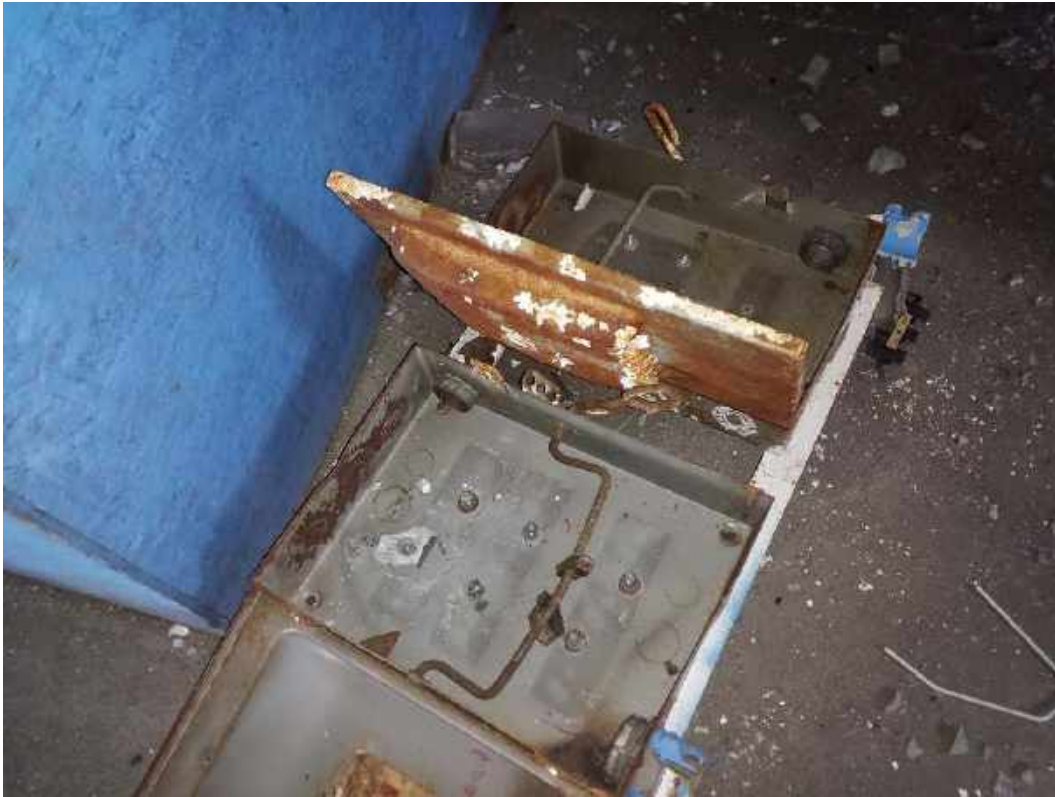
002A, 002 - Electrical transite in boxes, Room 9, 3rd Floor

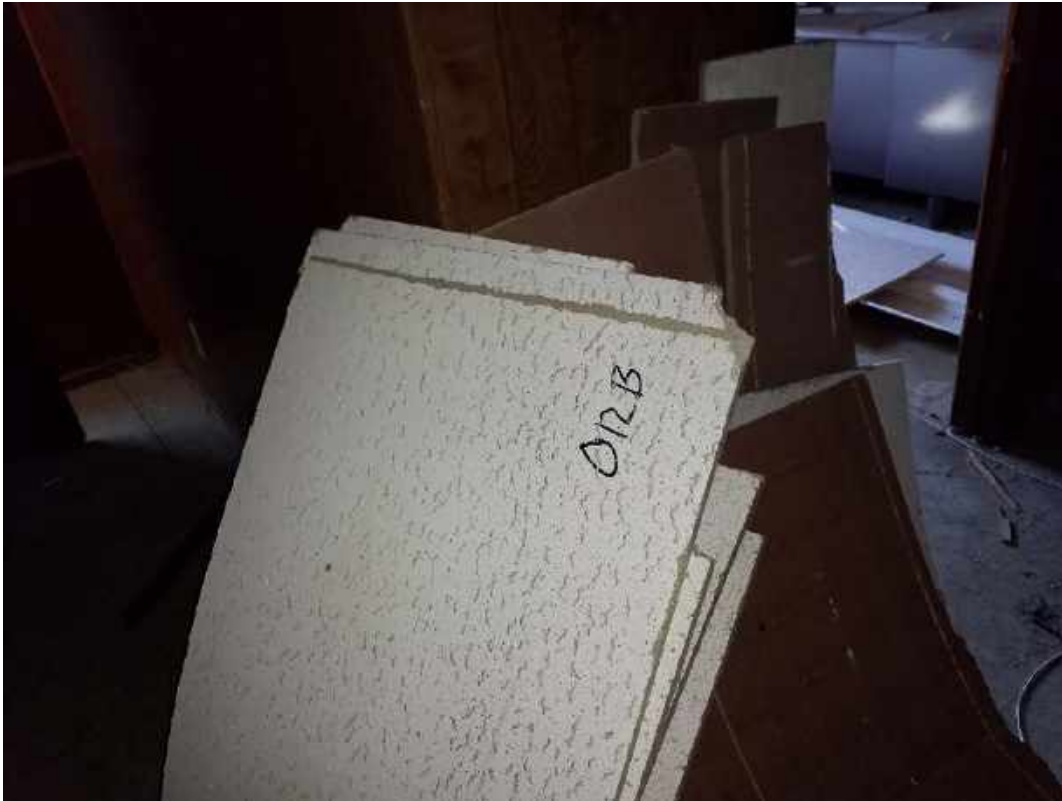
012A, 012 - Ceiling tile vertical fissure pin hole, Room 14, 2nd Floor

| Map ID | Sample ID | Section Name | Space Name | Material | Lab Result | Analytical Result |
|---|---|---|---|--|--|---|
| 12 | 012A | 2nd Floor | Room 14 | 012 - Ceiling tile vertical fissure pin hole | Tested Negative by Lab (No Asbestos Detected) | 0% |

| Client ID Lab ID | Lab Description | Lab Attributes | NON-ASBESTOS COMPONENTS | | | | ASBESTOS % |
|---|---|---|---|---|---|---|---|
| 012B B2320481.33 | Ceiling Tile | Heterogeneous White Fibrous Loosely Bound | 35% 35% | Cellulose Fiberglass | 5% 25% | Paint Perlite | None Detected |

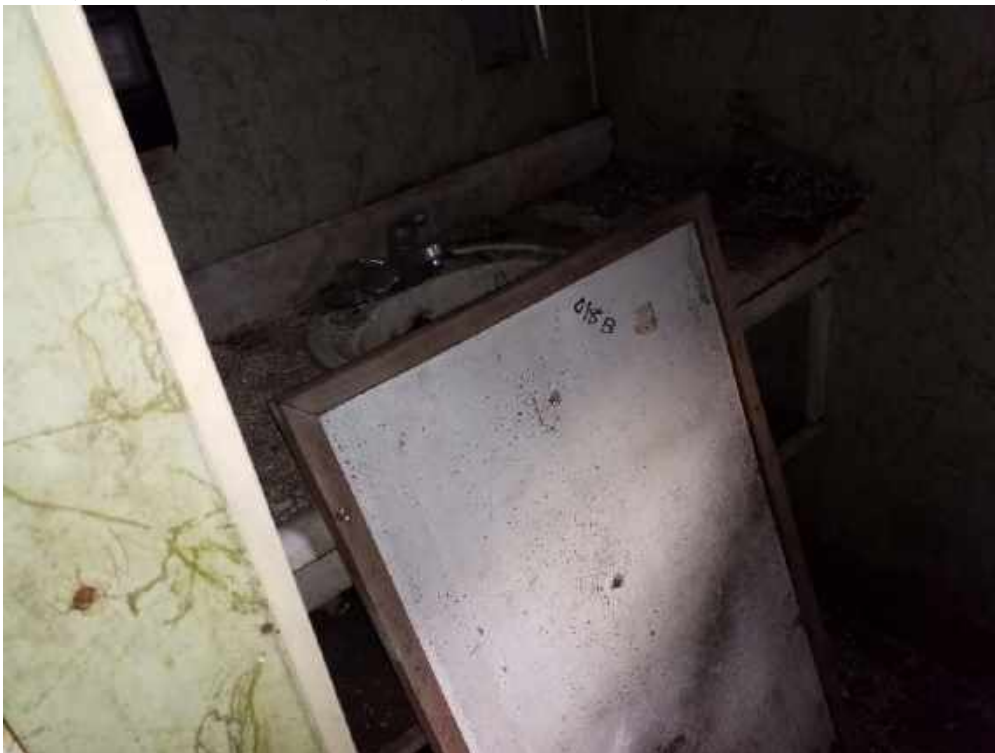
018A, 018 - Tac Board 2, Room 19, 2nd Floor

| Client ID Lab ID | Lab Description | Lab Attributes | NON-ASBESTOS COMPONENTS | | | | ASBESTOS % |
|---|---|---|---|---|---|---|---|
| 018A B2320481.39 | Tac Board | Heterogeneous White Fibrous Loosely Bound | 30% 40% | Cellulose Fiberglass | 5% 25% | Paint Perlite | None Detected |

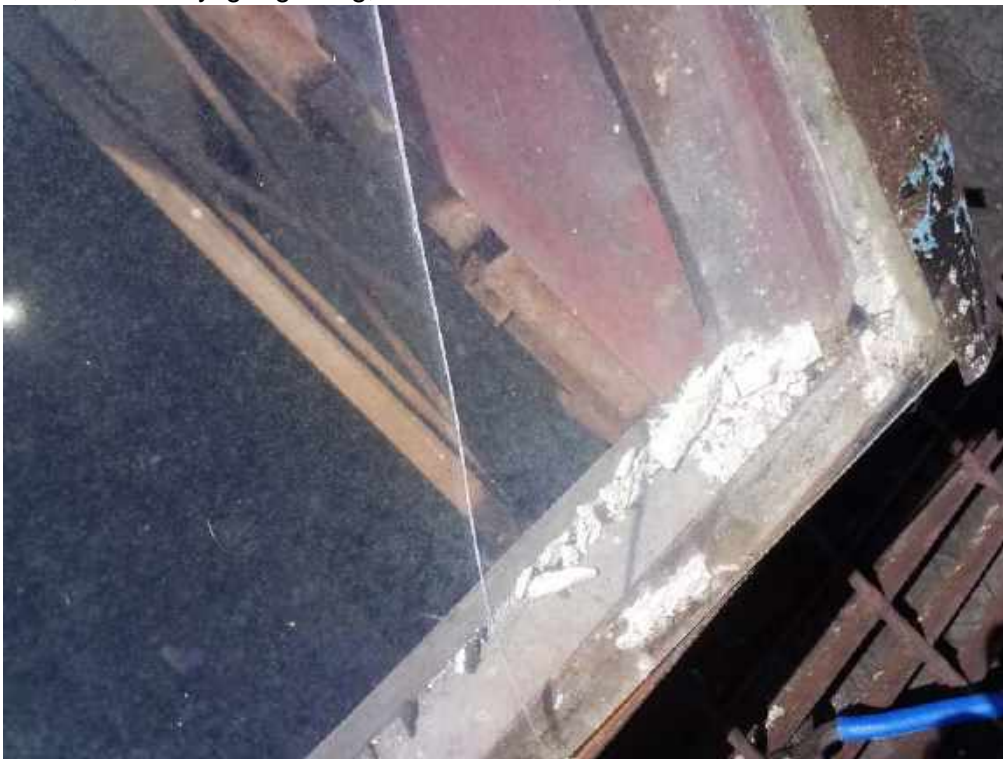
019A, 019 - Skylight glazing, 2nd floor roof, 2nd Floor

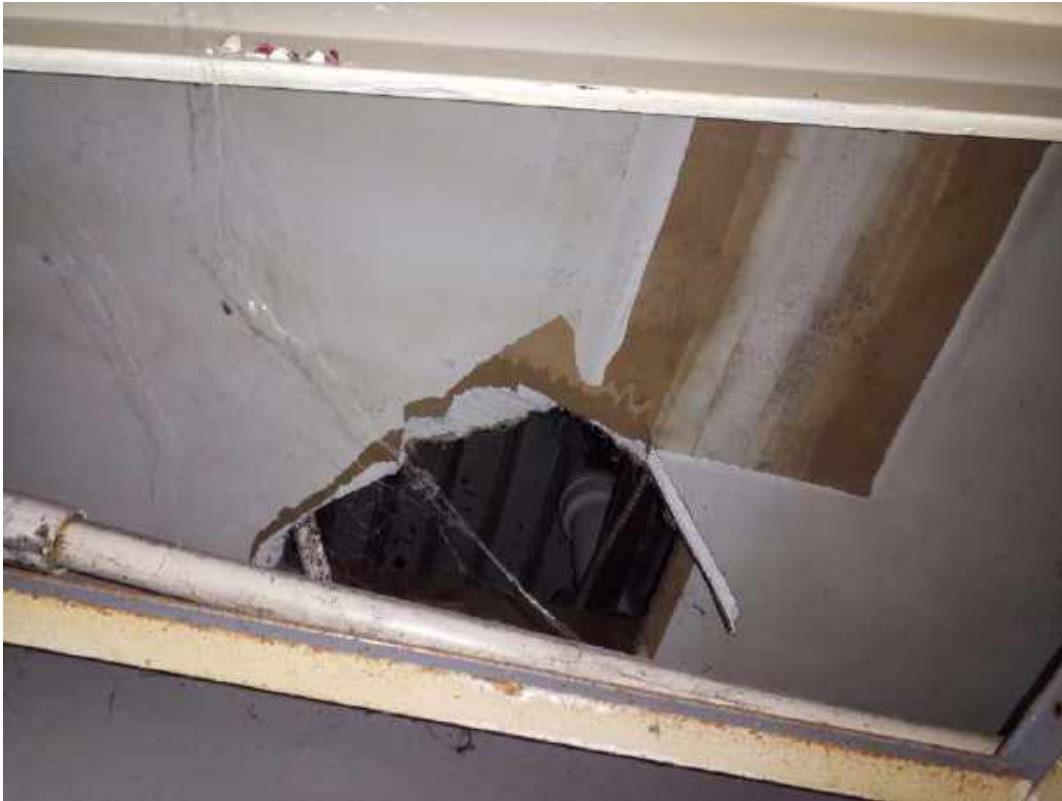
021A, 021 - Gypsum Wallboard System (Wallboard, Joint Tape, and Joint Compound), Room 32, Warehouse offices area

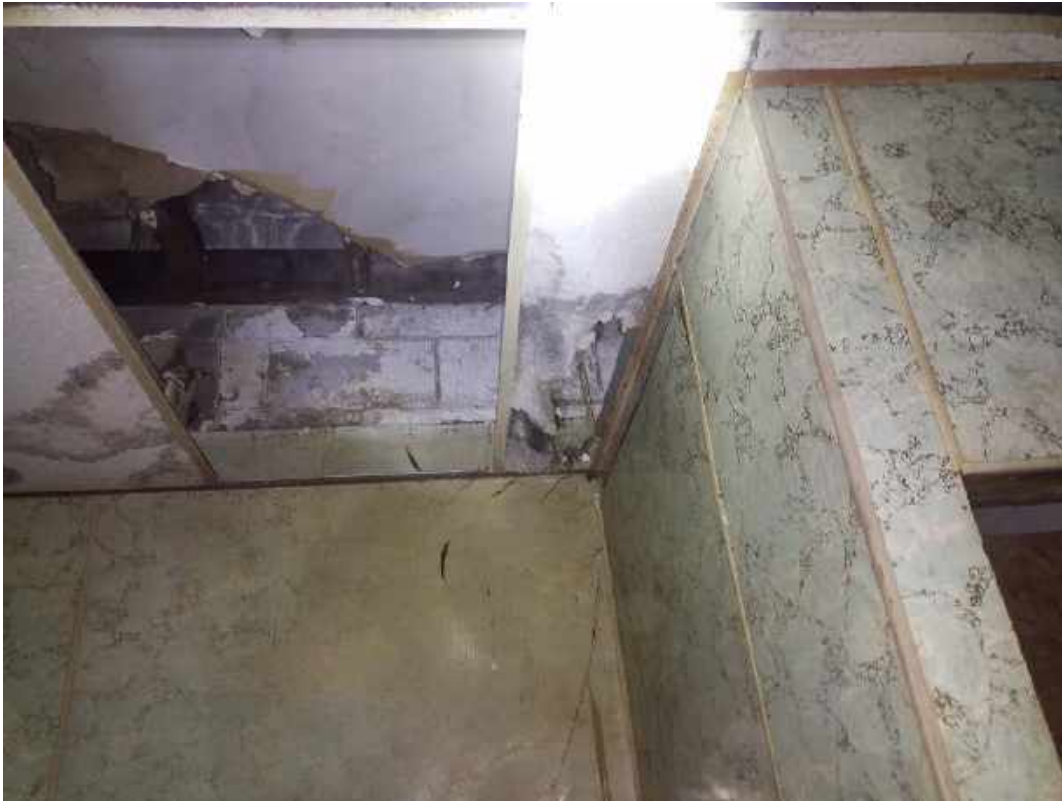
021B, 021 - Gypsum Wallboard System (Wallboard, Joint Tape, and Joint Compound), Room 33, Warehouse offices area

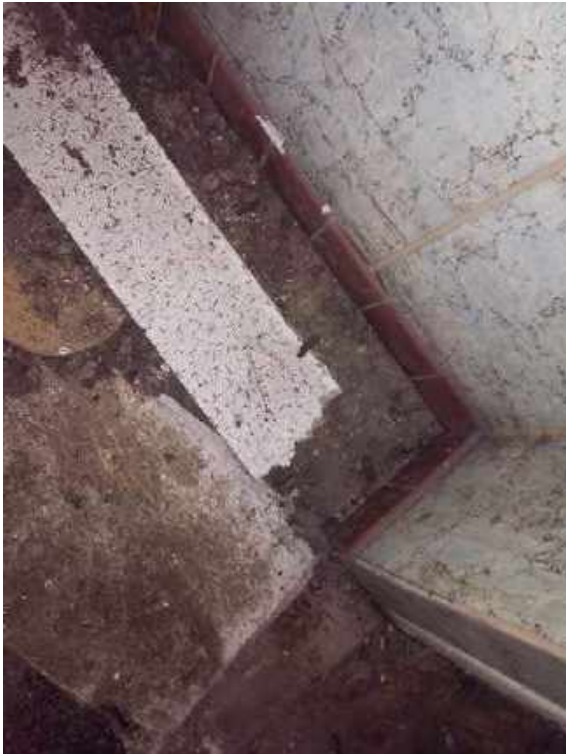
022A, 022 - Ceiling tile, Room 33, Warehouse offices area

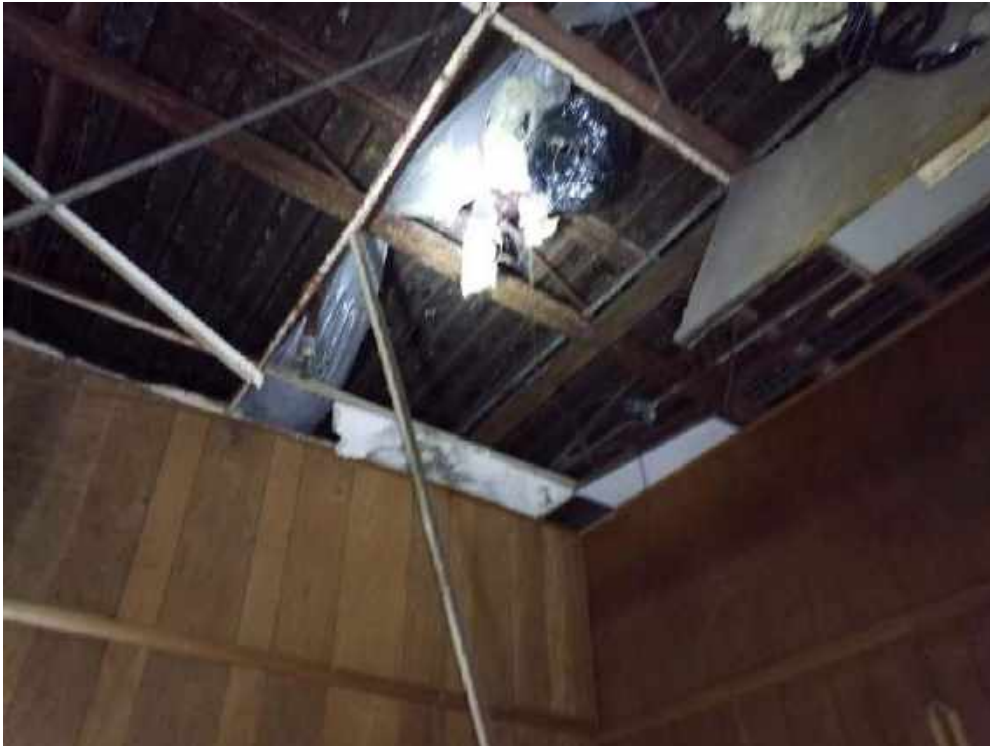
023A, 023 - Ceiling Tile, Lay In, Room 34, Warehouse offices area
